Inspection Report (On-Highway Dump Truck)

B&B Stock Number	A6804363
Year	2023
Make	Isuzu
Model	NPR HD
Serial Number	54DC4W1D1RS209203
Serial Plate

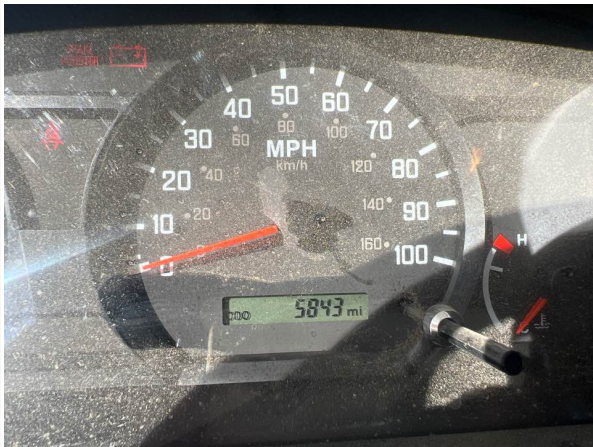
Odometer Activity	5 - Very Light or Minimal Wear				
Odometer	Odometer is working and in good condition				
Controls/Switches/Gauges	5 - Very Light or Minimal Wear				
Controls/Switches/Gauges	All switches/gauges are in good condition and functioning				
Brake System Type	Hydraulic				
Clutch	N/A				
Horn	5 - Very Light or Minimal Wear				
Horn Function	Horn is functioning as expected				
Reverse Alarm / Backup Camera	5 - Very Light or Minimal Wear				
Reverse Alarm / Backup Camera Condition	Backup camera has clear display and is working as expected				
Heater & A/C	5 - Very Light or Minimal Wear				
Heat & A/C	Heater and A/C work as expected				
Interior Lights	5 - Very Light or Minimal Wear				
Interior Lights	All interior lights are installed and functioning				
Seats/Seat Belts	5 - Very Light or Minimal Wear				
Seats/Seat Belt	Seat(s) in good condition, no stains or tears in upholstery

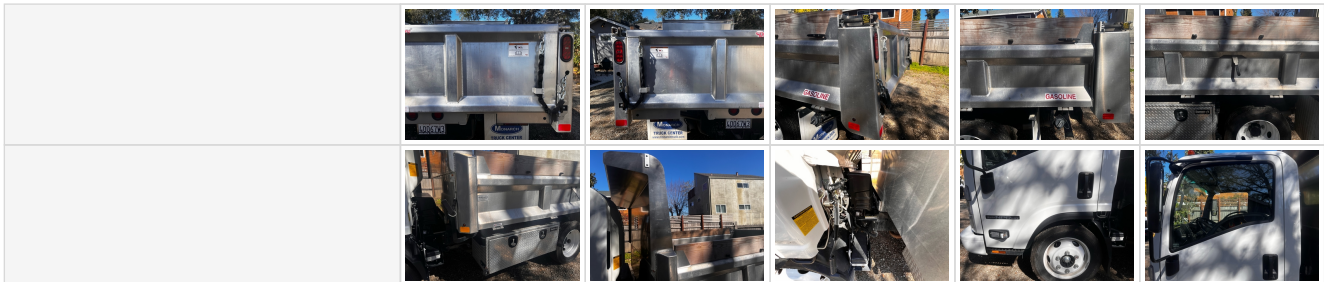
General Appearance Photos

Inspection Rating Criteria	Rating	Explanation
	5	Light or minimal wear for its age
	4	Expected wear and tear for its age, operates as expected
	3	Above average wear and tear for its age, still operates as expected
	2	Heavy wear, is operable but needs attention
	1	Requires repair(s) to function as expected
Body Panels	5 - Very Light or Minimal Wear	
Doors / Canopy Latches	5 - Very Light or Minimal Wear	
Steps / Ladders	5 - Very Light or Minimal Wear	
Handrails	5 - Very Light or Minimal Wear	
Glass	5 - Very Light or Minimal Wear	
Mirrors	5 - Very Light or Minimal Wear	
Exterior Lights	5 - Very Light or Minimal Wear	
Overall Exterior	5 - Very Light or Minimal Wear	
Comments	Light to minimal wear no major issues to report

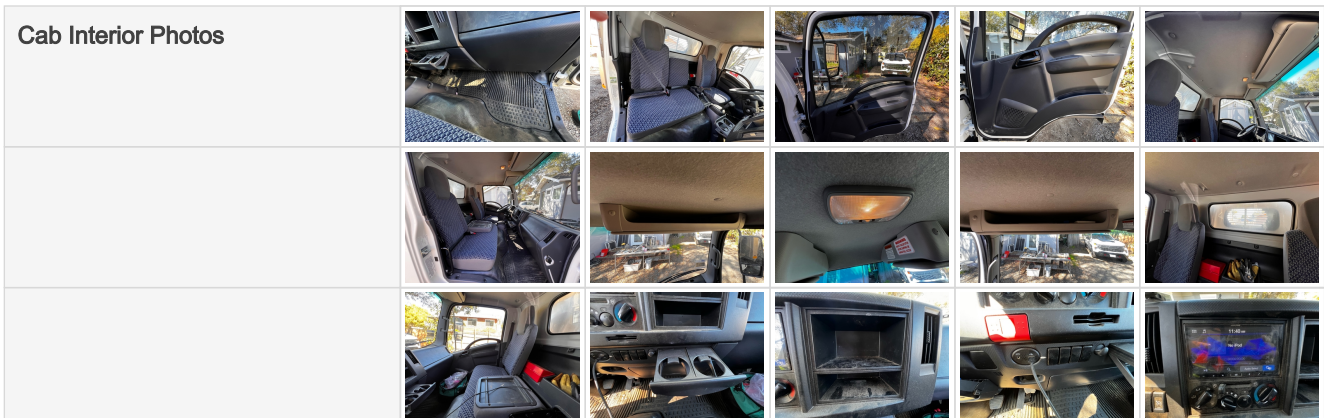
Cab Interior Photos

Cab Interior Overall	5 - Very Light or Minimal Wear

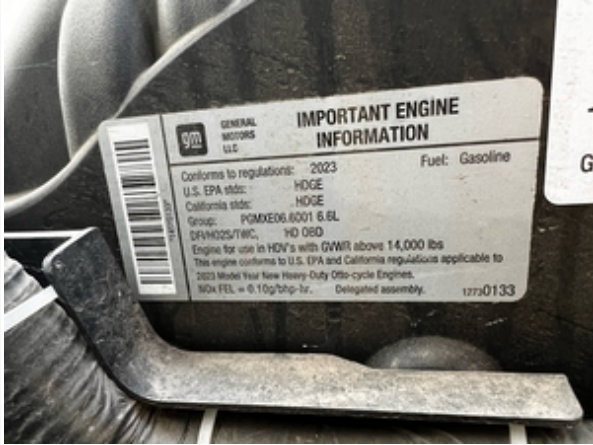
Engine Data Plate

Engine Type (Make, Model, Cylinders, Hp)	GM 6.6L				
Emissions Tier	Undetermined				
Engine Serial Number	Unable to verify				
Engine Fuel Type	Gasoline				
Blow-by (Visual Observation Check)	No				
Unusual Noises (Upon Start-up, Idle, Shutdown)	No				
Engine Exhaust Color	Clear				
Battery	5 - Very Light or Minimal Wear				
Battery Condition	Like new, recently replaced				
Radiator	5 - Very Light or Minimal Wear				
Radiator Condition	Radiator fins & components appear to be in good working order, no signs of damage or leaks

Belts	5 - Very Light or Minimal Wear
Belt Condition	Belts appear in good condition & alignment with proper tension
Hoses	5 - Very Light or Minimal Wear
Hose Condition	Firm, pliant hoses with no signs of wear or leaks
Water Pump	5 - Very Light or Minimal Wear
Water Pump Condition	No unusual pump noises heard
Cooling System Leaks	No
Coolant Appearance	5 - Very Light or Minimal Wear
Coolant Appearance Notes	Normal Translucent appearance, no visual signs of contamination
Oil Leaks	No
Oil Appearance	5 - Very Light or Minimal Wear
Oil Appearance Notes	Clean oil appearance, no signs of cross contamination
Fuel Leaks	No
Equipped with DPF (Diesel Particulate Filter)	No
Requires DEF (Diesel Exhaust Fluid)	No
Overall Engine Rating	5 - Very Light or Minimal Wear
Overall Engine Appearance	Clean & dry
Overall Engine Comments	Light to minimal wear no major issues to report
