Inspection Report (Excavator)

| B&B Stock Number | A4086940 |
| Make | John Deere |
| Model | 300G |

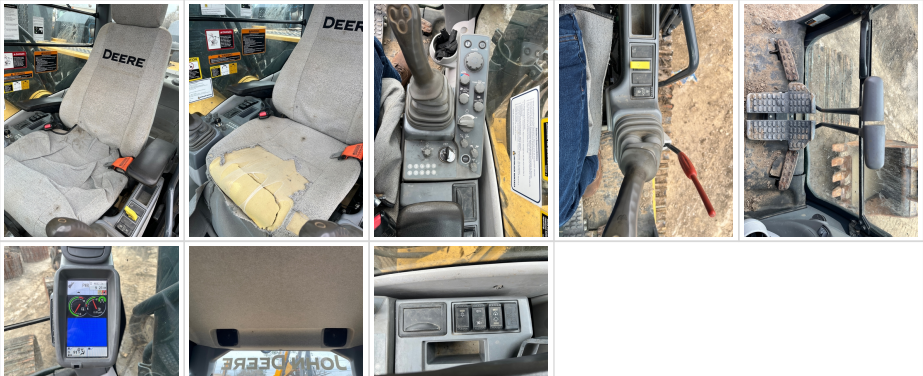
| Control Station Photos | | | | | |

| Seat | 2 - Heavy Wear - Needs Attention | | | | |
| Seat Condition | Seat has major surface staining or tears, Seat belt secures properly, Seat belt is intact and in good condition | | | | |

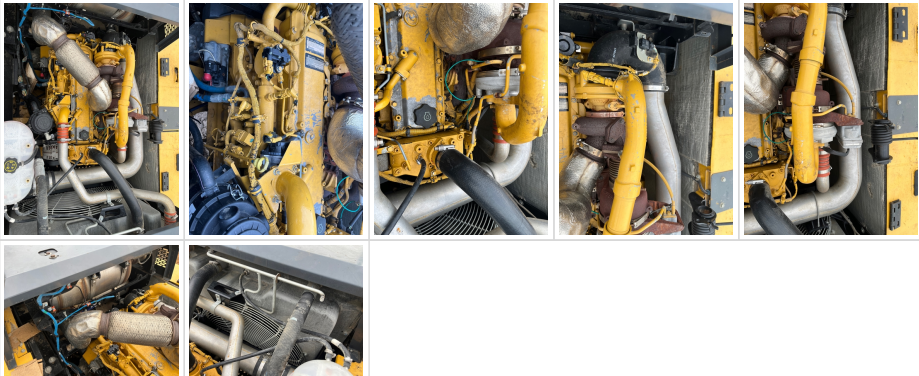
| Engine Compartment Photos | | | | | |

| Overall Engine Appearance | Clean & dry |
| Overall Engine Comments | General wear and tear. Engine panel was removed for maintenance. But will be put back on shortly |
