# Inspection Report

## Hydraulics

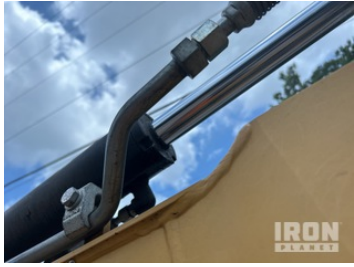
| Stick Cylinder | ★★★☆☆<br>Dripping leak | |

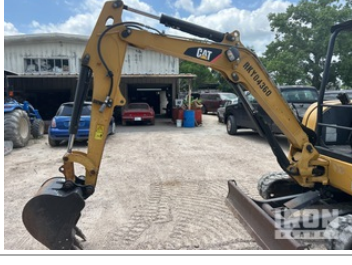
| Item | Assessment | Photo |
|---|---|---|
| Paint Condition** | Damage | |

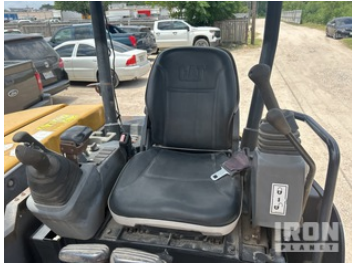
| Control Station - CE Excavator* | | |
|---|---|---|
| Seat/Armrests* | Operator seat cushion damaged | |

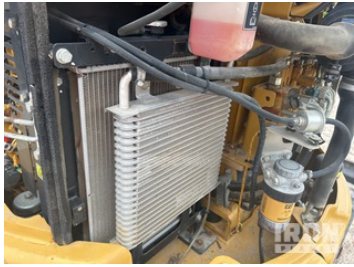
| Engine - CE* | | |
|---|---|---|
| Radiator | ☆☆☆☆ | |
