Inspection Report (Trailer)

B&B Stock Number	A6442613
Year	2021
Make	P.J. Trailers
Model	40' FB Retractable
Serial Number	2748
Serial Plate Photo

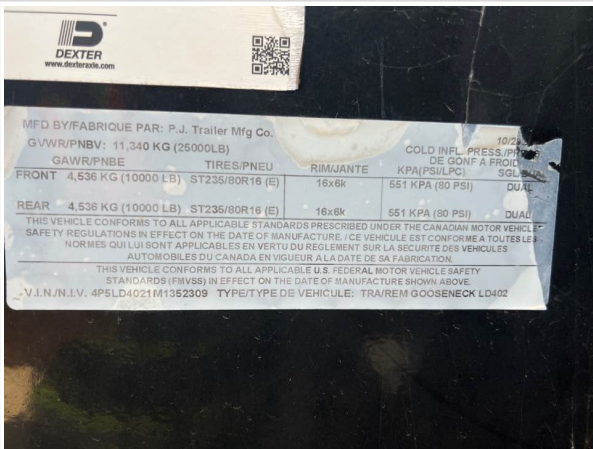
VIN Number	4P5LD4021M1352309
VIN Plate Photo

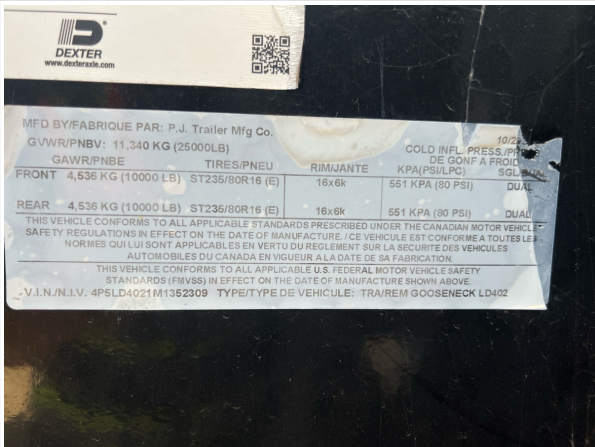
Data Plate Photo

Length (ft and inches)	10'
Width (ft and inches)	9'
Max Height (ft and inches)	12'7"
Dock Height (ft and inches)	2'8"
GVWR (lbs)	25000
GAWR (lbs)	10000

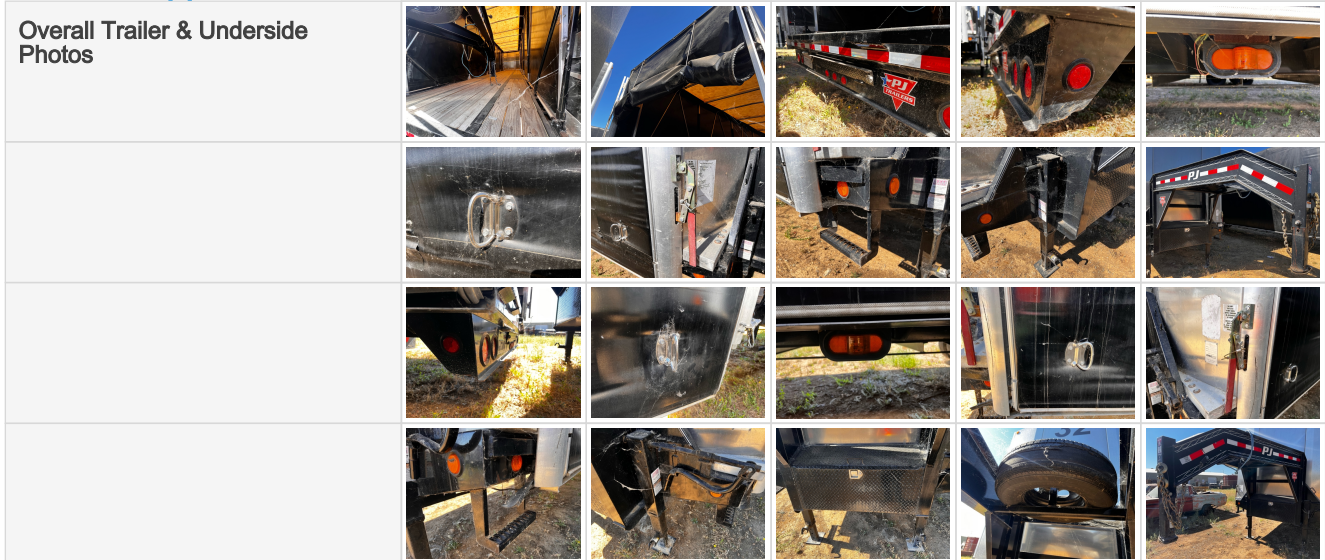
General Appearance Photos

Frame & Deck Condition	4 - Expected Wear - Fully Operable
Trailer Lights/Wiring (Stop, Tail, Turn)	4 - Expected Wear - Fully Operable
Frame & Body Overall Rating	4 - Expected Wear - Fully Operable
