## Inspection Report (Trailer)

B&B Stock Number	A7956315
Year	2020
Make	P.J. Trailers
Model	40' FB Retractable
Serial Number	2726
Serial Plate Photo

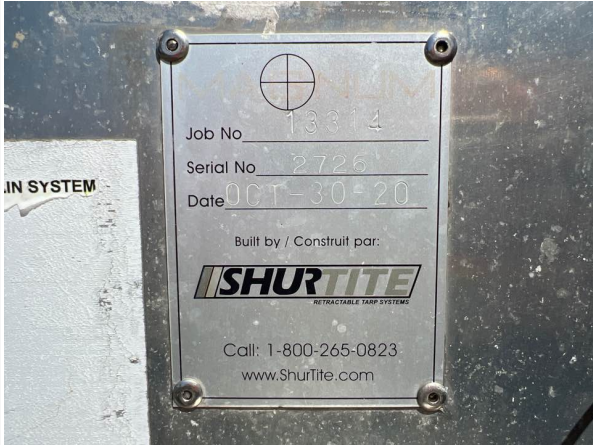
A photograph of a metal serial plate mounted on a dark surface. The plate contains the following information: Job No 13314, Serial No 2726, Date OCT-30-20. Below this, it says 'Built by / Construit par:' followed by the SHURTITE logo and 'RETRACTABLE TARP SYSTEMS'. At the bottom, it provides the contact information: 'Call: 1-800-265-0823' and 'www.ShurTite.com'.
VIN Number	4P5LD4021M1351838
VIN Plate Photo

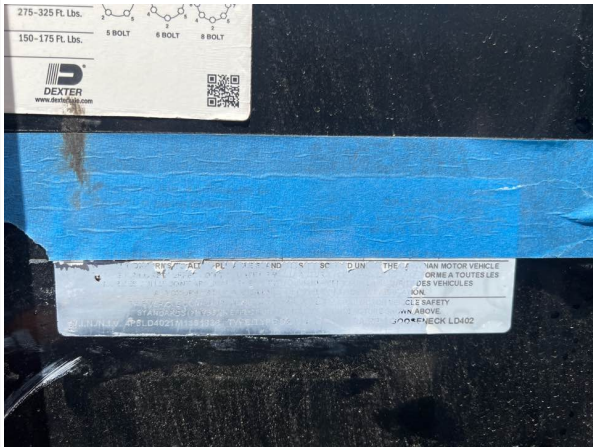
A photograph of a VIN plate mounted on a dark surface. The plate is white with black text and a QR code. It includes weight ratings: '275-325 FL. Lbs.' and '150-175 FL. Lbs.', and bolt specifications: '5 BOLT', '6 BOLT', and '8 BOLT'. The DEXTER logo and website 'www.dexter.com' are visible. Below the plate, a blue tarp is partially visible. At the bottom of the image, there is a white label with text in English and French, including the VIN number '4P5LD4021M1351838' and the model 'D4021'.
