CCR Annual Inspection

Ash Pile

San Miguel Plant

RE: CCR Annual Inspection Report for San Miguel Plant: Ash Pile CCR Unit

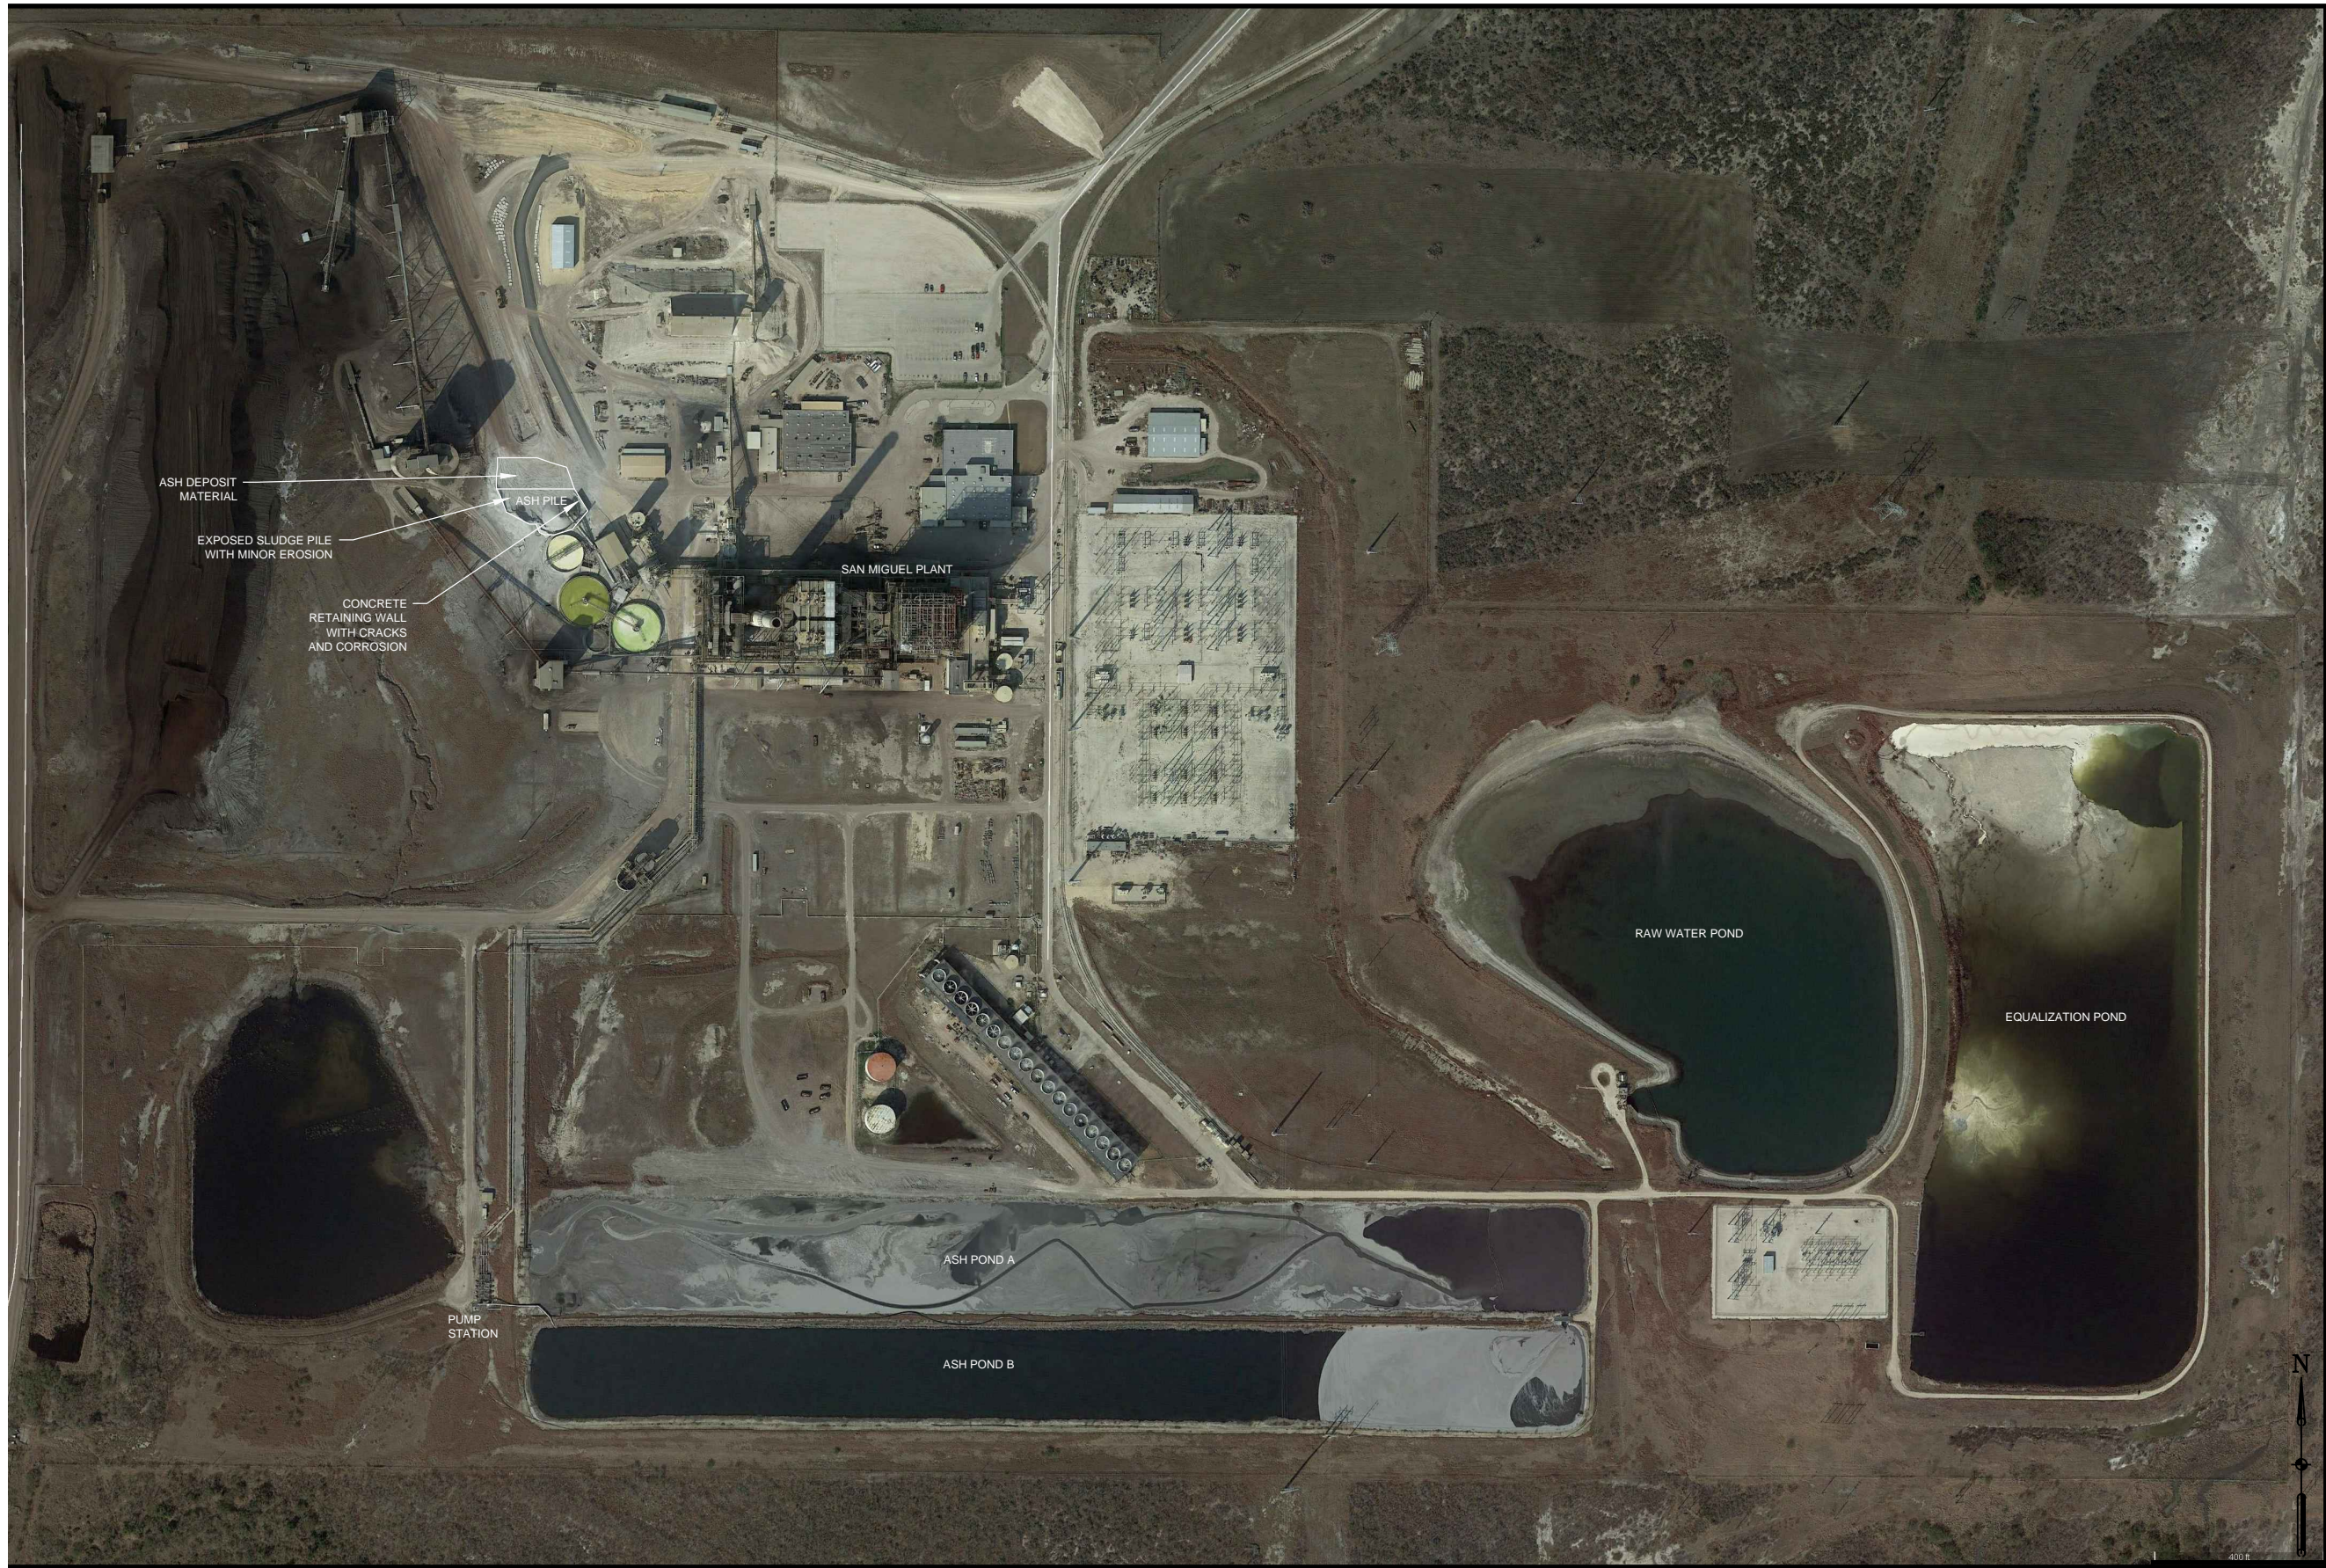
FIGURE 1

Five areas of concern were noted during the annual inspection performed on January 4, 2017. Corrective measures have been proposed to meet the requirements of §257.84 (b)(5) for each deficiency or observation identified as shown in **Table 2-2** below. **Figure 1** shows the location of the listed deficiencies observed during the most recent annual inspection conducted on January 4, 2017.

Table 3-2 – Areas of Concern (Inspected: January 4, 2017)	
Deficiency/Observation	Proposed Corrective Measure
Concrete retaining wall has large crack, signs of corrosion, and exposed rebar.	This concrete wall is a separation device that provides run-on and runoff protection to the CCR unit. A minimal amount of CCR material may come into contact with this wall for containment purposes. This minimal depth of CCR material that periodically abuts the wall produces very little need for structural support. The crack in the concrete retaining wall will be filled in order to protect the reinforcement from exposure to the elements. The stability of the wall will be monitored on a regular basis.
Steel Reinforcement on the concrete retaining wall appears to be corroded which could eventually pose a structural concern for the wall.	The crack in the concrete retaining wall will be filled in order to protect the reinforcement from exposure to the elements. The structural integrity of the wall will be evaluated and repaired as necessary. The condition of the steel will be evaluated and repairs will be performed as necessary.

Concrete retaining wall present only on east side and a steel retaining wall/ Baffle wall is used on the south side to contain the Sludge/Ash Pile.	Based on our observation, steel structures have a tendency to corrode when in contact with the CCR material. We recommend SMECI to evaluate the structure on a regular basis. The steel wall will be inspected for corrosion.
Erosion gullies observed along the drainage channel.	Protect the drainage channel for erosion control.
Sludge pile is exposed resulting in minor erosion.	Grade the area on the West and North side at a 2% slope

Stormwater runoff not draining properly. Storm water runoff ditches are present on west/north side. Run on drainage behind the concrete wall has no contact with the sludge waste.

such that all storm water or surface runoff is directed towards the drainage ditches and through the normal stormwater discharge system.
