CCR Annual Inspection

Equalization Pond

San Miguel Plant

RE: CCR Annual Inspection Report for San Miguel Plant: Equalization Pond CCR Unit

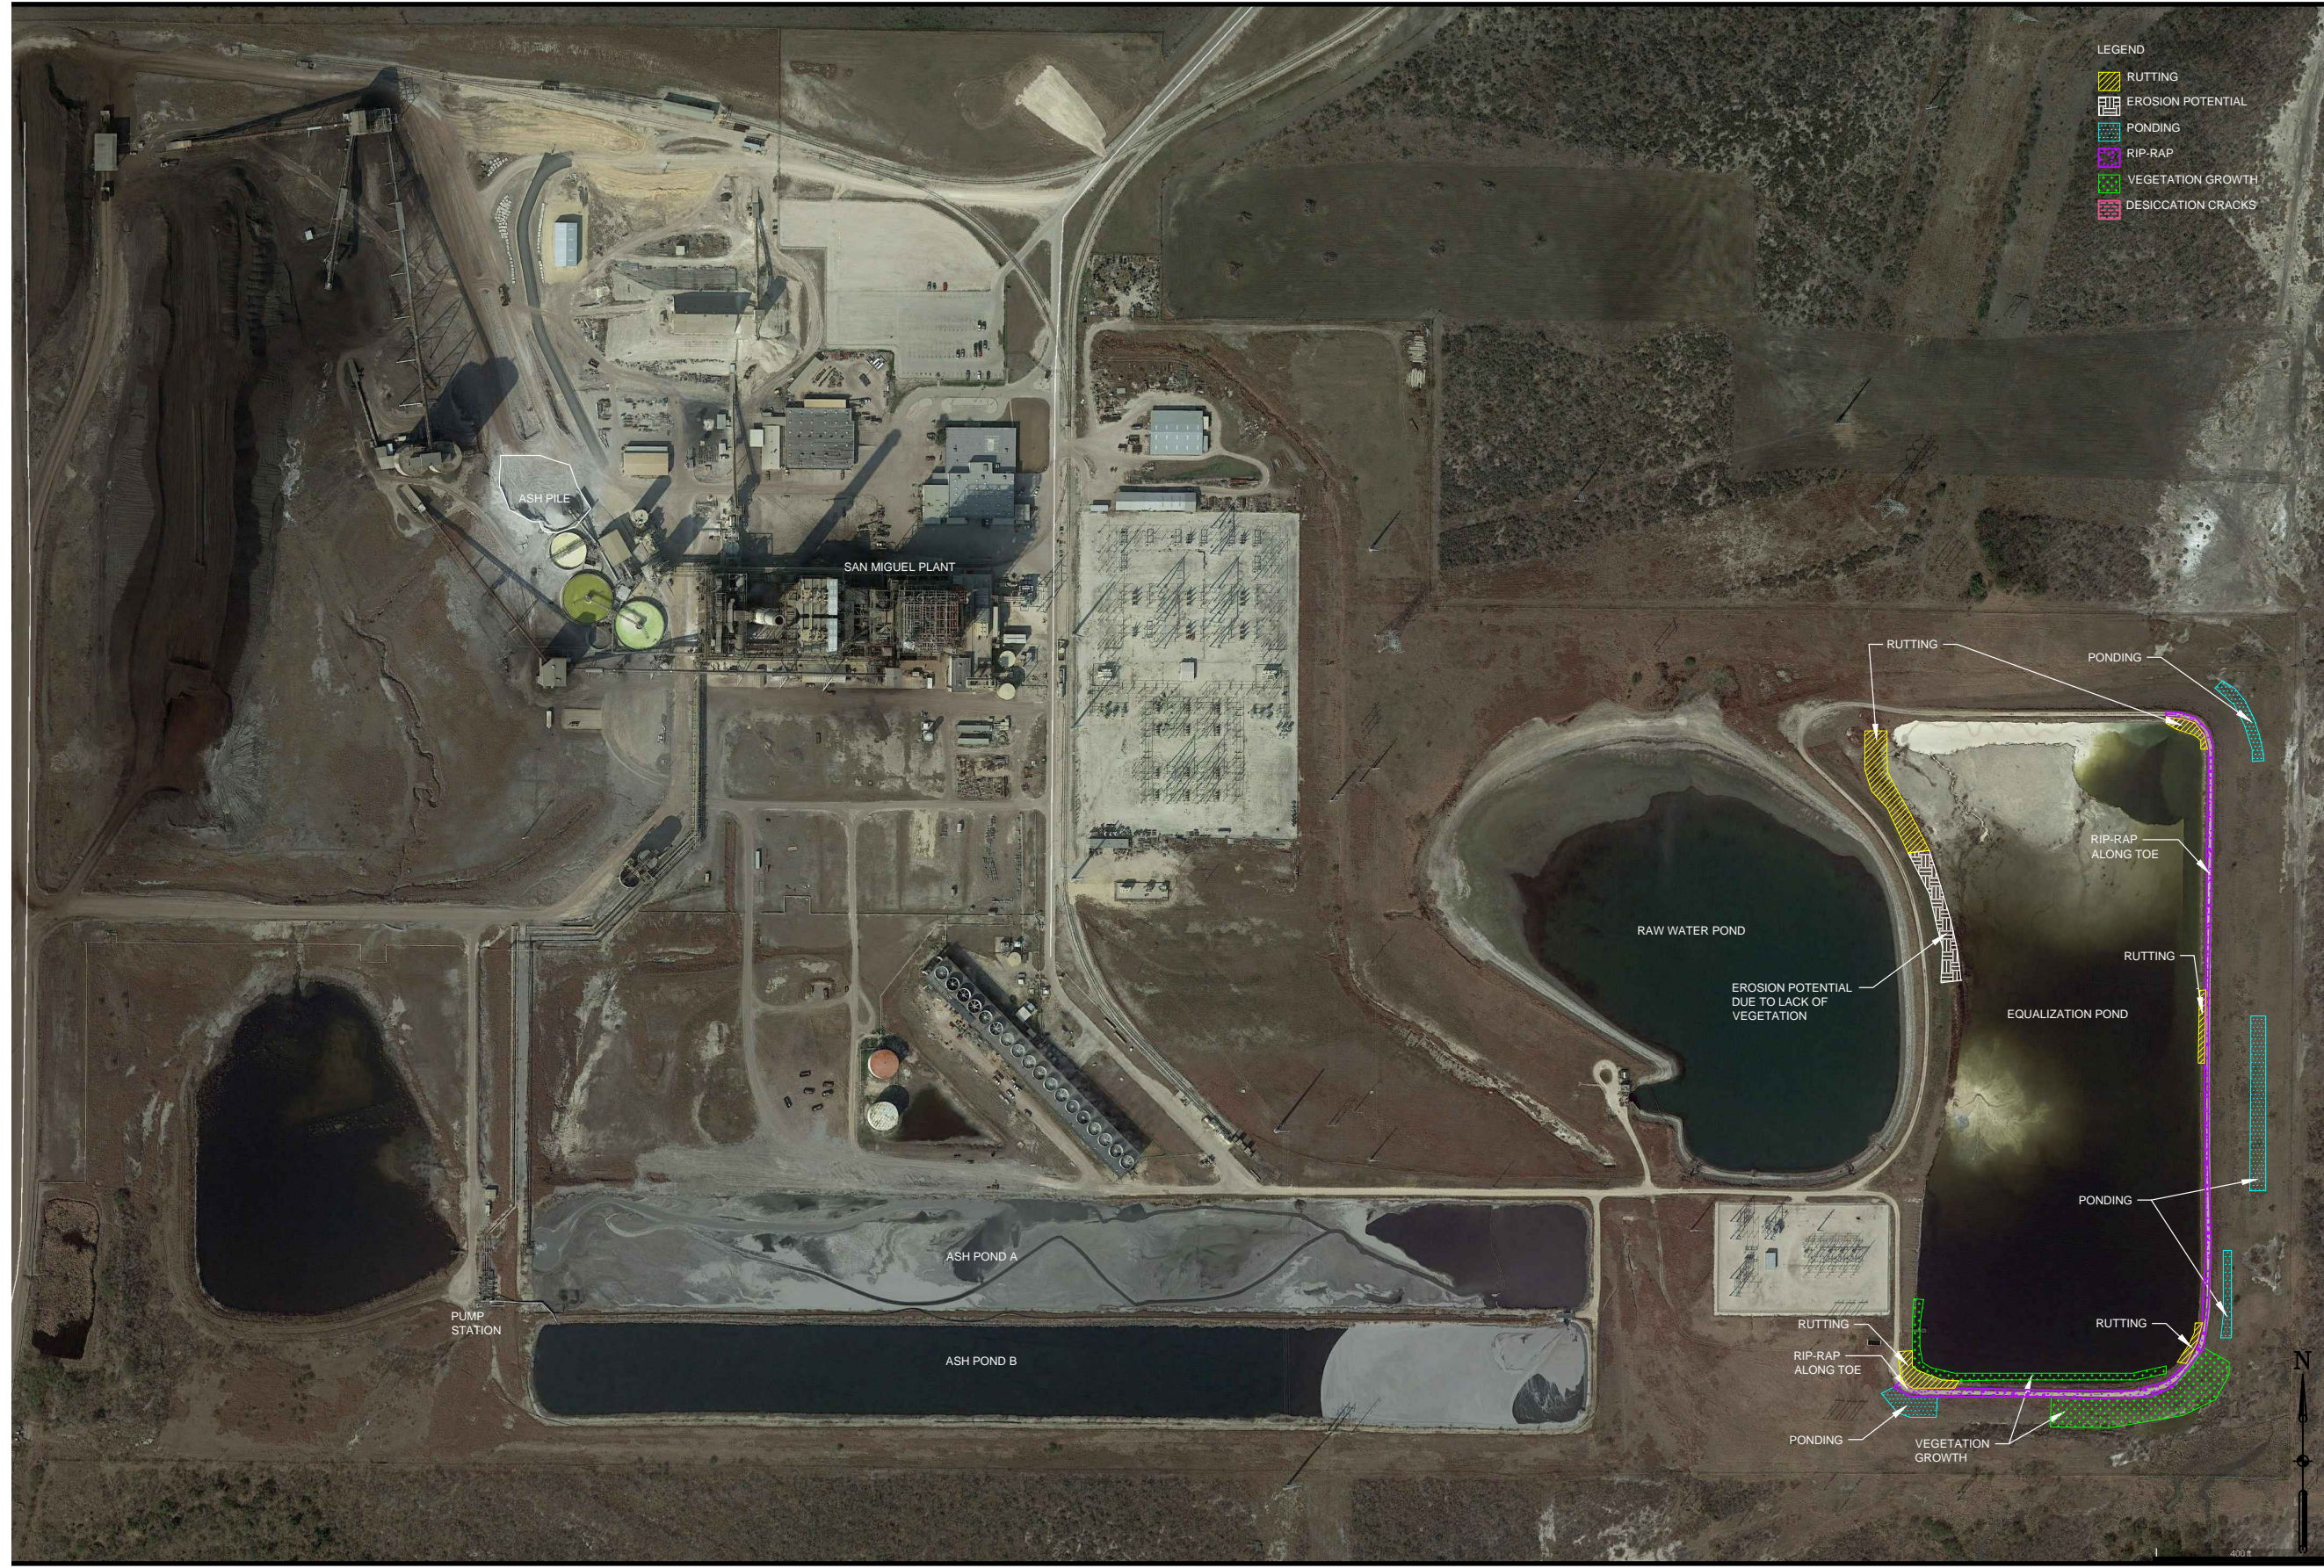
FIGURE 1
SHEET 1 OF 1

Five areas of concern were noted during the annual inspection performed on January 4, 2017. Corrective measures have been proposed to meet the requirements of §257.83 (b)(5) for each deficiency or observation identified as shown in **Table 2-3** below. **Figure 1** shows the location of the listed deficiencies observed during the most recent annual inspection conducted on January 4, 2017.

Deficiency/Observation	Proposed Corrective Measure
Slight slope softening on northwest levee face.	Slight slope failures were possibly due to the recent dredging activities. The entire area needs to be monitored and if conditions worsen, the area should be scarified and backfilled with cohesive material to adjust to necessary grades. Revegetate as necessary.
Sparse vegetation observed on west side face.	Revegetation recommended.
Rutting observed along turns and at various locations along the crest.	Repair damaged areas and regrade.
Dense vegetation observed on the south and east sides. Ponding and moist/soft spots appear along south and east sides.	Remove/Mow vegetation along embankment slopes and check for visual signs of seepage. Continued groundwater monitoring and sampling is recommended to determine source of ponding.
Vegetation growth in pond area along the inner face of the embankment/dike.	Remove vegetation and maintain freeboard with a minimum of 18". Remove vegetation and maintain.

Water ponding around the toe of the downstream embankment (potentially from storm activities prior to inspection).	Ponding water was observed at the localized areas near the toe from approximately the middle section of the southern slope to the south-eastern corner. Sampling of this ponded water is recommended to confirm the water is from surface drainage and not seepage from the CCR unit.
Accuracy of measuring water depth and volume of CCR material within unit.	Install new staff gages for water level readings and obtain a current bathymetric survey to determine an accurate volume for the existing quantity of CCR material.
