**SAN MIGUEL ELECTRIC COOPERATIVE, INC.**

**San Miguel Electric Station
Atascosa County, Texas**

CCR Impoundment Inspection Report

January 15, 2016

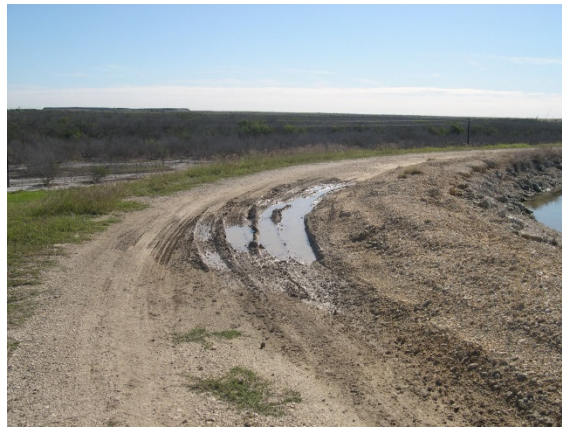
Figure 2: Crest Rutting

MINOR ITEM: The crest of the impoundment had areas with moderate rutting from vehicular traffic (Figure 2) in localized areas around the pond.

Recommendation 1: Repair damaged areas and grade to drain.

Recommendation 2: Discourage vehicular traffic from driving on impoundment crests after storm events.

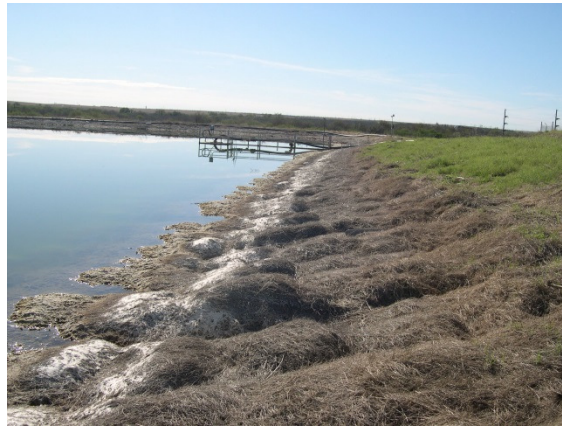
Figure 3: Wind/Wave Erosion Gullies

MODERATE ITEM: Wind/Wave Erosion is occurring at the water line of the pond (Figure 3).

Recommendation 1: Continue to monitor erosion to protective cover over liner and place riprap, erosion matting or concrete revetment if erosion persists.

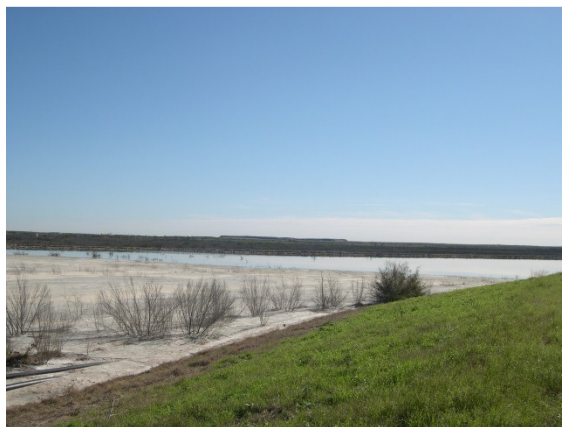
Figure 4: Vegetation Growing in Pond

MODERATE ITEM: Bushes and trees are growing around the interior of the pond (Figure 4).

Recommendation 1: Remove undesirable vegetation (bushes) from upstream embankment. Repair surface areas disturbed during removals.

Recommendation 2: Apply herbicide to vegetation within pond and monitor for impacts to liner.

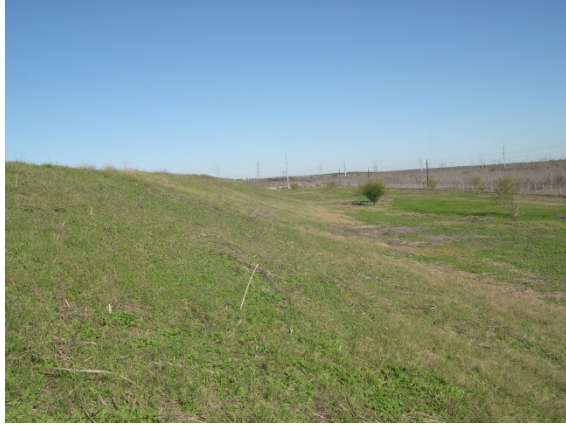
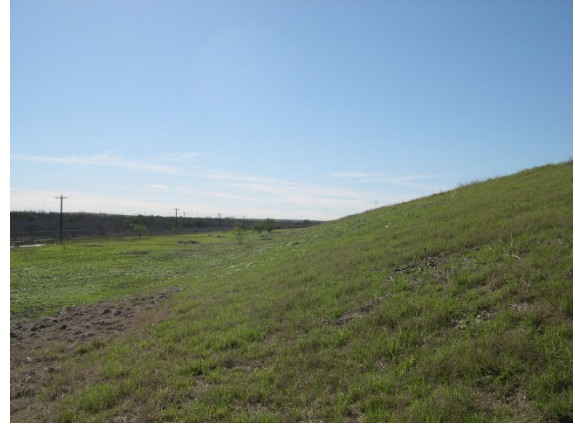
In general, the downstream embankment appeared to be in good condition and well vegetated (Figures 5 and 6).

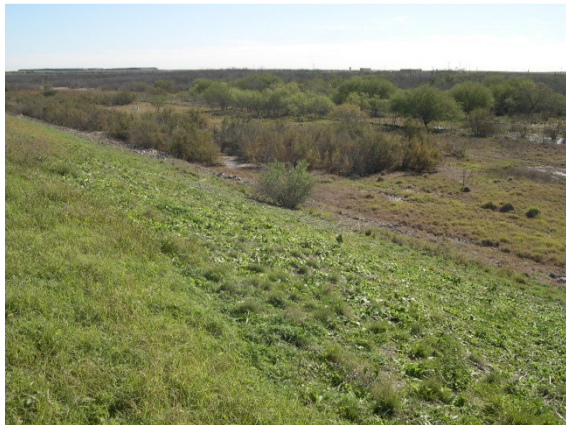
Figure 7: Tree on Downstream Embankment

MODERATE ITEM: Small trees/bushes are growing on the downstream embankment (Figures 7 and 8).

Recommendation 1: Remove undesirable vegetation. Repair surface in areas disturbed by removals.

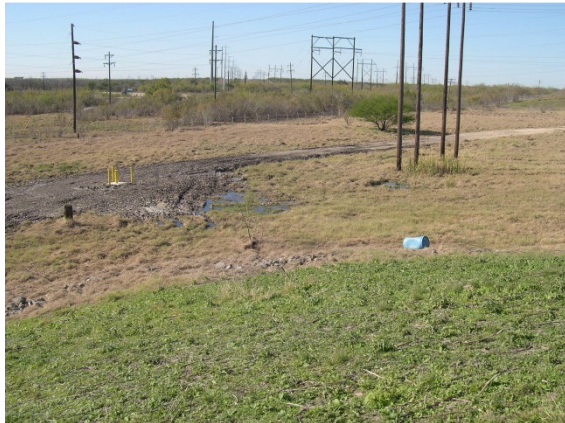
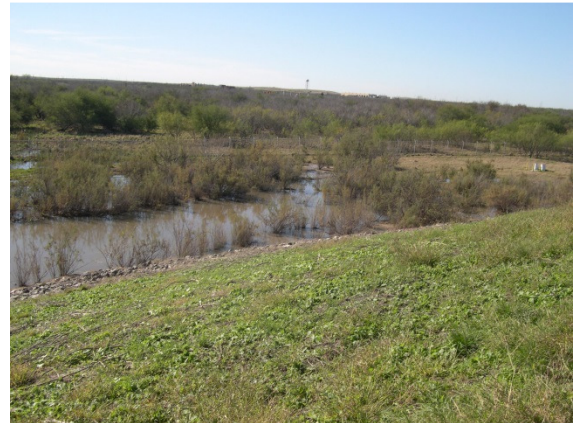
MINOR ITEM: Water is ponding in low areas or depressions around the toe of the downstream embankment (Figures 9 and 10). It is assumed the water was from recent storm activities, but this could also represent water migrating from the pond. The surface soils and slopes adjacent to the ponded areas appear largely unaffected/intact.

Recommendation 1: Continue to monitor this area, especially during dry (rain free) periods to determine if this is storm water or water migrating from the pond.

Recommendation 2: Provide compacted cohesive soil and grade to eliminate the ponding area.

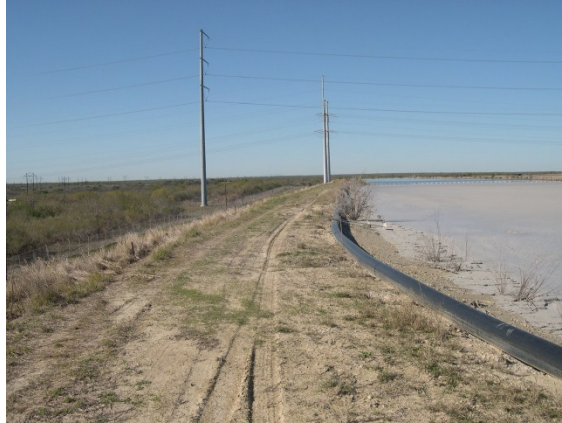
Figure 11: Crest Rutting

MINOR ITEM: The crest of the impoundment had areas with moderate rutting from vehicular traffic (Figure 11) in localized areas around the pond.

Recommendation 1: Repair damaged areas and grade to drain.

Recommendation 2: Discourage vehicular traffic from driving on impoundment crests after storm events.

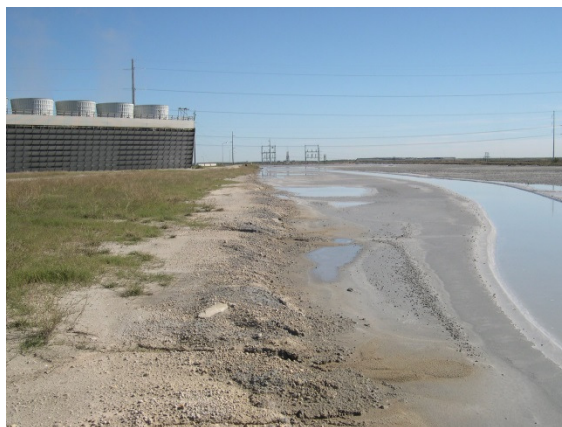
Figure 12: Wind/Wave Erosion Gullies

MODERATE ITEM: Wind/Wave Erosion is occurring at the water line of the pond (Figure 12).

Recommendation 1: Continue to monitor erosion to protective cover over the clay liner and place riprap, erosion matting or concrete revetment if erosion persists.

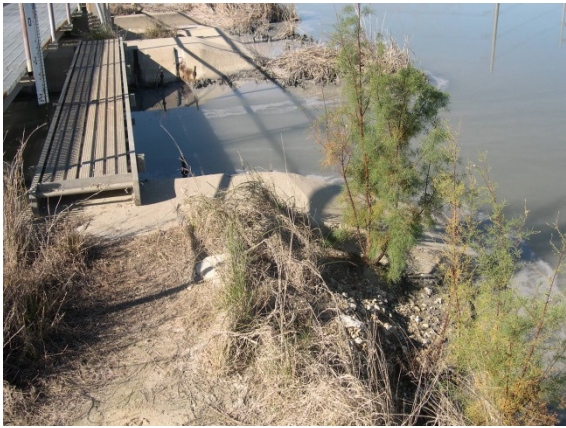
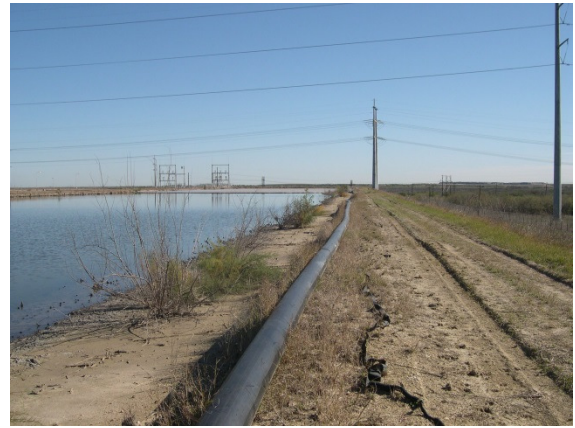
MODERATE ITEM: Bushes and trees are growing around the interior of the pond (Figures 13 and 14).

Recommendation 1: Remove undesirable vegetation (bushes) from upstream embankment. Repair surface areas disturbed during removals.

Recommendation 2: Apply herbicide to vegetation within pond and monitor for impacts to liner.

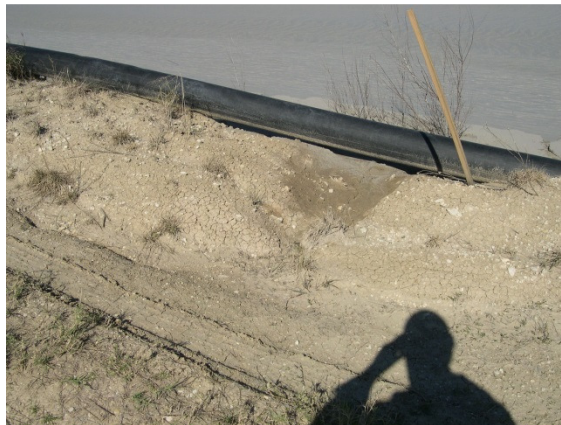
Figure 15: Erosion Gully

MODERATE ITEM: Erosion gullies (Figure 15) were found on the embankment in isolated areas around the perimeter of the disposal area.

Recommendation 1: Scarify and re-grade areas impacted by erosion gullies. Place cohesive fill as needed to achieve uniform surface grades. Compact any fill and re-graded soils. Re-seed. Lightly loosen uppermost soils during re-seeding to facilitate re-vegetation.

Recommendation 2: Place riprap or stone in areas of concentrated flow.

Recommendation 3: Continue to monitor for erosion.

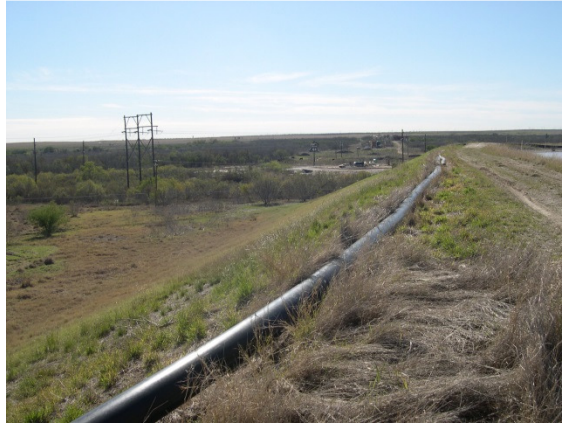
Figure 16: Downstream Embankment

In general, the downstream embankment appeared to be in good condition and well vegetated (Figure 16).

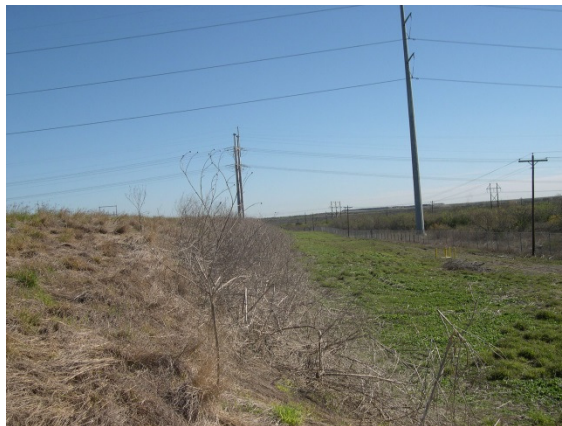
Figure 17: Tree/Bush on Downstream Embankment

MODERATE ITEM: Small trees/bushes are growing on the downstream embankment (Figure 17).

Recommendation 1: Remove woody vegetation. Repair surface in areas disturbed by removals.

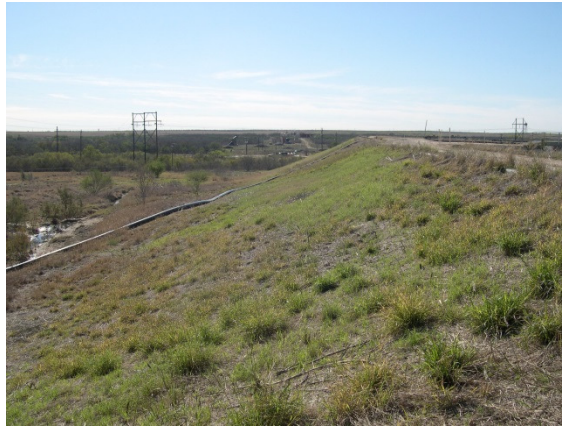
Figure 18: Ponded Water Toe of Embankment

MINOR ITEM: Water is ponding around the toe of the downstream embankment (Figure 18). It is assumed the water was from recent storm activities, but this could also represent water migrating from the pond.

Recommendation 1: Continue to monitor this area, especially during dry (rain free) periods to determine if this is storm water or water migrating from the pond.

Recommendation 2: Provide compacted cohesive soil and grade to eliminate the ponding area.

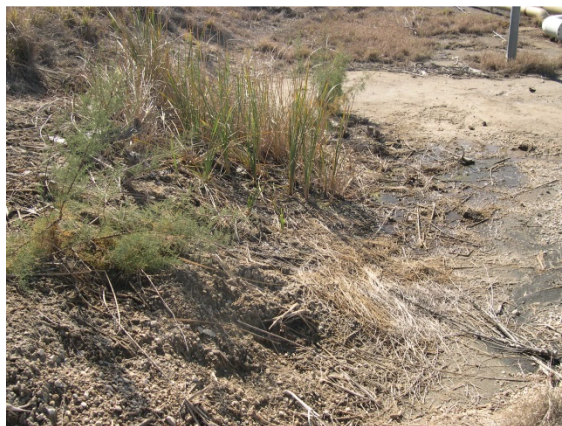
Figure 19: Toe Seep on Downstream Embankment

MODERATE ITEM: Water appears to be seeping from the toe of the downstream embankment of Ash Transport Pond A (Figure 19) along the western edge. The water was not cloudy nor was it flowing on the day of observation. Soils in the adjacent areas are wet and appeared saturated.

Recommendation 1: Initiate investigation recommendations provided by HDR in a memorandum dated 4/28/2015 to determine the root cause and course of action to address the seepage and the potential slope instability.

Recommendation 2: Continue to monitor seepage for turbidity or signs of slope distress. Consult an engineer if conditions deteriorate.

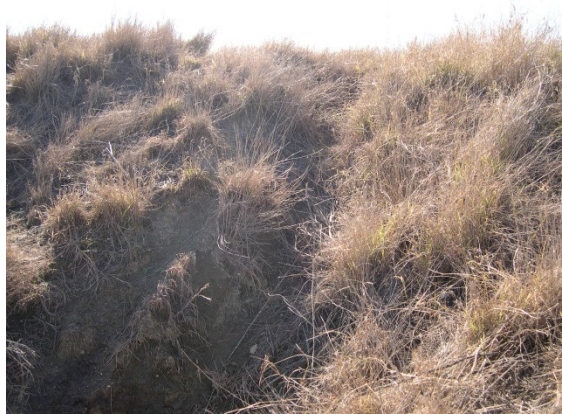
Figure 20: Erosion Gully

MODERATE ITEM: An erosion gully (Figure 20) was found on the embankment at the northwest corner of Ash Transport Pond A.

Recommendation 1: Scarify and re-grade areas impacted by erosion gullies. Place cohesive fill as needed to achieve uniform surface grades. Compact any fill and re-graded soils. Re-seed. Lightly loosen uppermost soils during re-seeding to facilitate re-vegetation.

Recommendation 2: Place riprap or stone in areas of concentrated flow.

Recommendation 3: Continue to monitor for erosion.

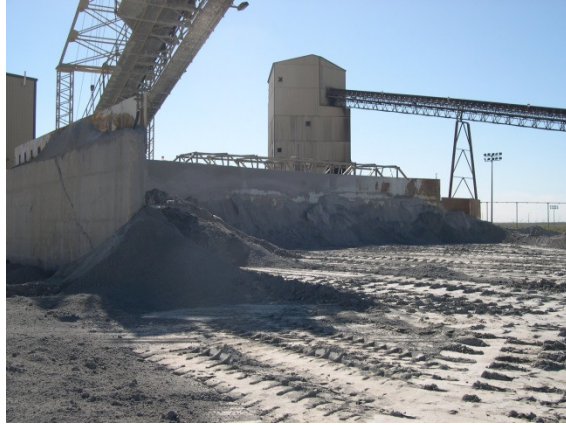
Figure 21: FGD Sludge Pile

A concrete wall partially contains the Pile. On the day of the inspection, it was noted that there is evidence of corrosion on the wall and structural cracks (Figure 21). A misting system is mounted to the conveyor built to minimize fugitive dust emissions from the Pile.
