CCR Annual Inspection
§257.83 (b)
for the
Ash Pond
at the
San Miguel Plant
Revision 0

RE: CCR Annual Inspection Report for San Miguel Plant: Ash Pond CCR Unit

**ANNUAL CCR
INSPECTION**

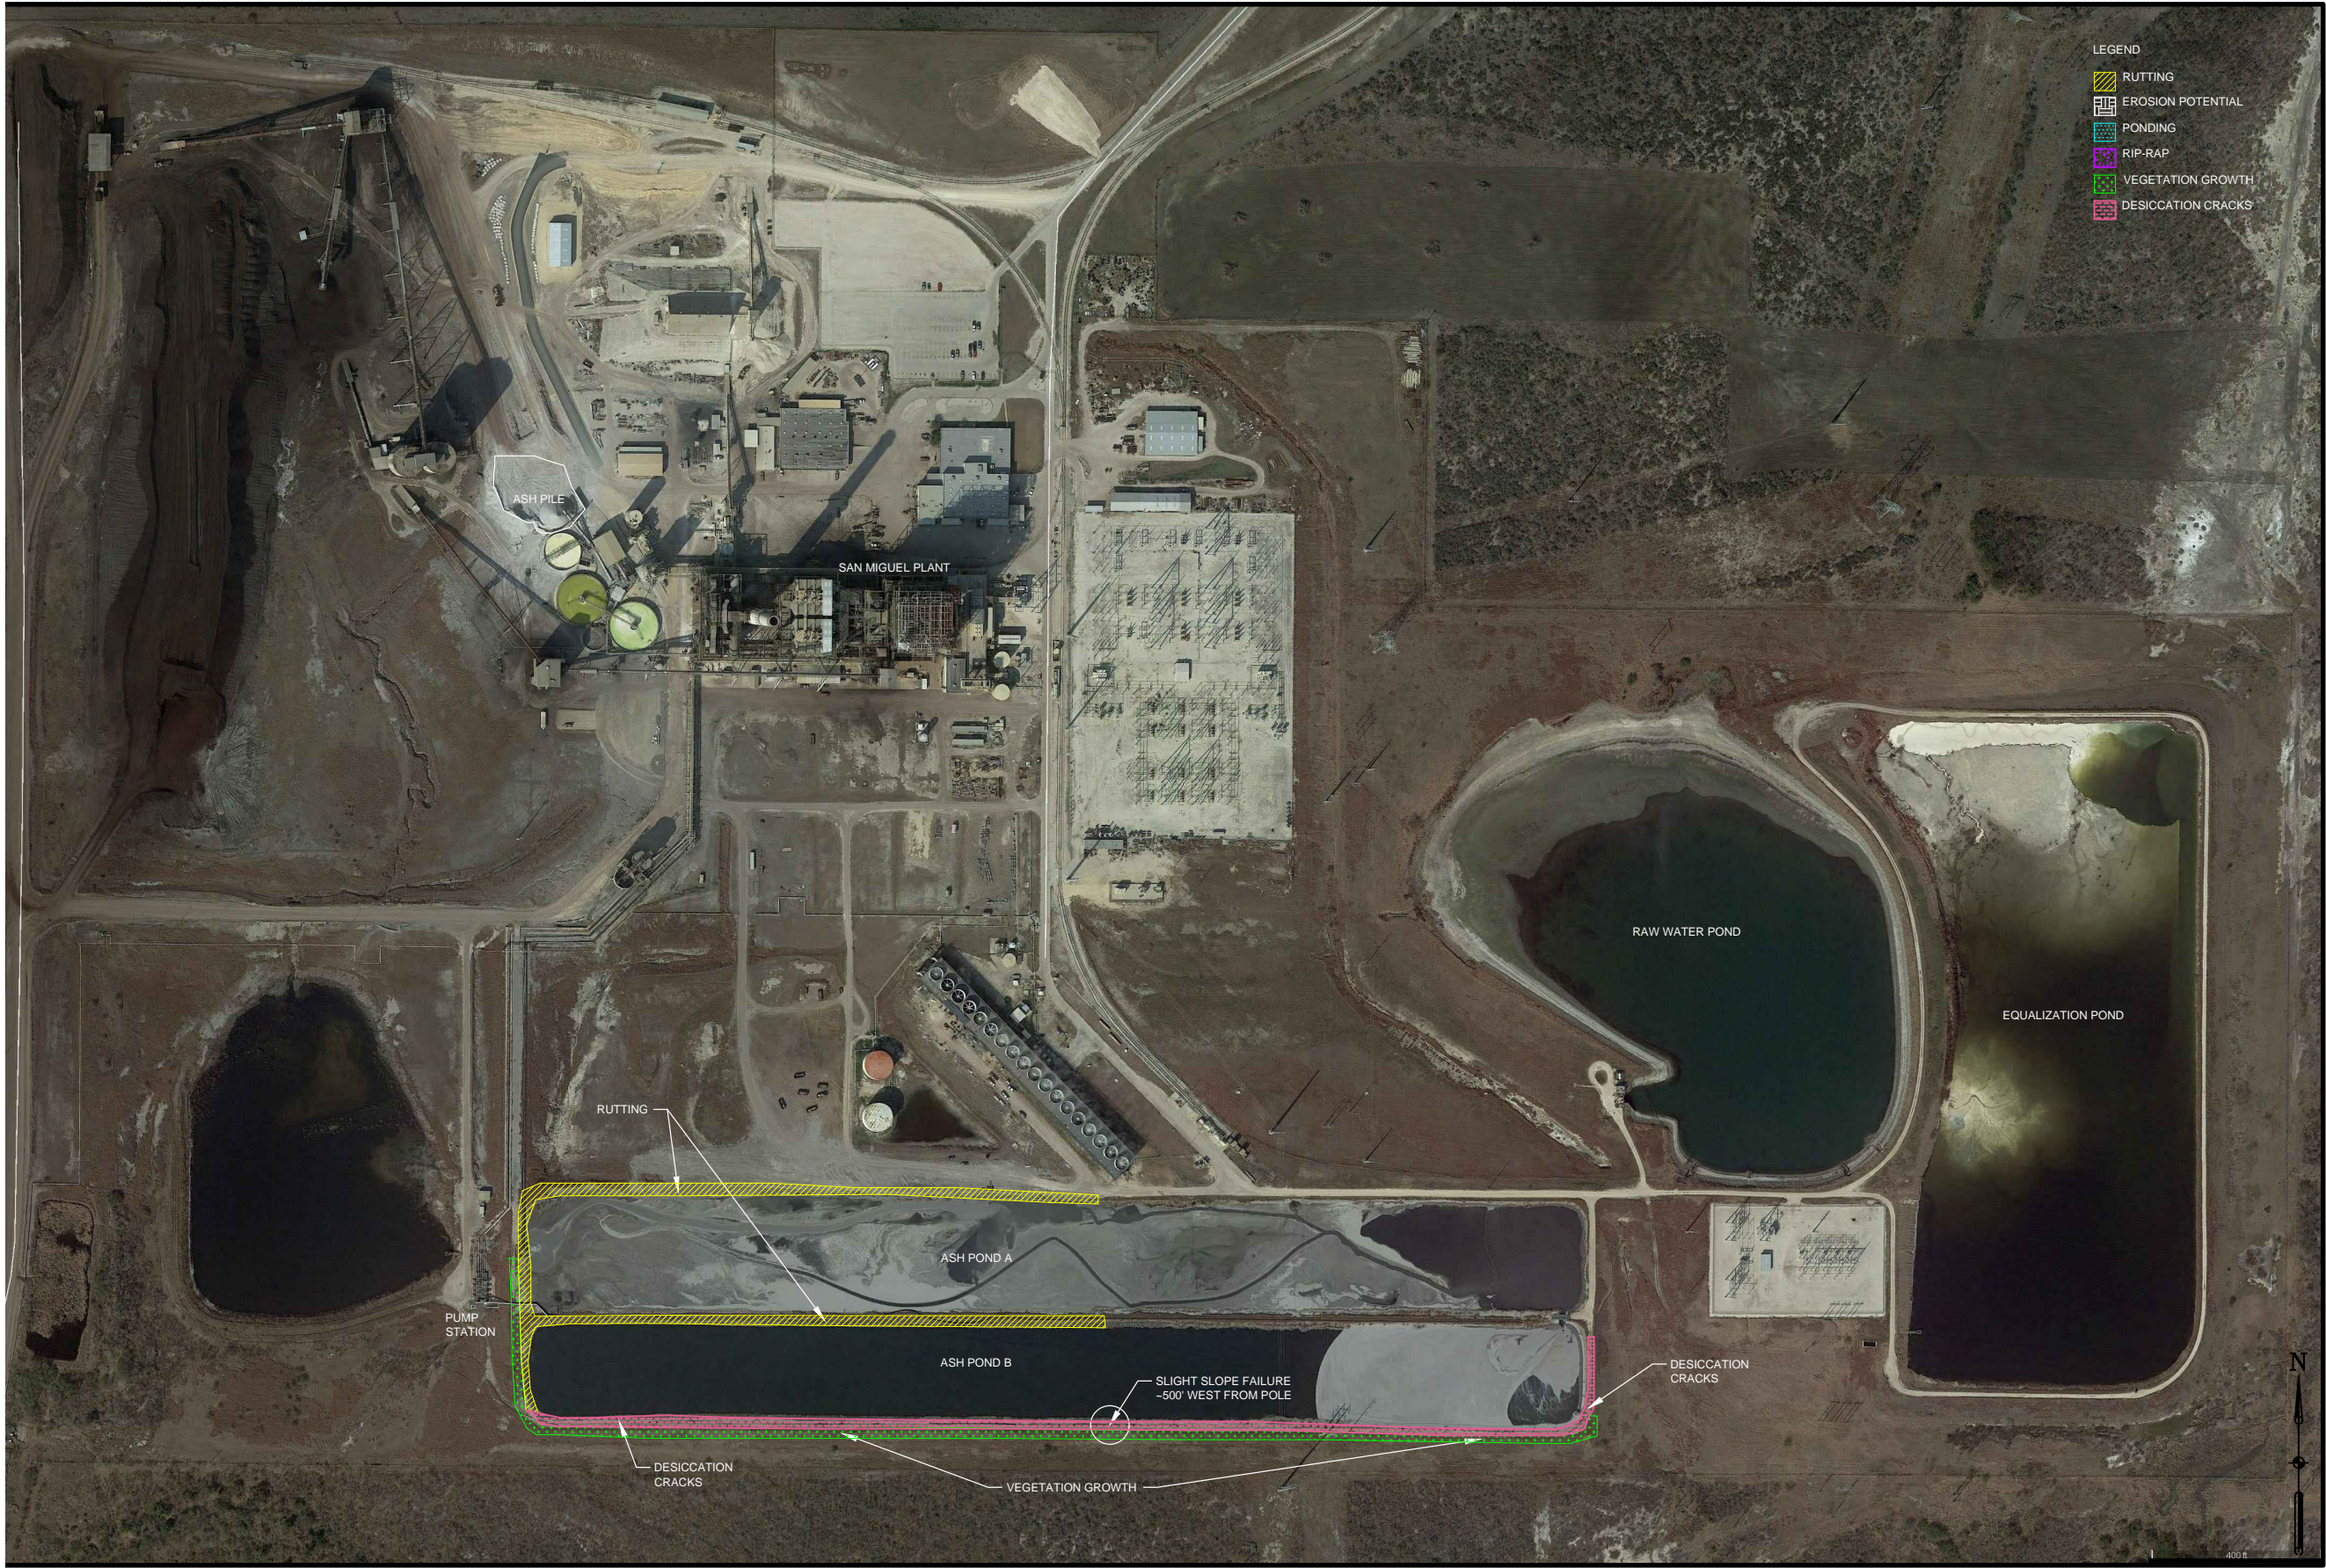
Figure 1 – Site Map

Six areas of concern were noted during the annual inspection performed on January 4, 2017. Corrective measures have been proposed to meet the requirements of §257.83 (b)(5) for each deficiency or observation identified as shown in **Table 2-3** below. **Figure 1** shows the location of the listed deficiencies observed during the most recent annual inspection conducted on January 4, 2017.

| Deficiency/Observation | Proposed Corrective Measure |
|---|---|
| Dense vegetation/ tall grasses were observed along the southern exterior slope. | Mow vegetation on a periodic basis. |
| Crest has minor desiccation cracks on south side. | Proof roll the crest area and install a 3 to 4-inches thick flex base layer as cover. Alternative, the crest can be vegetated to prevent further deepening of the cracks. |
| Major rutting observed along southeast and northwest of the crest. | Repair damaged areas and regrade. |
| Drainage channel along east side at toe has ponding. | Grade drainage channel along east side. |
| Vegetation growth in pond area. | Remove vegetation. Apply herbicide to vegetation and monitor. |
| Minor slope failure observed on south side. | Minor slope failure could be due to lack of grass growth in this area. Periodically check and maintain southern embankment slopes to maintain required slopes. |
