Submitted to
San Miguel Electric
Cooperative, Inc.
6200 FM 3387
Christine, Texas 78012

Submitted by
AECOM
9400 Amberglen Boulevard
Austin, Texas 78729

January 10, 2018

CCR Annual Inspection
§257.84 (b)
for the
Ash Pile
at the
San Miguel Plant
Revision 0

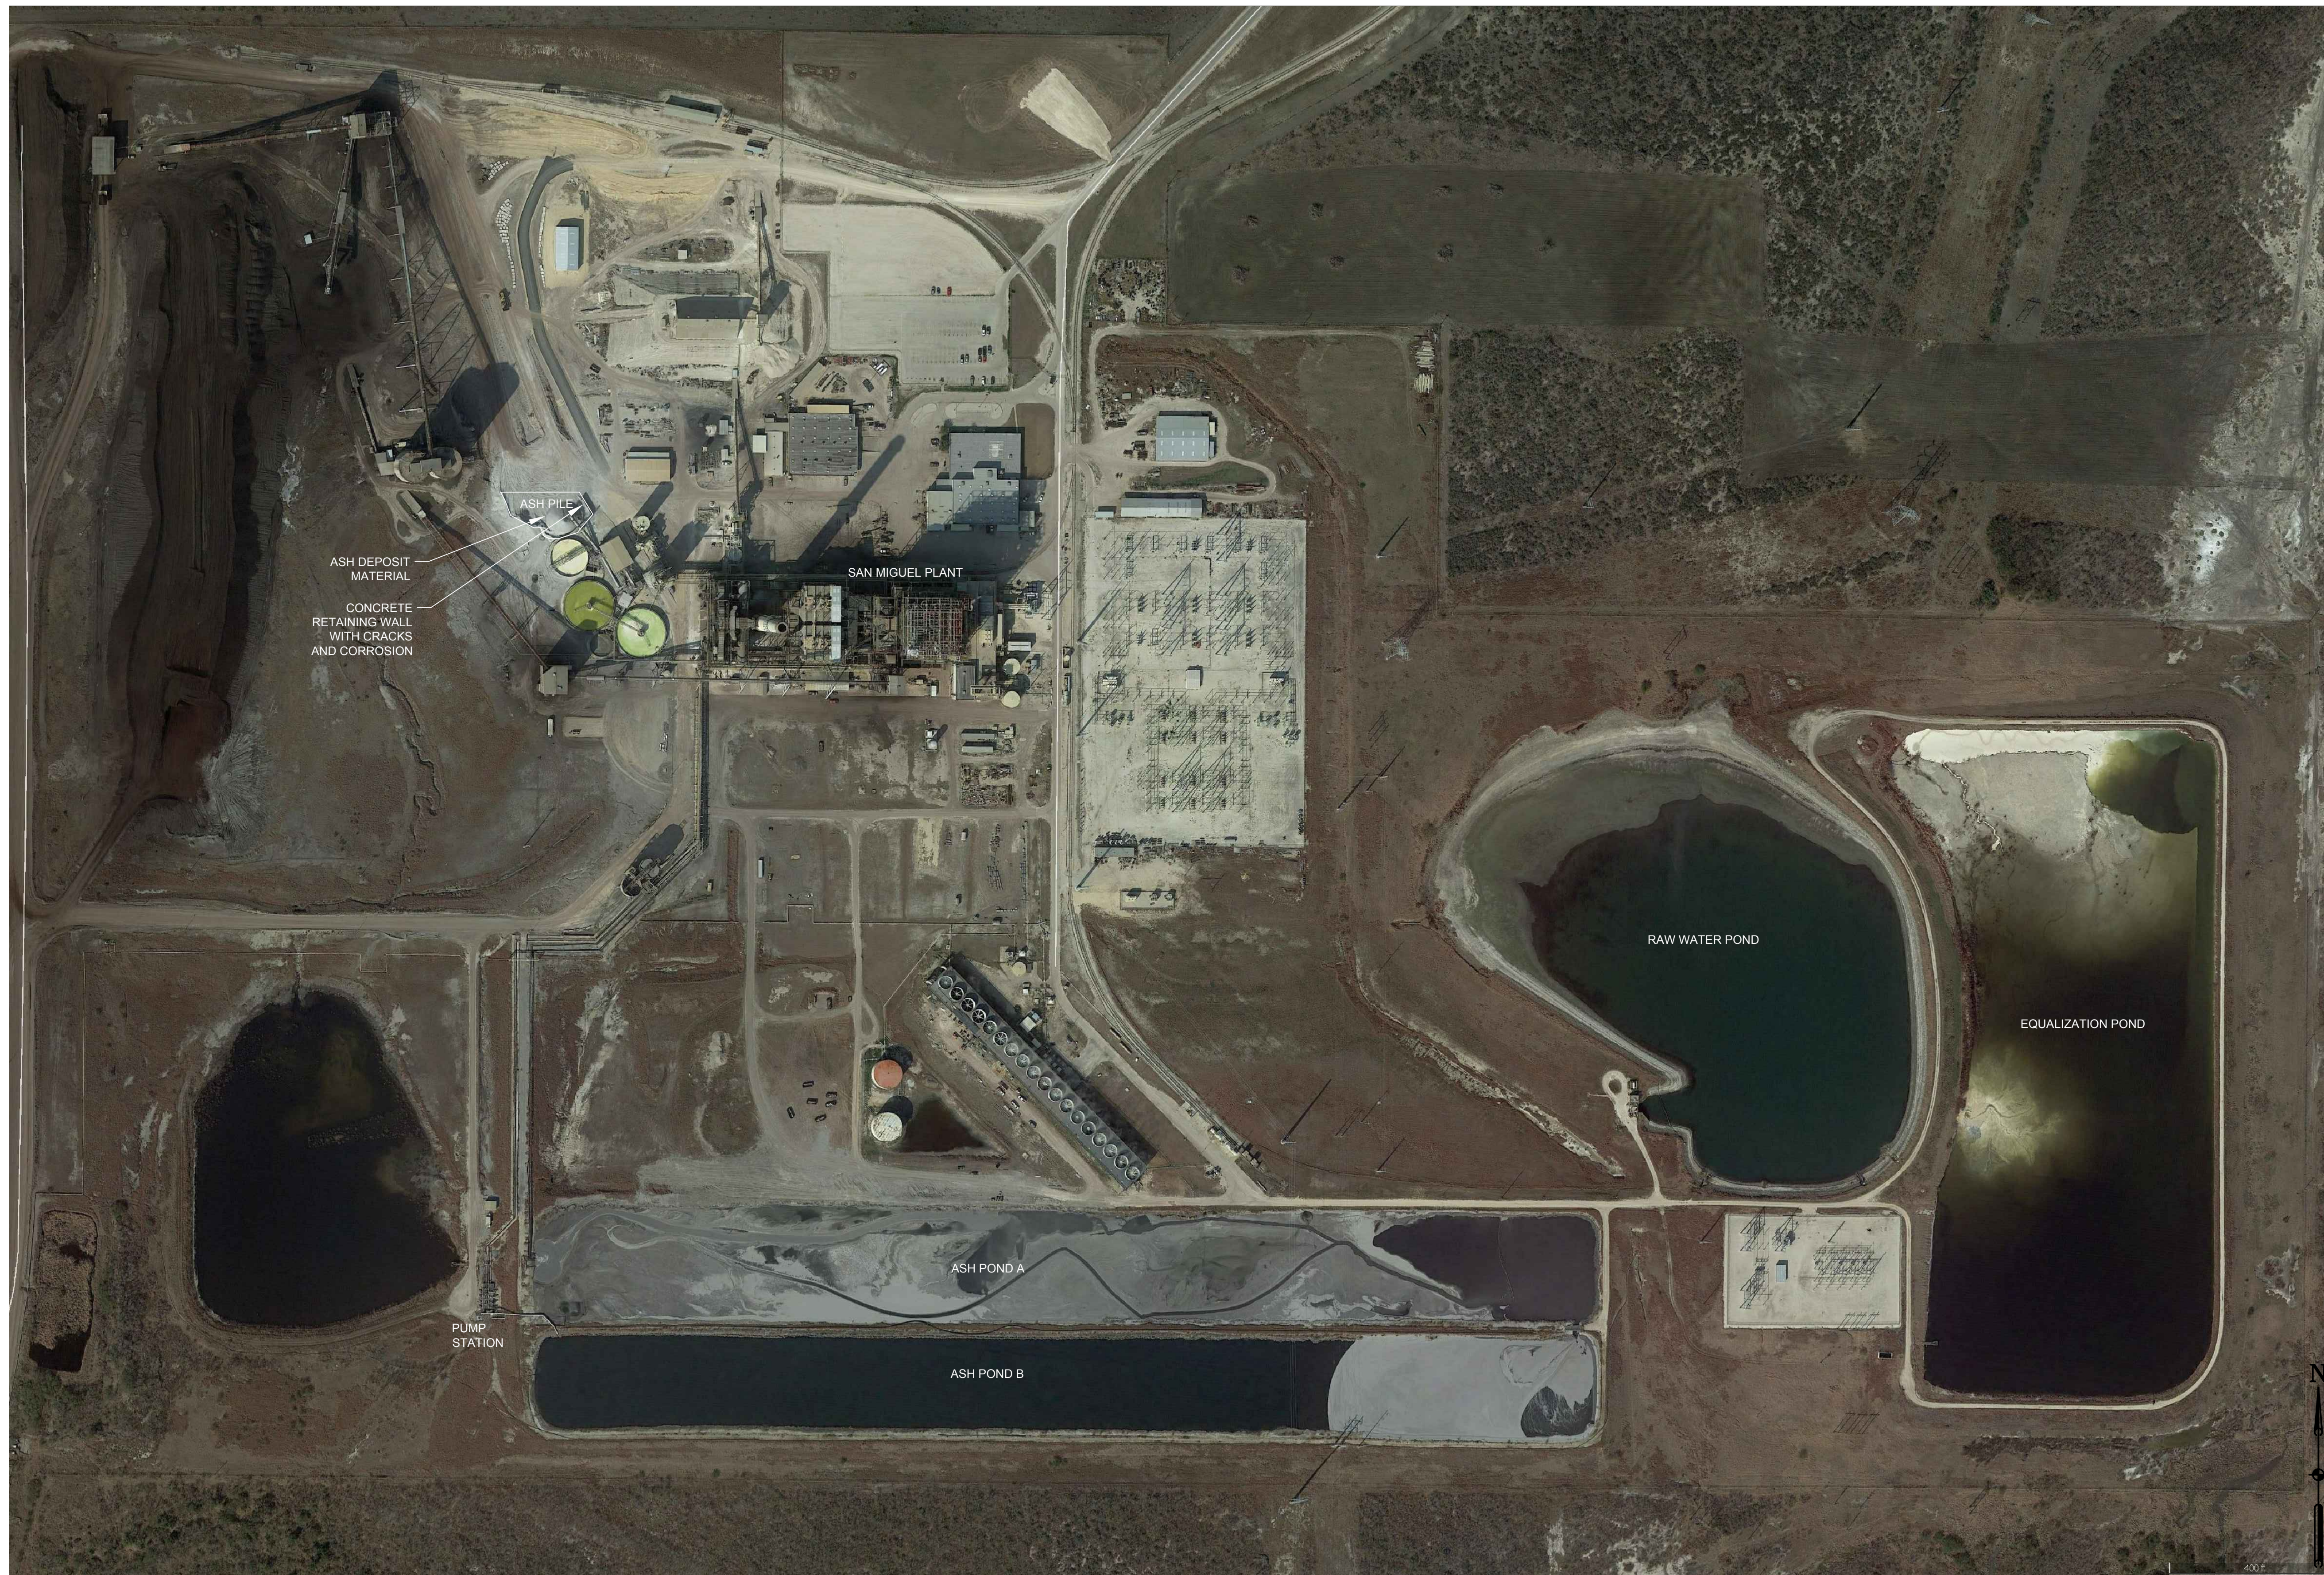
Figure 1 – Site Map

Eight (8) areas of concern were noted during the annual inspection performed on December 26, 2017. Corrective measures have been proposed to meet the requirements of §257.84 (b)(5) for each deficiency or observation identified as shown in **Table 2-2** below. **Figure 1** shows the location of the listed deficiencies observed during the most recent annual inspection conducted on December 26, 2017.

Table 3-2 – Areas of Concern (Inspected: December 26, 2017)	
Deficiency/Observation	Proposed Corrective Measure
Concrete retaining wall has large crack, signs of corrosion, and exposed rebar.	<p>AECOM understands that the concrete wall is a separation device that provides run-on and runoff protection to the CCR unit. Also, a minimal amount of CCR material may come into contact with this wall for containment purposes. This minimal depth of CCR material that periodically abuts the wall produces very little need for structural support.</p> <p>AECOM recommends to fill the cracks in the concrete retaining wall to be filled in order to protect the reinforcement from exposure to the CCR elements. The stability of the wall shall be monitored on a regular basis.</p>
Wind/Storm Events have the potential to migrate Ash pile material.	AECOM recommends installing additional sprinklers and building a retaining wall on the West side of the Ash Pile unit. This will help minimize CCR material migration and help provide necessary dust control. Care should be taken to keep Ash Pile height below existing wall heights to prevent ash migration.

Steel Reinforcement on the concrete retaining wall appears to be corroded which could eventually pose a structural concern for the wall.	AECOM recommends SMECI to fill the cracks in the concrete retaining wall in order to protect the reinforcement from exposure to the elements. The structural integrity of the wall shall be evaluated and repaired as necessary. The condition of the steel shall be evaluated and repairs will be performed as necessary.
Concrete retaining wall present only on east side and a steel retaining wall/ Baffle wall is used on the south side to contain the Sludge/Ash Pile.	Based on our observation, steel structures have a tendency to corrode when in contact with the CCR material. AECOM recommends SMECI to monitor the structure on a regular basis and perform the suggested repairs at the appropriate time. The steel wall will be inspected for corrosion.
<p>Ash pile is exposed resulting in minor erosion.</p> <p>Storm water runoff ditches are present on west/north side which flow towards the Lignite Retention Pond or Ash Pond. This water is recycled for plant use.</p>	Grade the area on the West and North side at a 1% - 2% slope such that all storm water or surface runoff is directed towards the drainage ditches and does not cause any ponding issues around the Ash pile.

Deficiency/Observation	Proposed Corrective Measure
Run on drainage behind the concrete wall has no contact with the ash pile.	
Erosion gullies observed along the drainage channel.	Protect the drainage channel for erosion control. Use geotextile/fabric to line the drainage channel.
Rutting along haul roads.	Maintain the haul roads as necessary to prevent storm water ponding issues.
Stormwater structures need repair.	Repair the stormwater drain pipes, diversion ditches and provide riprap for erosion protection as necessary.
