Submitted to
San Miguel Electric
Cooperative, Inc.
6200 FM 3387
Christine, Texas 78012

Submitted by
AECOM
9400 Amberglen Boulevard
Austin, Texas 78729

January 10, 2018

CCR Annual Inspection
§257.83 (b)
for the
Ash Pond
at the
San Miguel Plant
Revision 0

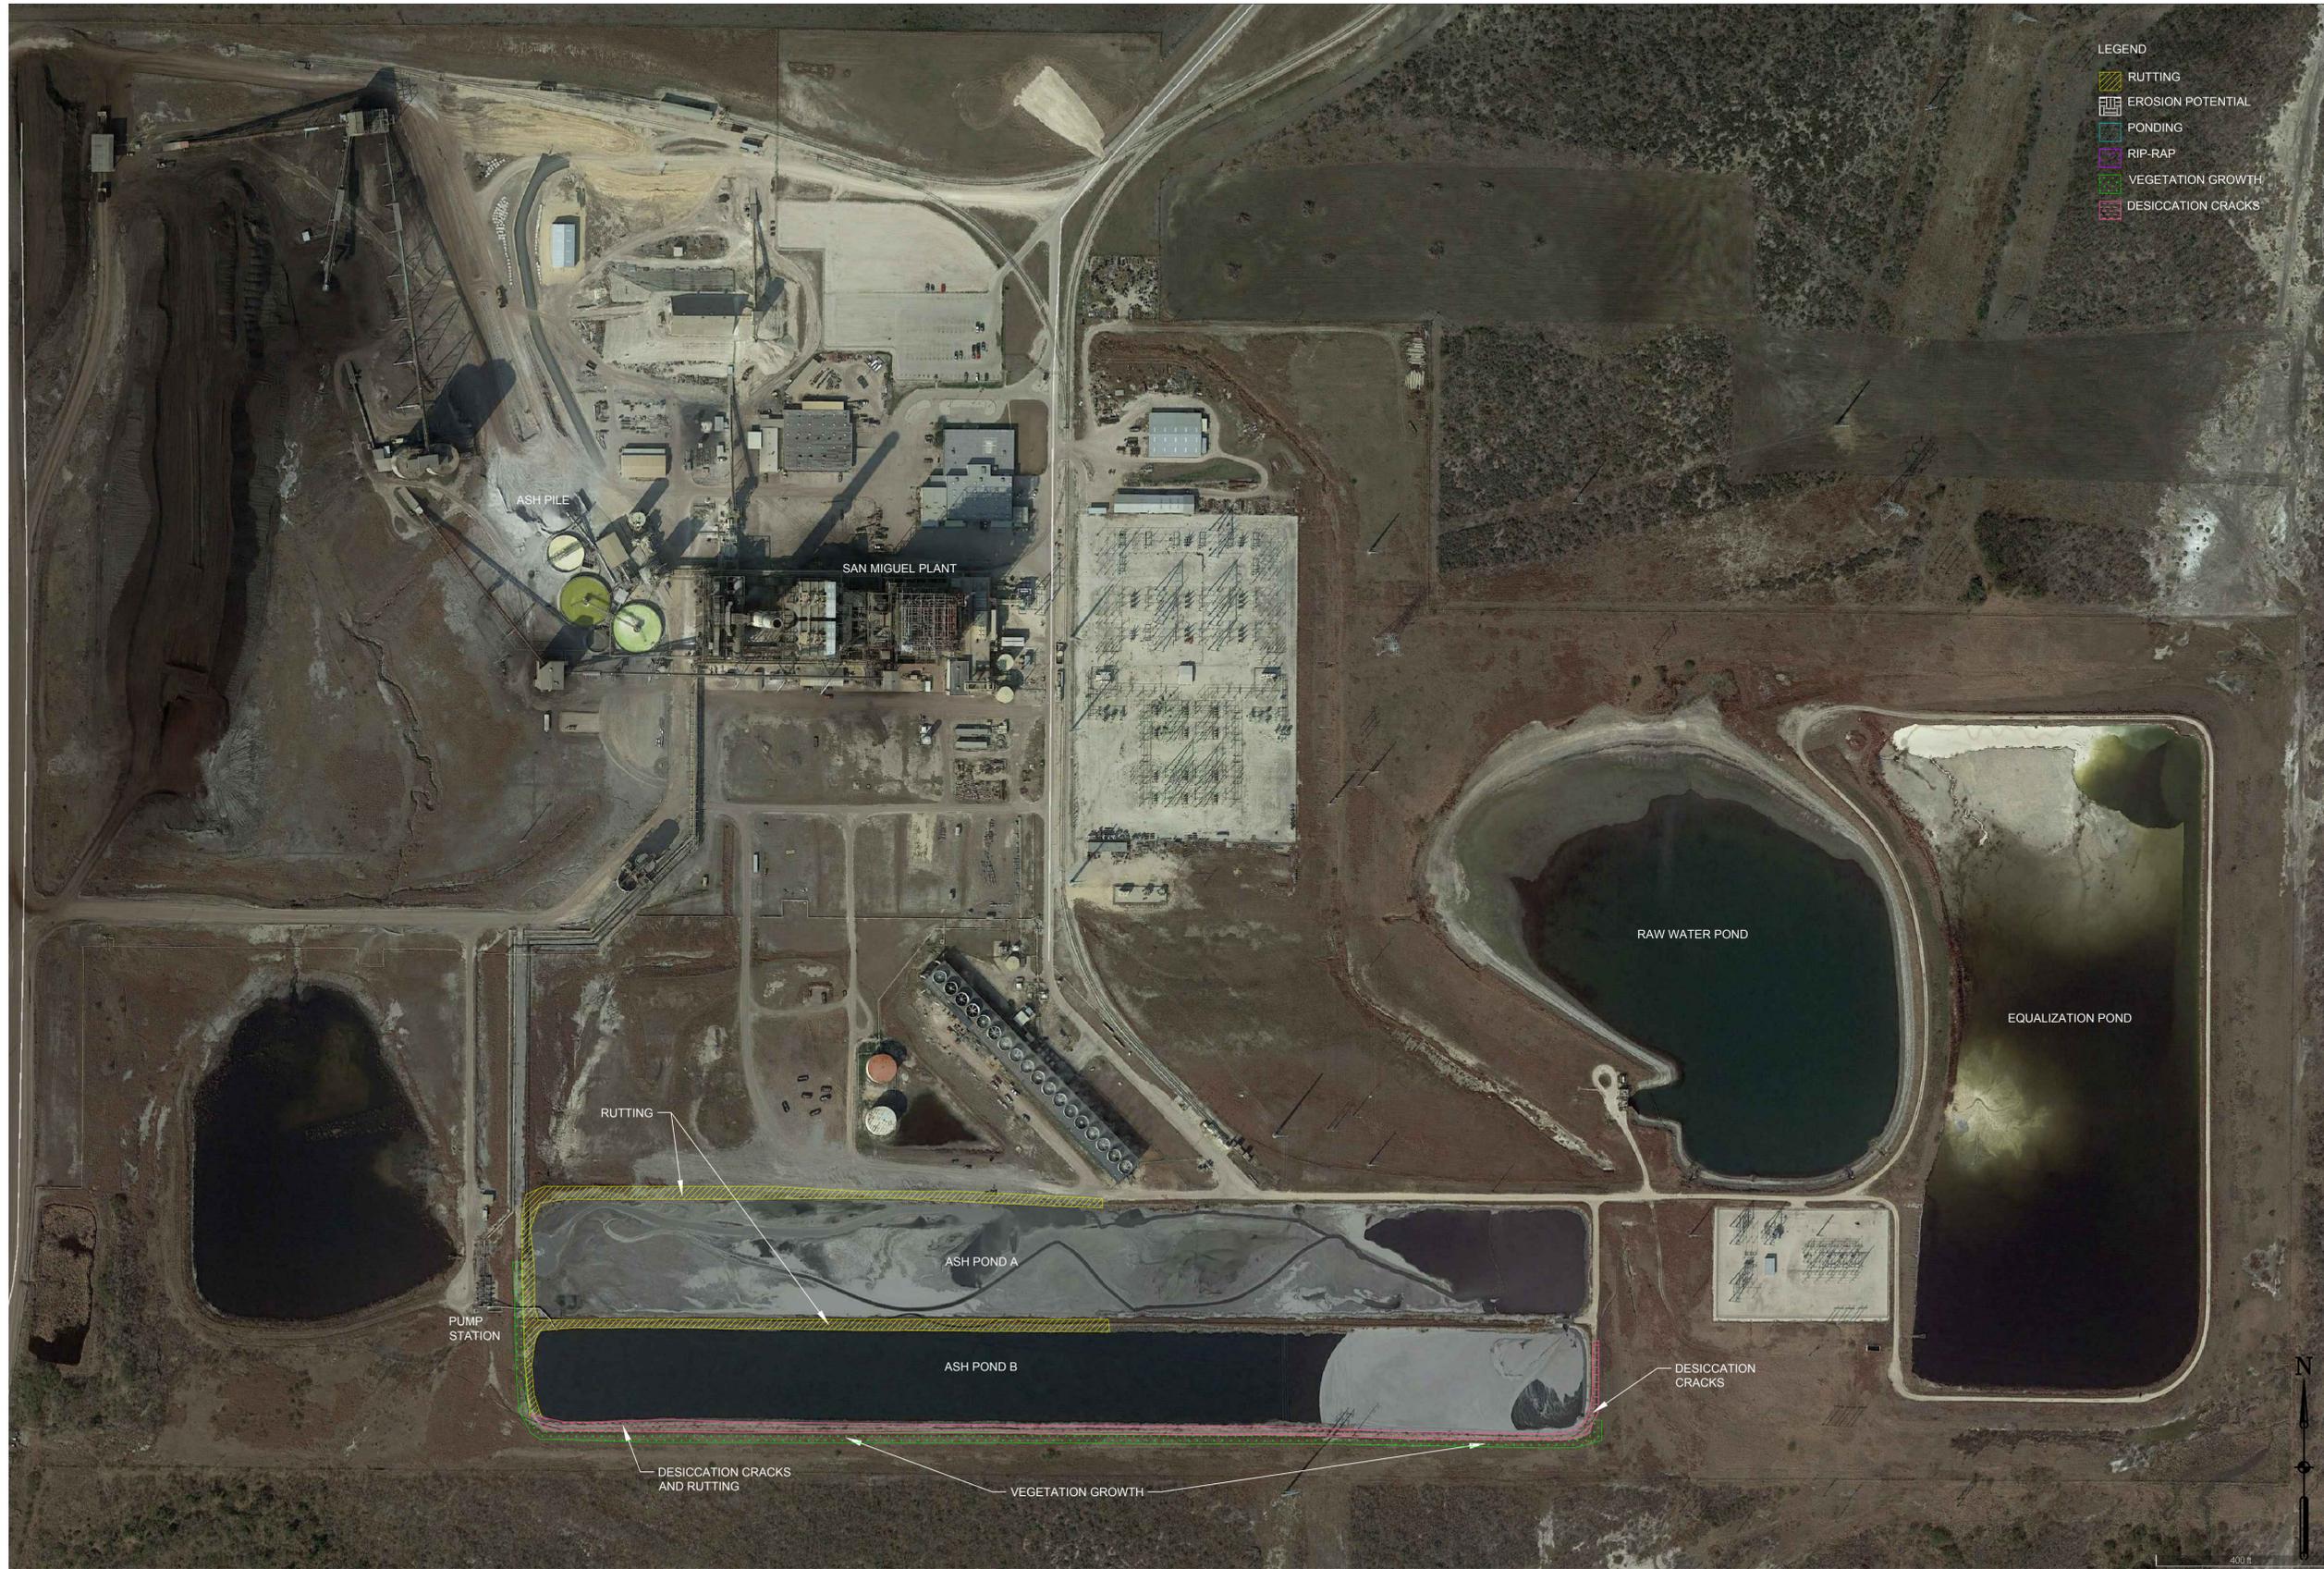
FIGURE 1
SHEET 1 OF 1

observation identified as shown in **Table 2-3** below. **Figure 1** shows the location of the listed deficiencies observed during the most recent annual inspection conducted on December 26, 2017.

Deficiency/Observation	Proposed Corrective Measure
Dense vegetation/ tall grasses were observed along slopes.	<p>Mow vegetation on a periodic basis. At the time of this inspection (December 26, 2017), it was difficult to visually inspect the condition of the downstream slopes for cracks, seepage or shallow slides.</p> <p>AECOM recommends SMECI to mow the downstream slopes on the east, south and west sides prior to performing additional inspections around the Ash ponds.</p> <p>Slopes did not show any signs of failure at the time of this inspection.</p>
Vegetation growth along the downstream toes	AECOM recommends mowing to be performed along the downstream toes on the east, south and west sides prior to performing additional inspections around the Ash ponds.
Vegetation growth in pond area along the inner slopes	<p>Remove vegetation along inner slopes as necessary. Alternatively, grade the inner slopes of the Ash Ponds (A&B) to avoid vertical faces and minimize wave action.</p> <p>As was the case during the time of this inspection, AECOM suggests SMECI to maintain the Ash ponds at or below the freeboard elevation in order to properly inspect the inner slopes.</p>

Lack of vegetation on west side.	Provide seeding on west slope near pump station.
Crest has minor desiccation cracks on south side.	<p>Proof roll the crest area and install a 3 to 4-inches thick flex base layer as cover.</p> <p>AECOM understands that SMECI intends to raise the crest of the Ash Pond by approximately 4-inches using flex base material in order to address the concerns related to the desiccation cracks and rutting along the crest of the pond. This will increase the freeboard of the pond as well as add necessary protection against wave action.</p> <p>AECOM also recommends SMECI to give consideration to installing a concrete lined spillway for emergency pond relief.</p>

Deficiency/Observation	Proposed Corrective Measure
Major rutting observed along southeast and northwest of the crest.	Repair damaged areas and regrade.
Pond A boundary/limits needs to be reestablished.	The exact extent of Pond A is not clearly defined along the northwest corner of the pond. AECOM recommends extending the access road all along the northern boundary of Pond A. This action can be performed when SMECI raises the crest of the Ash Pond as discussed earlier.
Drainage channel along east side needs to be vegetated	Grade drainage channel along east side and vegetate as necessary.
Accuracy of measuring water depth and volume of ash within unit	<p>AECOM understands that the Ash ponds were primarily designed as evaporation ponds without any outlet. A pump station on the west side of the ponds is used to recycle water back to the plant as service water.</p> <p>Majority of the sediment is contained in Pond A (approximately 78% at the time of inspection) and the water is separated and channeled into Pond B by using a weir on the East side of the pond. Pond B was approximately 90% full at the time of inspection (with less than 10% sediment).</p> <p>AECOM recommends installing additional instrumentation on the West side of Pond A to properly assess the quantity of Ash being deposited in the pond.</p> <p>Other considerations could include performing a bathymetric survey of the pond on a regular basis (every year) in order to determine the quantity of Ash deposited or removed from the ponds.</p>

Scour/erosion around weir structures/pipes.	Add flex base or riprap near the weir structure/pipes to prevent scour/erosion around foundations. Grade separator berm for access and inspection.
Maintain the pump station area.	Perform necessary maintenance along the pump station area.
