Submitted to
San Miguel Electric
Cooperative, Inc.
6200 FM 3387
Christine, Texas 78012

CCR Annual Inspection

Equalization Pond

San Miguel Plant

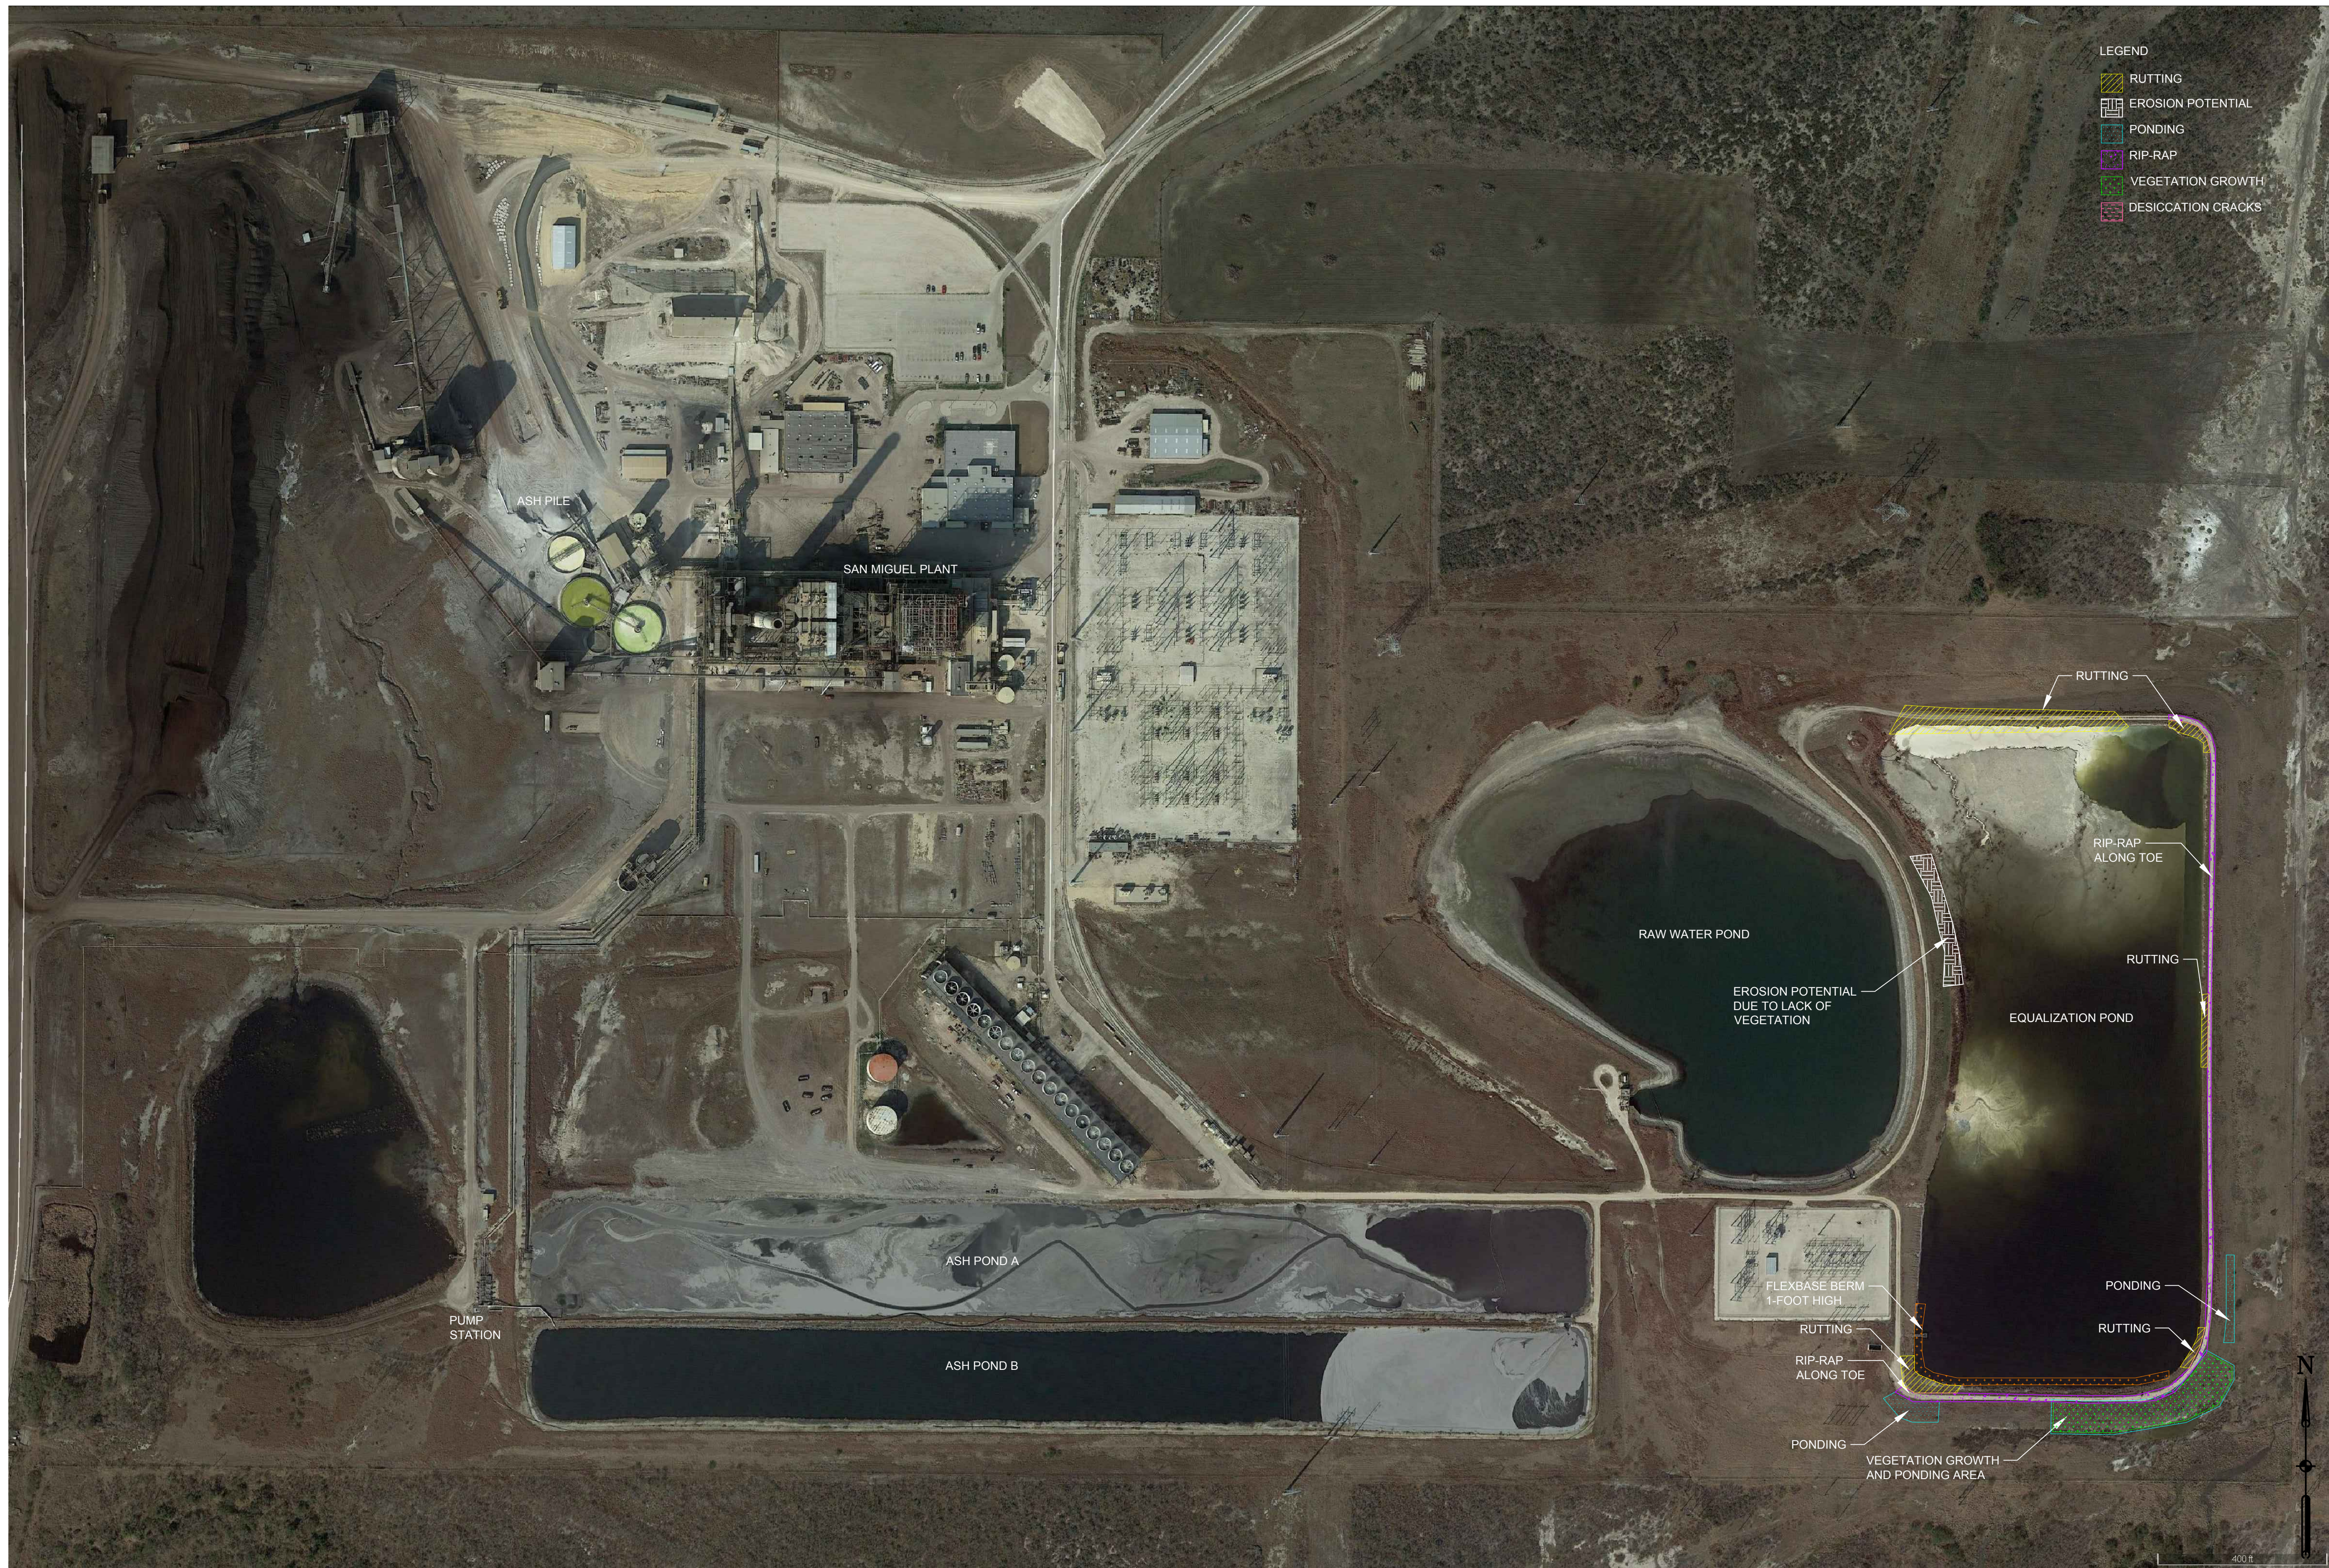
FIGURE 1

Eight (8) areas of concern were noted during the annual inspection performed on December 27, 2017. Corrective measures have been proposed to meet the requirements of §257.83 (b)(5) for each deficiency or observation identified as shown in **Table 2-3** below. **Figure 1** shows the location of the listed deficiencies observed during the most recent annual inspection conducted on December 27, 2017.

Deficiency/Observation	Proposed Corrective Measure
Dense vegetation observed on the downstream slopes on the south and east sides. Ponding and moist/soft spots appear along south and east sides.	<p>Mow vegetation on a periodic basis. At the time of this inspection (December 27, 2017), it was difficult to visually inspect the condition of the downstream slopes for cracks, seepage or shallow slides.</p> <p>AECOM recommends SMECI to mow the downstream slopes on the south, east and north sides prior to performing additional inspections around the Equalization pond.</p> <p>Slopes did not show any signs of failure at the time of this inspection.</p>
Vegetation growth along the downstream toes	AECOM recommends mowing to be performed along the downstream toes on the south, east and north sides prior to performing additional inspections around the Equalization pond.
Vegetation growth in pond area along the inner slopes	<p>Remove vegetation along inner slopes as necessary. Alternatively, grade the inner slopes of the Equalization pond to avoid vertical faces and minimize wave action.</p> <p>The pond elevation was approximately 1-foot 4-inches above the freeboard. AECOM suggests SMECI to maintain the Equalization pond at or below the freeboard elevation in order to properly inspect the inner slopes.</p>

Deficiency/Observation	Proposed Corrective Measure
	<p>AECOM understands that SMECI intends to raise the crest of the Ash Pond by approximately 4-inches using flex base material in order to address the concerns related to rutting along the crest of the pond. This will increase the freeboard of the pond as well as add necessary protection against wave action.</p> <p>AECOM also recommends SMECI to give consideration to installing a concrete lined spillway for emergency pond relief.</p>
Water ponding around the toe of the downstream embankment	Ponding water was observed at the localized areas near the toe from approximately the middle section of the southern slope to the south-eastern corner. Sampling of this ponded water is recommended to confirm the water is from surface drainage and not seepage from the CCR unit.
Sparse vegetation observed on the inner slopes on the north west side and along the downstream toe on the north east side.	Revegetation recommended.

Accuracy of measuring water depth and volume of CCR material within unit.	<p>AECOM understands that the Equalization pond was primarily designed as evaporation pond without any outlet. A temporary/mobile pump is used to recycle water back to the plant as service water.</p> <p>The existing instrumentation gage is hard to read. AECOM recommends replacing the existing instrumentation gage prior to the next inspection.</p> <p>AECOM recommends installing additional instrumentation on the Northwest side of the Equalization pond to properly assess the quantity of Ash being deposited in the pond.</p> <p>Other considerations could include performing a bathymetric survey of the pond on a regular basis (every year) in order to determine the quantity of Ash deposited or removed from the ponds.</p>
Riprap needs realignment.	Realign the riprap along the toe of embankment on the south and east sides.

Prevent wave action from occurring.	SMECI has constructed a 1-foot high berm with flex base on east and south side of the Equalization pond to prevent wave action for major storm events. This is a temporary measure.
