**Maintenance and Corrective Measures
San Miguel Electric Cooperative Inc.
(as of October 2018)**

Equalization Pond

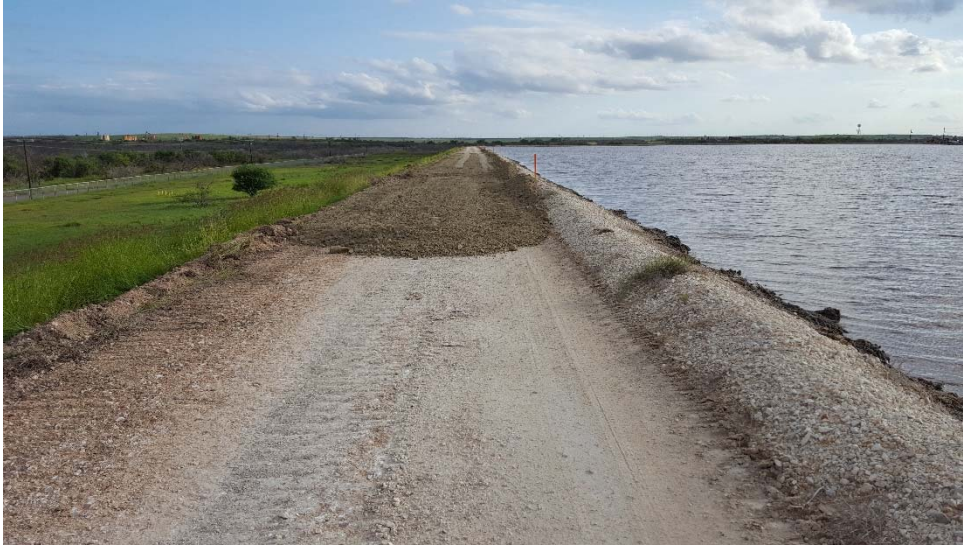
PHOTO 1:

This is the first lift of clay soils being added to the eastern crest of the Equalization Pond to bring it to a 296 foot elevation. The view of the crest is to the south along the crest. The crest was leveled and wet rutted materials were removed and replaced with clay soils.

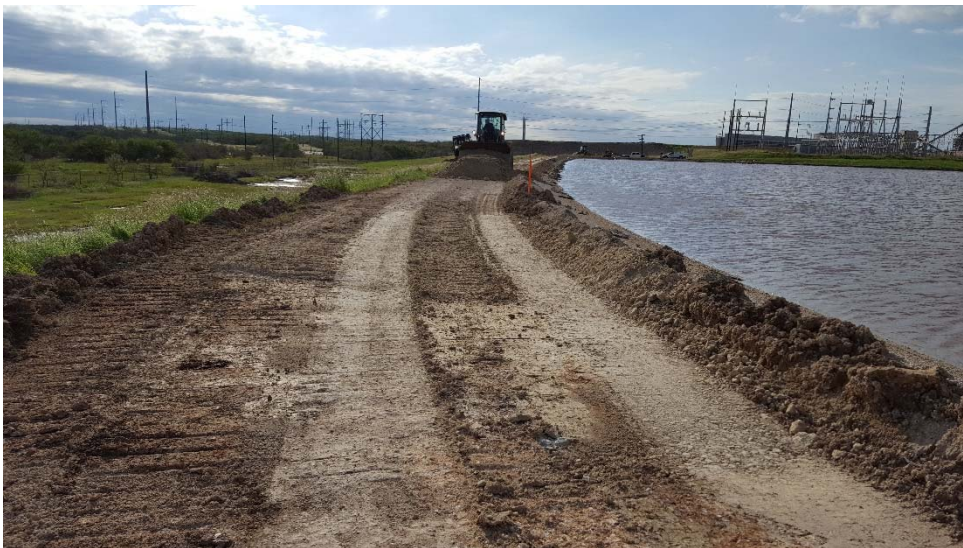
PHOTO 2:

Clay soils were added to the crest of the berm behind the temporary berm previously installed. Wave erosion was minimal along the shoreline and the underlying clay liner was not exposed. This view is to the west-southwest.

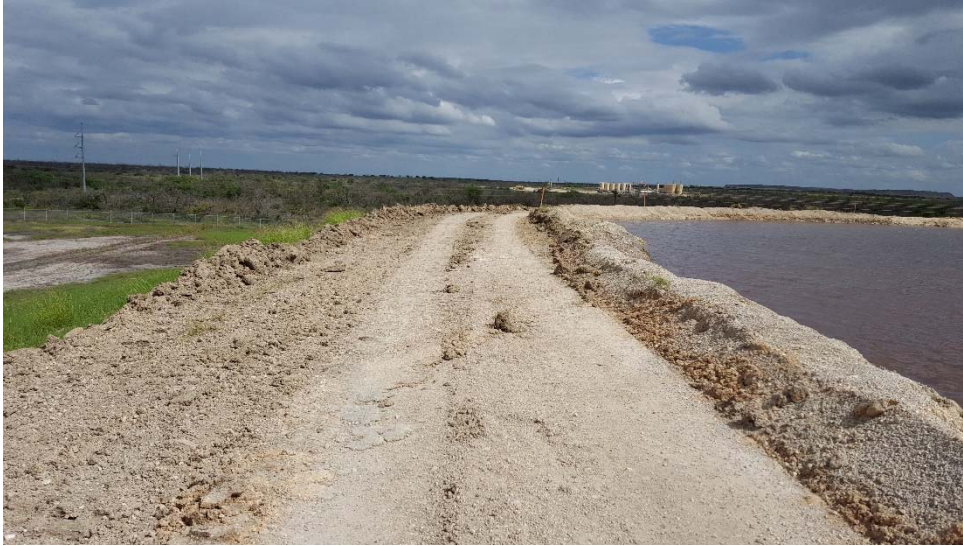
PHOTO 3:

Vegetation along the interior of the berm crest has been removed. This view is to the east-southeast during the installation of the first lift of clay soils on the berm crest.

Summary of Prior Deficiency/Observation*	Maintenance and Corrective Measures
The crest of the impoundment had areas with moderate rutting from vehicular traffic in localized areas around the pond.	This is a routine operations maintenance matter. Where needed, the crest of the Equalization Pond is being adjusted to an elevation of 296 feet above mean sea level and these areas are being reconditioned. See Photo No. 1
Moderate wind/wave erosion occurring at the water line of the pond.	This is a routine operations maintenance matter. The water level has been lowered and only minor erosion is present, the liner was not exposed. Maintenance and repair of the inner pond berm is performed by SMECI's Maintenance Contractor. Additionally, the inner berm is being adjusted during the heightening of the berm. See Photo No. 2
Vegetation growth in pond area along the inner face of the embankment/dike.	This is a routine operations maintenance matter. Vegetation has been removed. See Photo No. 3

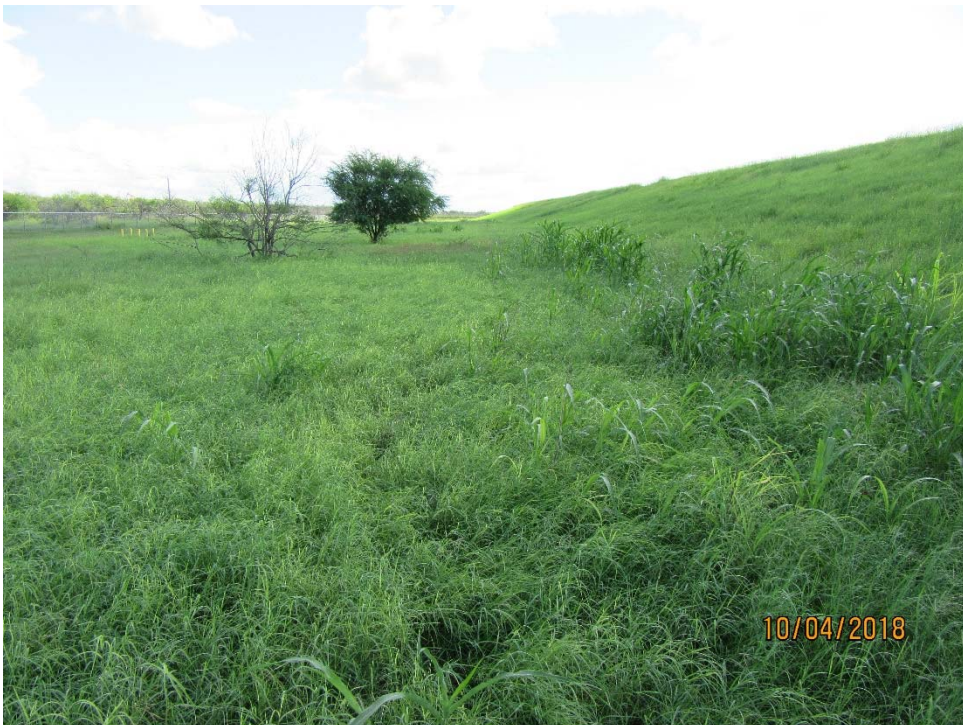
PHOTO 4:

This photograph is looking to the south along the eastern flank of the Equalization Pond and shows the vegetative cover following recent precipitation events. No trees or brush were observed along the slope.

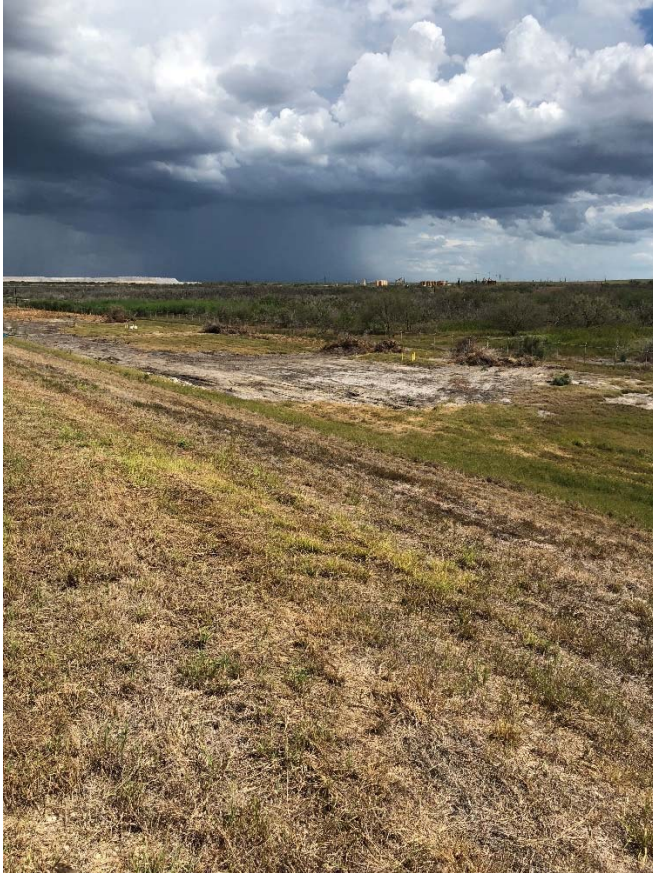
PHOTO 5:

Looking to the southeast from the southern crest of the Equalization Pond toward a recently disturbed area associated with brush and vegetation removal. This picture is from a drier period showing the brown vegetation. This area is a streambed that parallels the southern and eastern sides of the Equalization Pond.

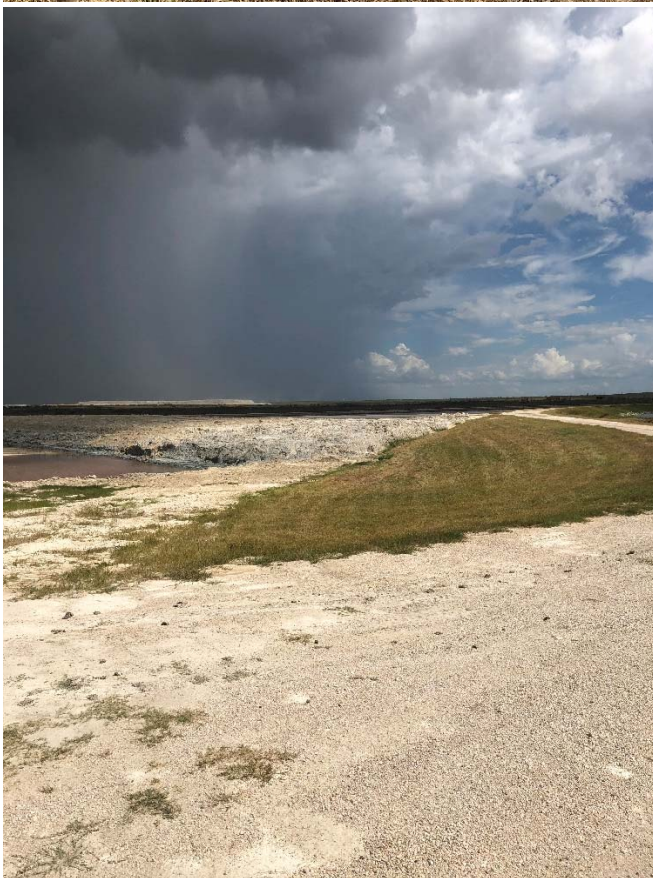
PHOTO 6:

Looking to the south-southeast from near the northwestern corner of the Equalization Pond. There was sparse vegetation near the shoreline. This area was disturbed by heavy equipment during the piling of ash within the pond. This area will be reseeded following the completion of the crest work at the pond.

Dense vegetation observed on the south and east sides. Ponding and moist/soft spots appear along south and east sides.	This is a routine operations maintenance matter. The berms and other areas were mowed. Soft spots were not observed. No evidence of seeps, cracks, or slope failures were observed. Mowing and vegetation clearing is performed on a routine and as-needed basis by the SMECI Maintenance Contractor. See Photo Nos. 4 (after rain) and 5 (dry period)
Sparse vegetation observed on the inner slopes on the north west side and along the downstream toe on the north east side.	This is a routine operations maintenance matter. The areas of sparse vegetation are related to recent machinery operation near the northwestern corner of the Equalization Pond. The equipment was used to stack ash within the pond for drying and eventual removal. The area along the toe of the embankment was cleared of vegetation and is scheduled for reseeding. See Photo Nos. 6 and 7

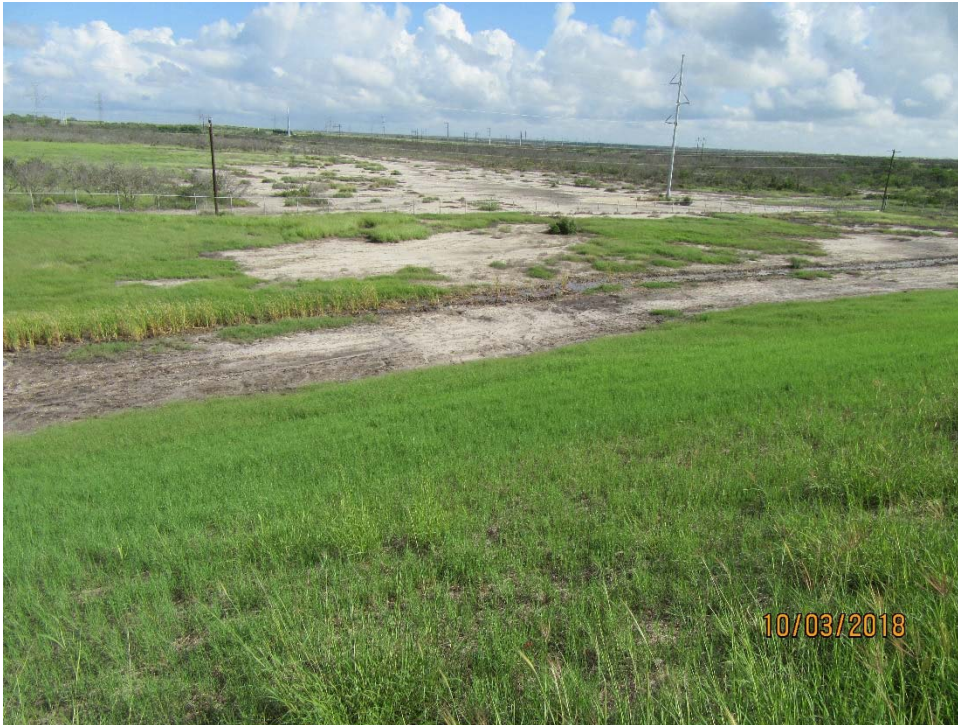
PHOTO 7:

This photograph is looking to the northeast down the slope of the Equalization Pond berm. The area on the southern side of the small drainageway was recently scraped and leveled near the toe of the embankment.

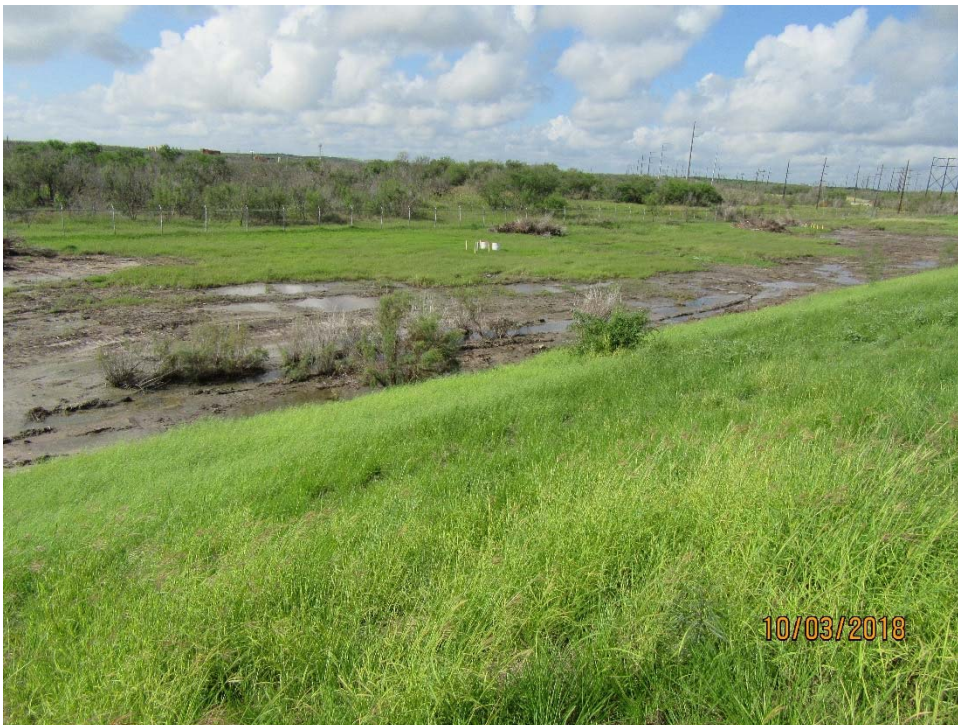
PHOTO 8:

Two small bushes remain on the southern slope of the Equalization Pond embankment, all other brush has been removed. The area in the background is the streambed after recent rainfall events. Small amounts of ponded rain water were observed in shallow depressions.

Small trees/bushes growing on the downstream embankment.	This is a routine operations maintenance matter. Trees and bushes have been removed, a very minor amount of brush remains. See Photo No. 8

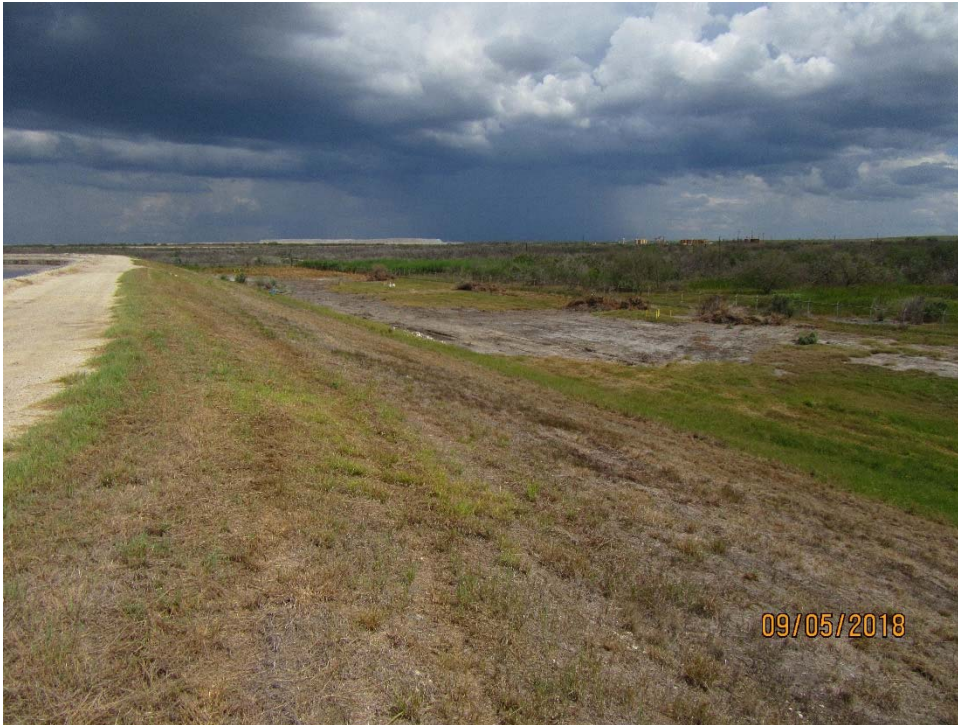
PHOTO 9:

This photograph is looking to the southeast from the crest of the berm near the southwestern corner of the Equalization pond berm. This shows the streambed along the toe of the berm to be nearly dry after a period of no rainfall and the vegetation to be brown. No water was observed at the toe of the berm.

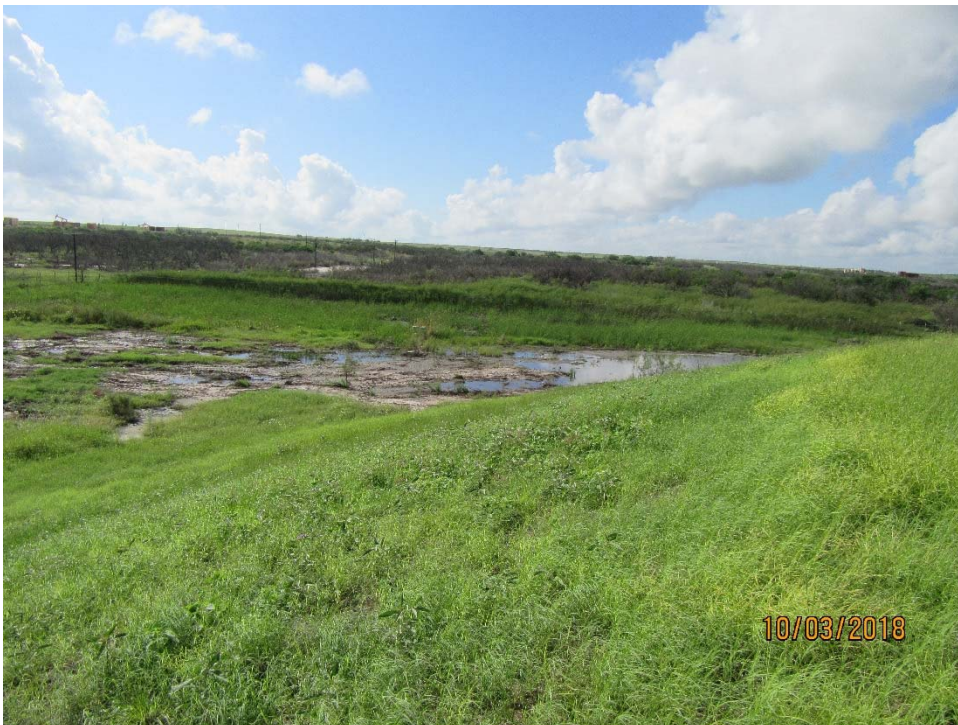
PHOTO 10:

This photograph shows ponded water near the toe of the berm after a heavy rainfall event. No seeps were observed along the toe of the berm during a walking inspection of the toe of the berm.

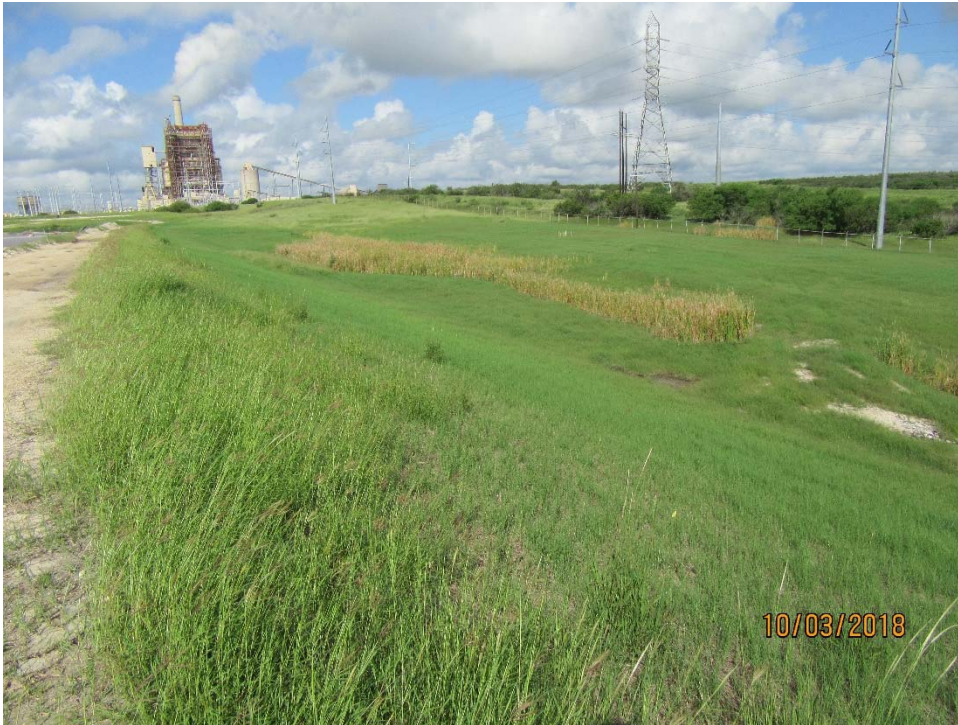
PHOTO 11:

Looking to the west along the northern slope of the Equalization Pond embankment. A crossing with a culvert is visible near the right side of the photograph. Water tends to pond upstream of the culvert which is partially responsible for the cattail growth. Slope softening was not observed.

Summary of Prior Deficiency/Observation*	Maintenance and Corrective Measures
<p>Water ponding around the toe of the downstream embankment (potentially from storm activities prior to inspection).</p>	<p>This area has had the vegetation removed to help alleviate the ponded water. A streambed is located in this area and flows around the base of the Equalization Pond. Based on visual observations, the surface water is related to the adjacent streambed flowing to the northeast.</p> <p>Recent rain water was pooled in small ruts formed as a result of recent vegetation removal and relatively minor ponding was observed along the streambed. There is no indication of Pond seepage.</p> <p style="text-align: center;">See Photo Nos. 9 (dry) and 10 (after rain)</p>
<p>Slight slope softening on northwest levee face.</p>	<p>No slope softening or slope failure areas were observed.</p> <p style="text-align: center;">See Photo No. 11</p>

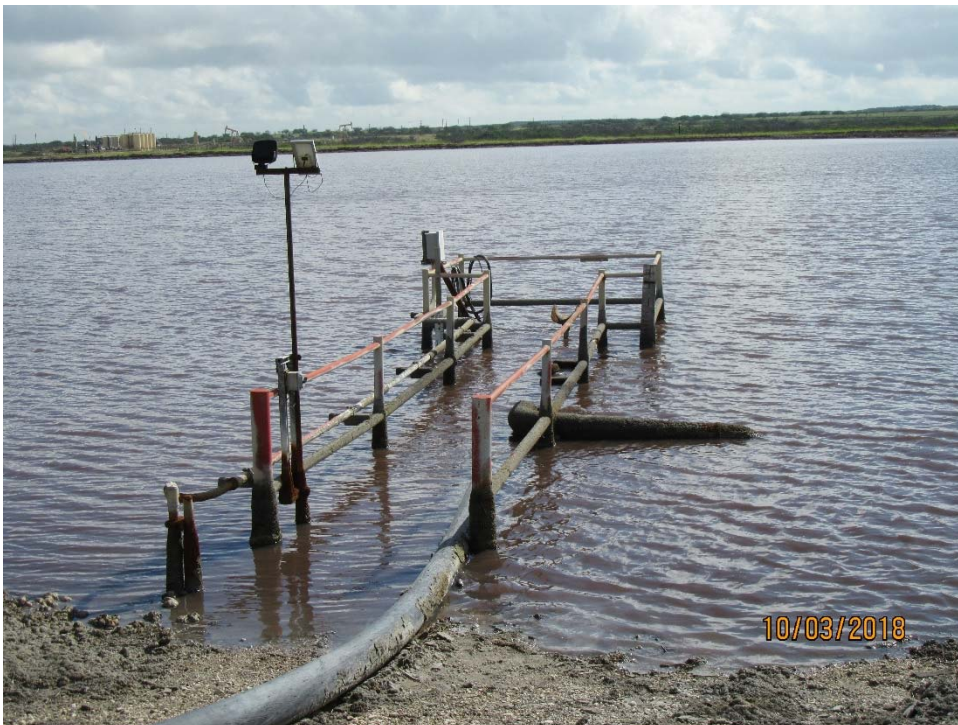
PHOTO 12:

The Equalization Pond gauge is readily visible on the north side of the pier near the end of the pier.

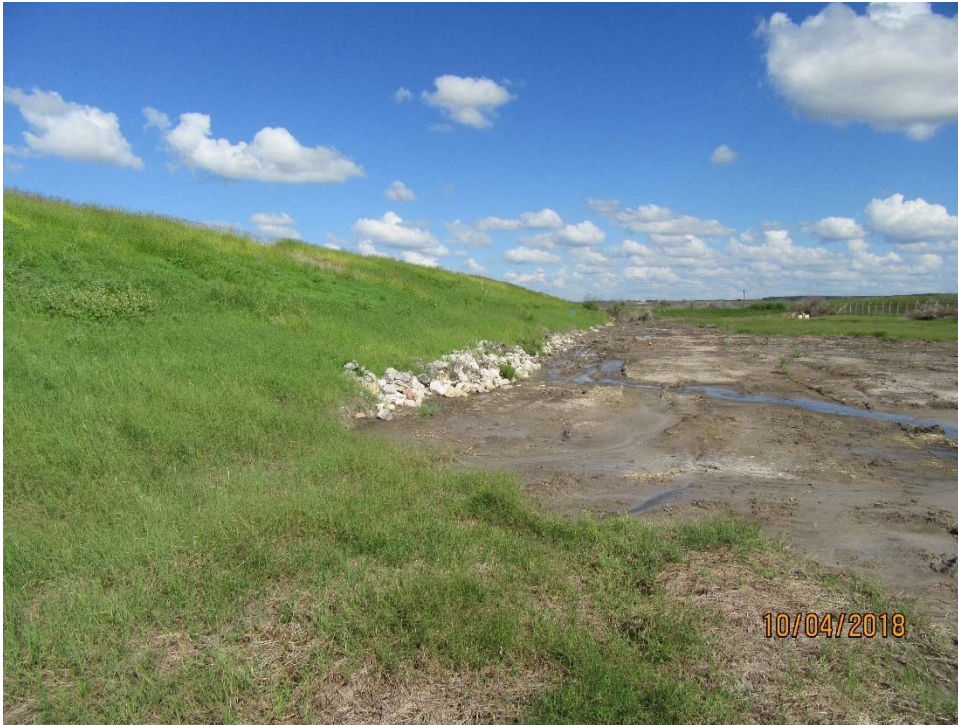
PHOTO 13:

Rip rap was realigned during the removal of brush near the toe of the Equalization Pond embankment. Rip rap was observed to be grass covered for several feet up the embankment. This picture was taken after a rainfall event which is the source of the pooled water.

<p>Accuracy of measuring water depth and volume of CCR material within unit.</p>	<p>SMECI utilizes operational knowledge and, as needed, drone surveys, to appropriately estimate ash volume at any given time.</p> <p>SMECI replaced the staff gage on the pier in 2016.</p> <p>In July 2018, SMECI dropped the water level and flew the pond with a drone to perform bathymetric survey. At the time the total ash volume was estimated at 90,000 cy.</p> <p style="text-align: center;">See Photo No. 12</p>
<p>Riprap needs realignment.</p>	<p>Riprap was realigned during maintenance activities that removed vegetation near the toe of the Equalization pond.</p> <p style="text-align: center;">See Photo No. 13</p>

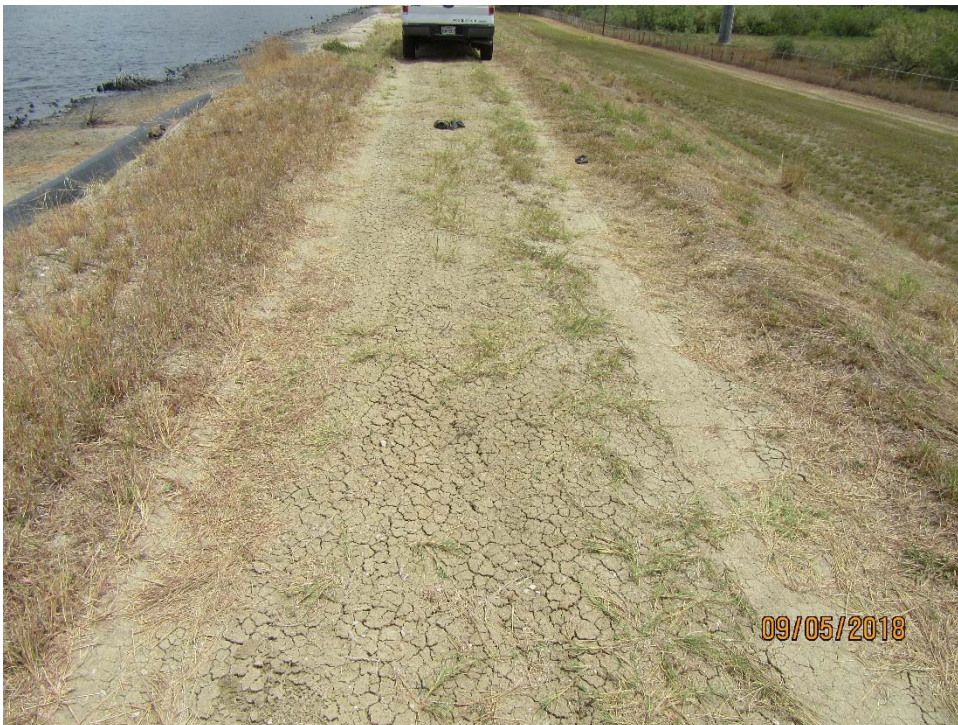
PHOTO 14:

This is a view to the east along the southern crest of the Ash Pond B embankment. This was a relatively dry period and negligible rutting was observed on the crest of the berm. Rutting on the southeastern and northwestern corners of the Ash Ponds had been addressed by applying clay soils to the effected areas.

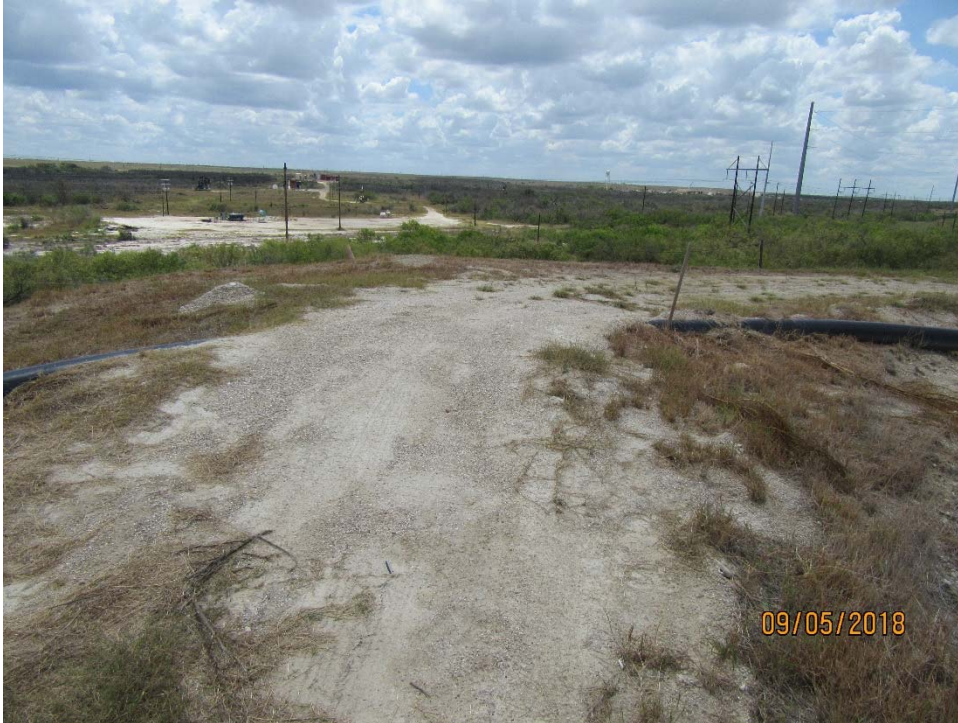
PHOTO 15:

The southeastern corner of Ash Pond B looking to the south. This area was not rutted and has clay soils placed in this area.

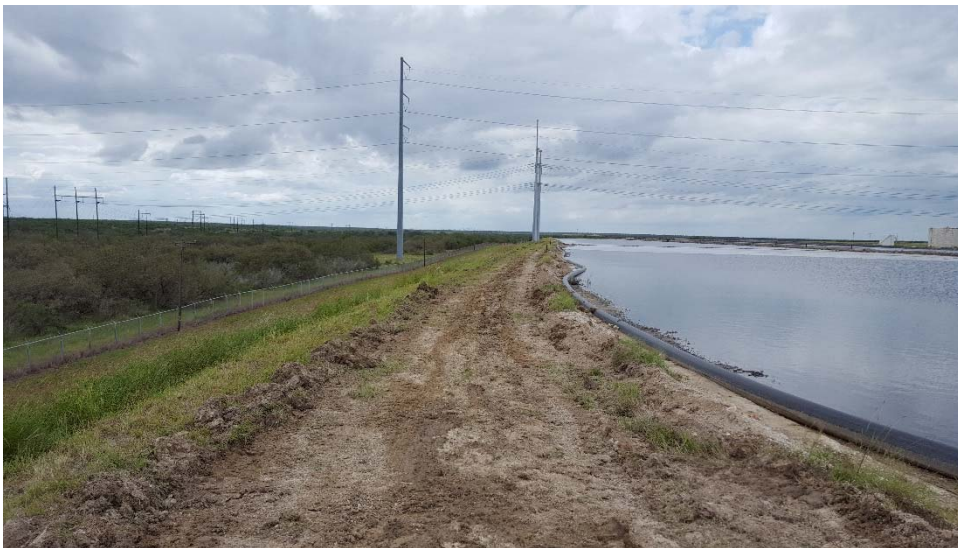
PHOTO 16:

Looking to the west along the crest of the Ash Pond B. A temporary berm had been placed along the crest and will be incorporated into the ongoing crest repairs. Only minor erosion of the interior embankment was observed and the clay liner was not exposed.

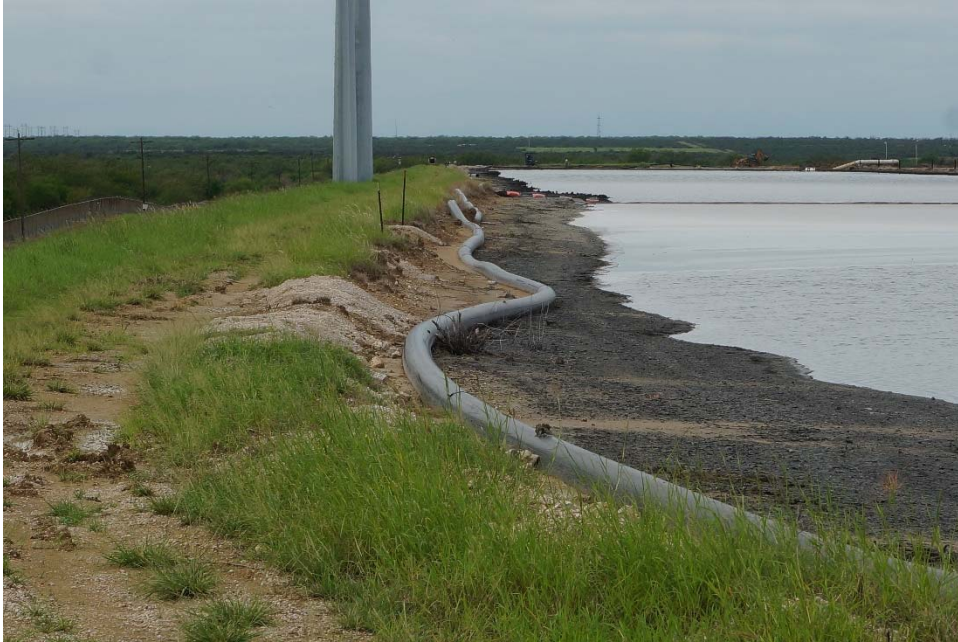
PHOTO 17:

This view is to the west along the crest of Ash Pond B embankment. All brush and vegetation was removed from the embankment. The shoreline showed only minor erosion.

Summary of Prior Deficiency/Observation*	Maintenance and Corrective Measures
<p>The crest of the impoundment had areas with moderate rutting from vehicular traffic in localized areas around the pond.</p> <p>Major rutting observed along southeast and northwest of the crest.</p>	<p>This is a routine operations maintenance matter. The crest of the Ash Pond is being raised to the prescribed elevation of 316 feet above mean sea level and the rutted areas are being reconditioned.</p> <p>See Photo Nos. 14 (minor rutting and cracking when dry prior to crest adjustment) and 15 (SE corner prior to crest adjustment)</p>
<p>Moderate wind/wave erosion occurring at the water line of the pond.</p>	<p>This is a routine operations maintenance matter. Some minor erosion was observed, but it did not expose the liner.</p> <p>See Photo No. 16 (prior to ongoing crest adjustments)</p>
<p>Bushes and trees growing around the interior of the pond.</p>	<p>This is a routine operations maintenance matter. The vegetation has been removed. Mowing and vegetation clearing is performed on a routine and as-needed basis by the SMECI Maintenance Contractor.</p> <p>See Photo No. 17</p>

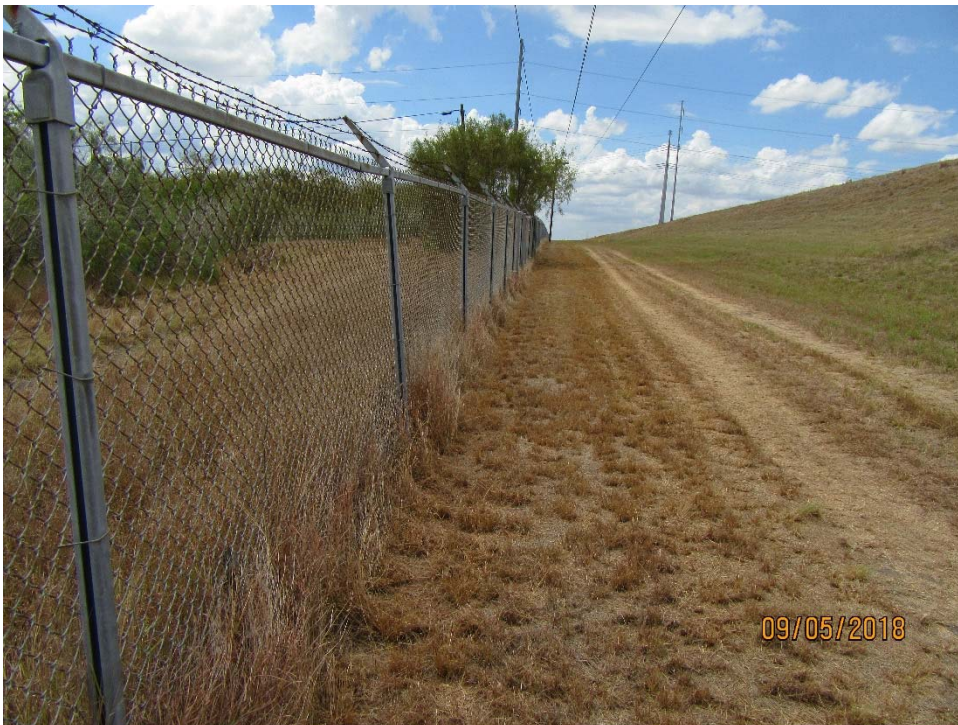
PHOTO 18:

Looking to the west along the toe of the Ash Pond's southern side. All brush has been removed from the slope. No seeps or erosion were observed in this area and the berm is well vegetated.

<p>Small trees/bushes growing on the downstream embankment.</p>	<p>This is a routine operations maintenance matter. Vegetation has been removed. Mowing and vegetation clearing is performed on a routine and as-needed basis by SMECI's Maintenance Contractor.</p> <p>See Photo No. 18</p>
<p>Dense vegetation/ tall grasses were observed along the southern exterior slope.</p>	<p>This is a routine operations maintenance matter. This area has been mowed. Mowing and vegetation clearing is performed on a routine and as-needed basis by SMECI's Maintenance Contractor.</p> <p>See Photo No. 19</p>
<p>Lack of vegetation on west side.</p>	<p>This is a routine operations maintenance matter. This area is scheduled for reseeding following the ongoing installation of a toe drain and a top soil cover.</p> <p>See Photo No. 20 (prior to removing vegetation) and 21 (after removing vegetation)</p>
<p>Drainage channel along east side needs to be vegetated</p>	<p>This is a routine operations maintenance matter. The drainage channel was recently cleaned out and vegetation has not been completely reestablished.</p> <p>See Photo No. 22</p>

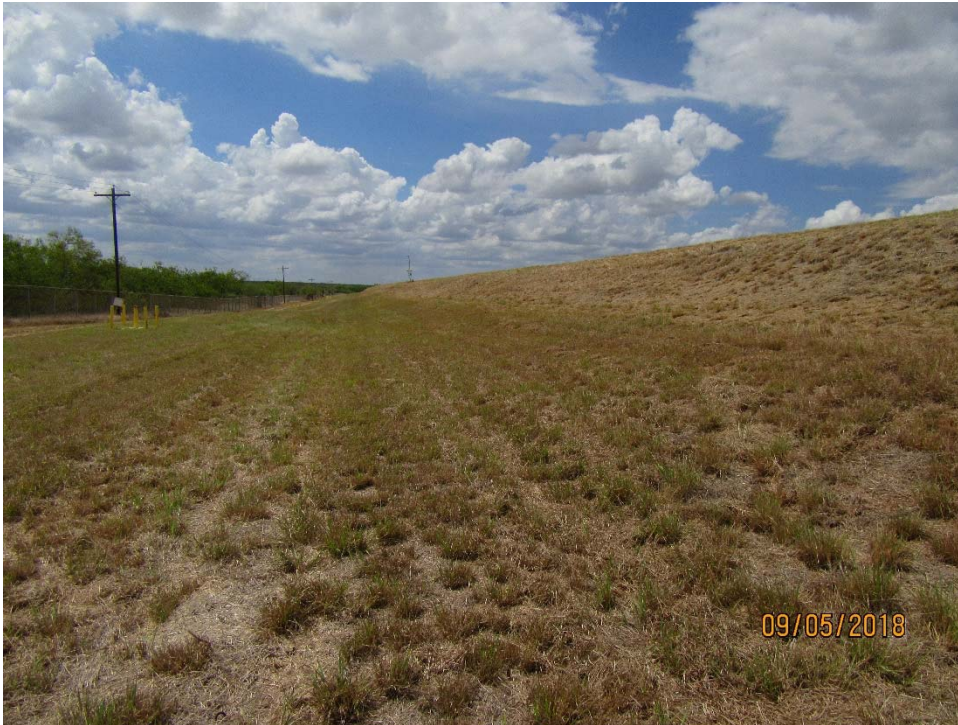
PHOTO 19:

Looking to the west from near the midpoint of the southern side of the Ash Ponds. No seeps were observed in this area. Only minor erosional rills were observed along the southern edge of the embankment in this area. These erosional rills are scheduled to be addressed as part of the ongoing crest repairs.

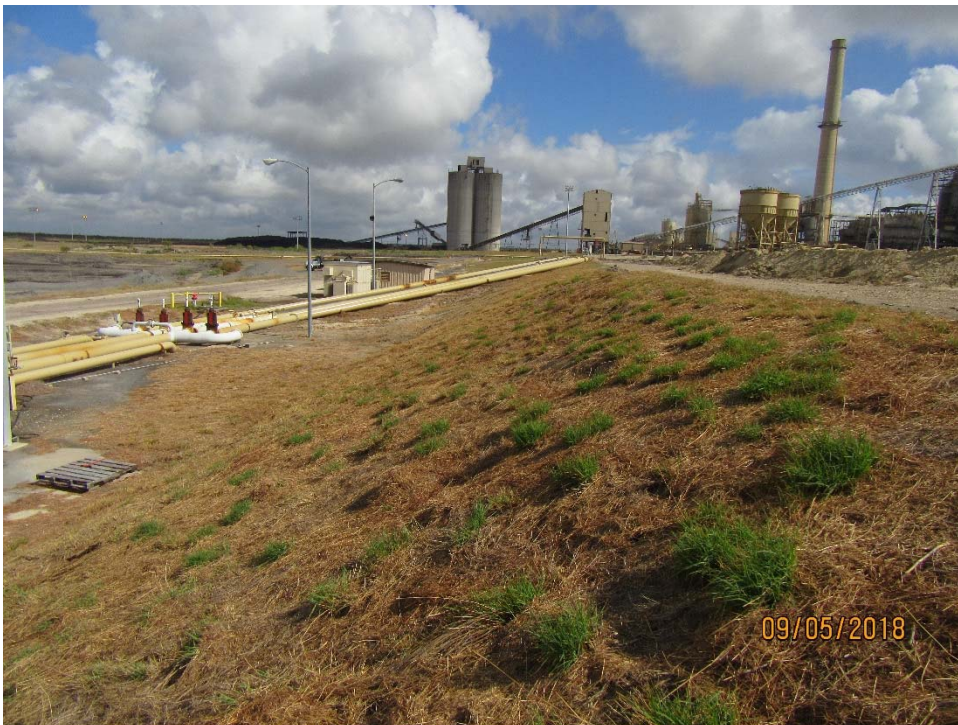
PHOTO 20:

This view is to the north along the western slope of the Ash Ponds embankment. This was a dry period and vegetation was sparse.

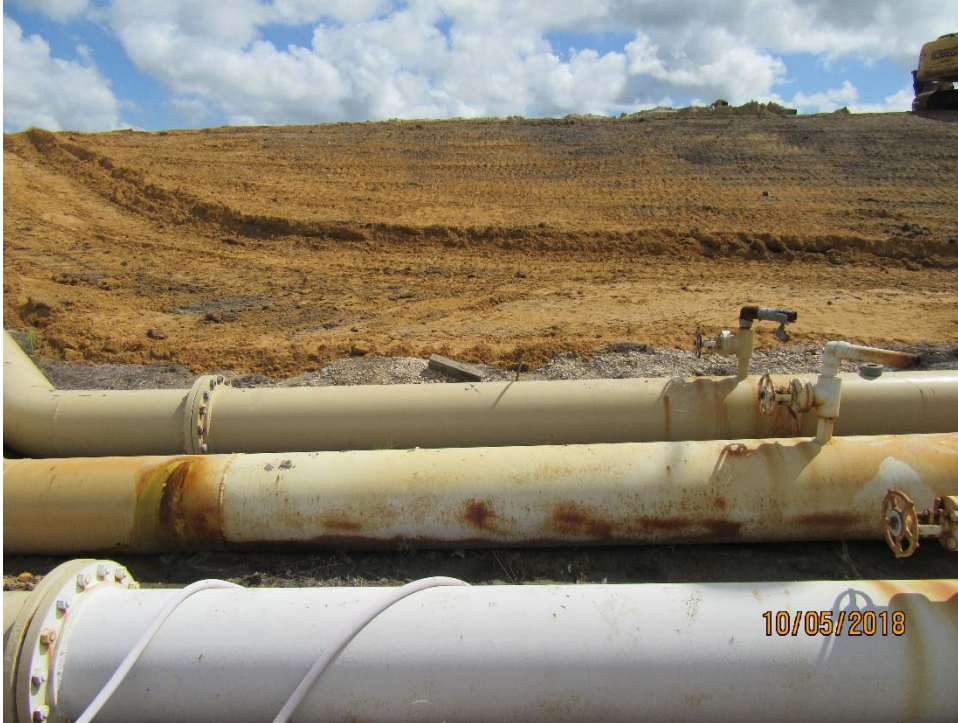
PHOTO 21:

This photograph is looking to the east and shows the western slope of the Ash Ponds embankment during ongoing repairs. The slope was leveled and a key was installed in the foreground beyond the piping in preparation for the installation of the toe drain. Rain events have postponed this work.

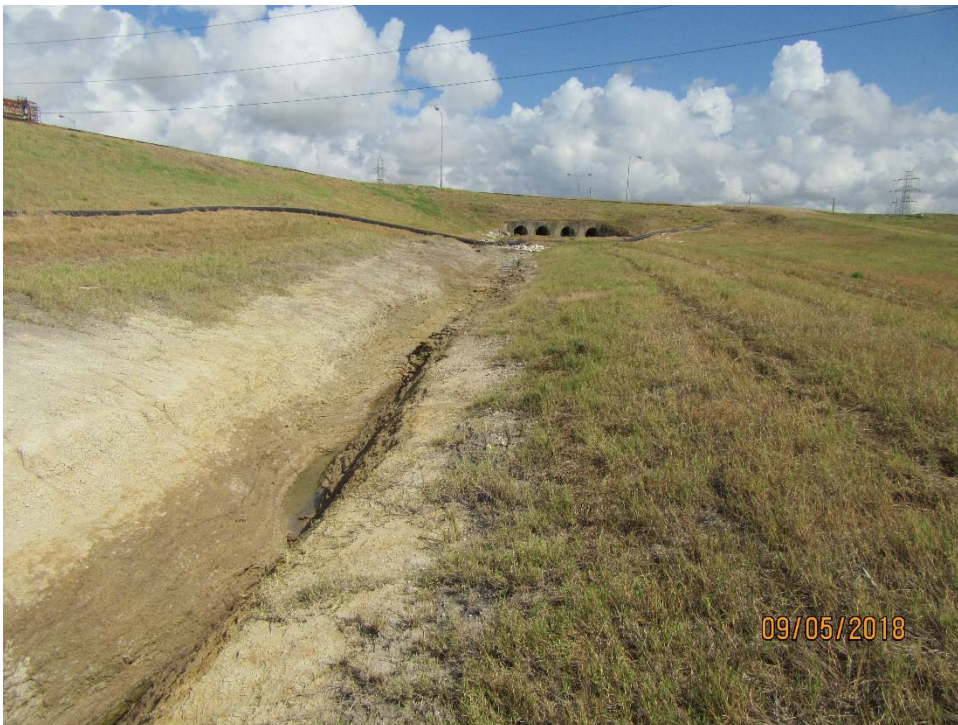
PHOTO 22:

This photograph is looking to the north along the drainageway east of the Ash Ponds. The drainageway was recently cleaned out and channelized to enhance drainage.

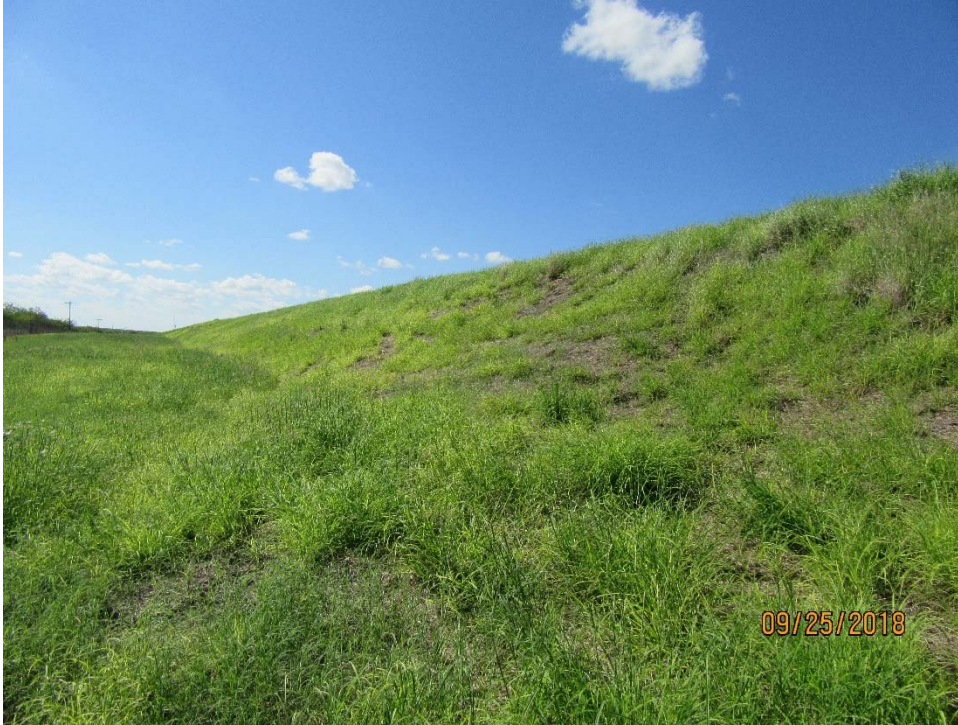
PHOTO 23:

Looking to the west at the southern side of the Ash Ponds southern embankment. This is the area of small erosion rills near the crest of the embankment. This area will be addressed as part of the ongoing crest repairs. The photograph was taken after recent rain events.

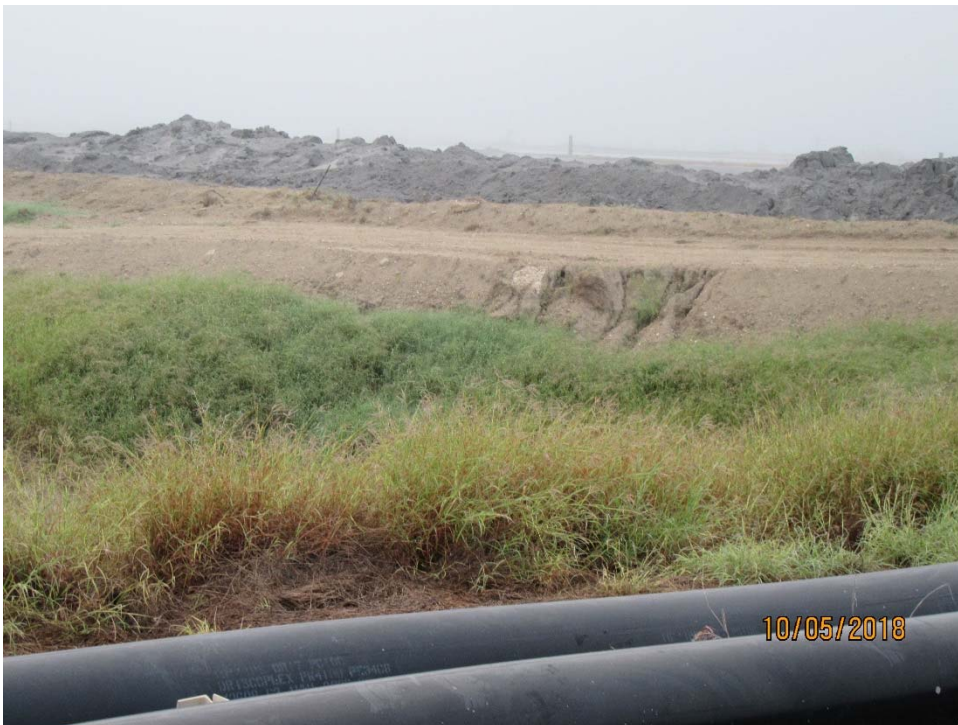
PHOTO 24:

This photograph is looking to the south at the northwestern corner of Ash Pond A. The erosional gully in the foreground is on a temporary road constructed specifically for ash removal activities. The road will be removed upon completion of the ash removal.

<p>Erosion gullies were found on the embankment in isolated areas around the perimeter of the disposal area.</p> <p>Minor slope failure observed on south side.</p>	<p>This is a routine operations maintenance matter. These minor erosional rills and slumps are scheduled to be addressed as part of the ongoing crest elevation adjustments.</p> <p>The minor slope failure is associated with an erosional rill.</p> <p>See Photo No. 23 (rills located along the south slope with minor amounts of material washed downslope)</p>
<p>An erosion gully was found on the embankment at the northwest corner of Pond A.</p>	<p>This is an area of active ash removal. The erosional gully is on a temporary roadway constructed specifically for the ash removal activities, not on the Pond A embankment. The temporary road will be removed upon completion of ash removal. See Photo No. 24</p>

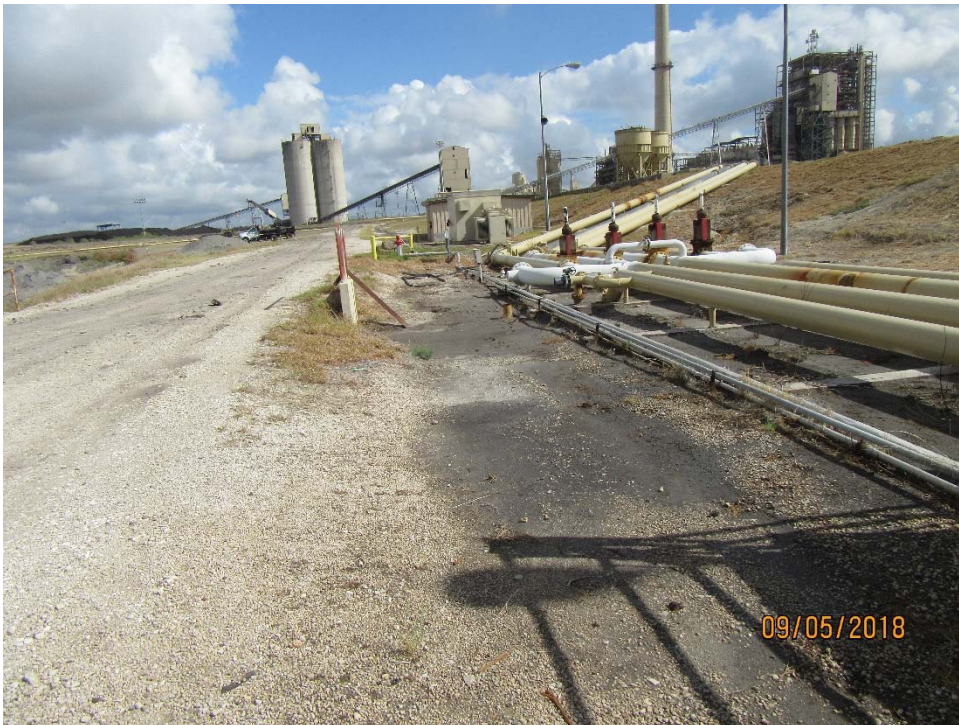
PHOTO 25:

This photograph is looking to the north along the western side of the Ash Pond area. Some ponding of storm water was observed along the access road to the pump area and along the piping leading to the pump area. No ponding was observed at the toe of the berm.

Summary of Prior Deficiency/Observation*	Maintenance and Corrective Measures
Water ponding around the toe of the downstream embankment (potentially from storm activities prior to inspection).	No ponded water was observed at the toe of the berm at the time of the site visit. See Photo No. 25
Water appeared to be seeping from the toe of the downstream embankment of Pond A along the western edge.	This area was assessed as part of the berm repairs and it was determined the seepage was related to surface water drainage into a large buried lens of gravel that had washed down from the crest. Upon removal of the gravel, the area quickly dried up. The pond is not seeping. See Photo Nos. 26 (small patch of cattails) and 27 (gravel lens that held storm water runoff). See Photo. No. 26 and 27
Crest has minor desiccation cracks on south side.	This is a routine operations maintenance matter. Very minor desiccation cracks were observed at the time of the site visit, but they were only surficial. See Photo No. 14

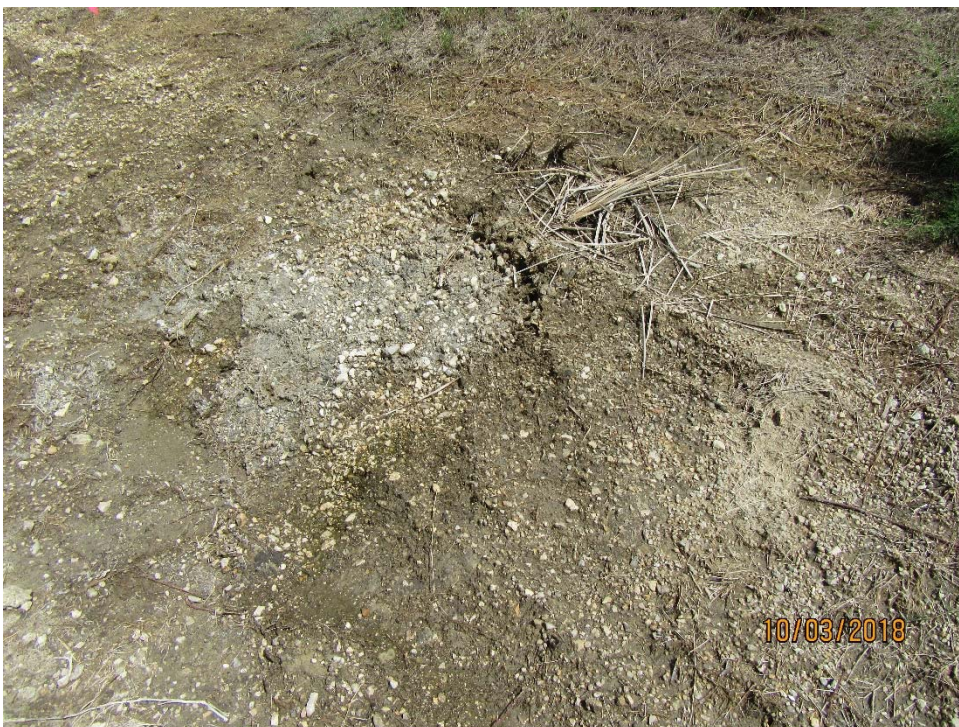
PHOTO 26:

A small area of dead cattails was observed along the western slope of the Ash Ponds. This is the same area depicted in earlier reports (Arias). There was no seepage at the time the photograph was taken. There was some small gravel present on the surface of the ground along the slope.

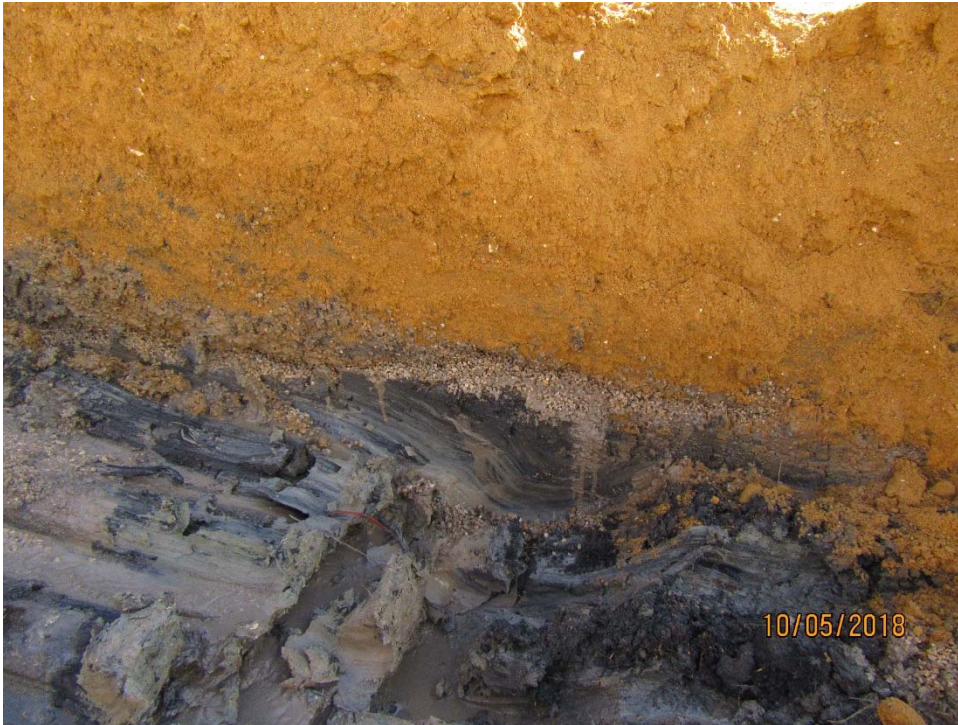
PHOTO 27:

View of the excavation completed at the location of the dead cattails. The excavation revealed a buried lens of small gravel. This gravel lens was holding stormwater runoff and slowly allowing it to seep to the surface. The material underlying the gravel was a fat clay. After exposing and removing the gravel lens, the excavation quickly dried up confirming there is no pond seepage.

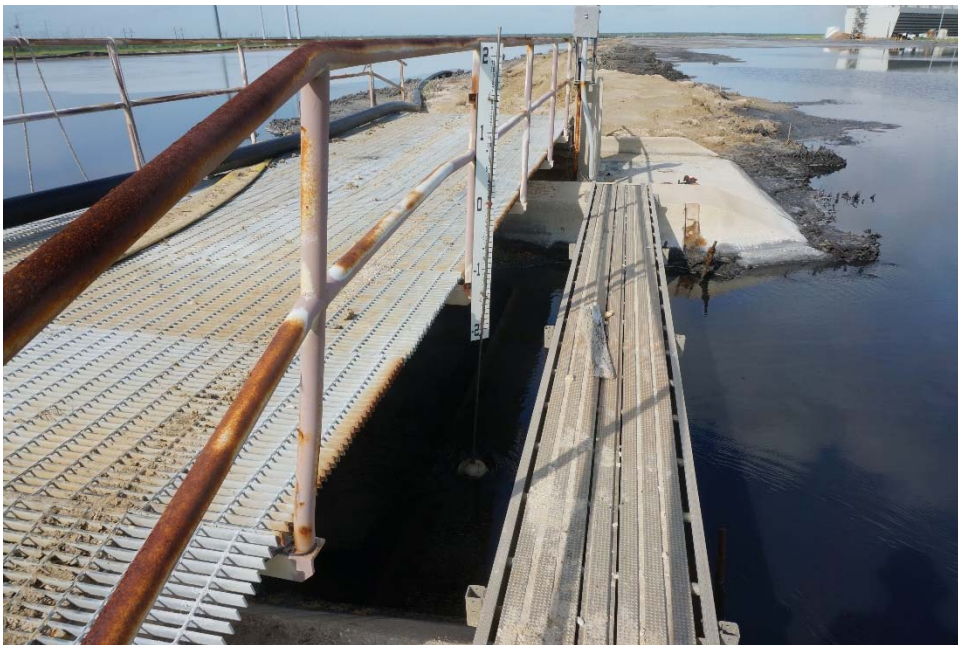
PHOTO 28:

The gauge located at the weir between Ash Pod A and B. New clay soils had recently been added to the berm on both side of the weir bridge.
