**Maintenance and Corrective Measures
San Miguel Electric Cooperative Inc.
(as of October 2018)**

Equalization Pond

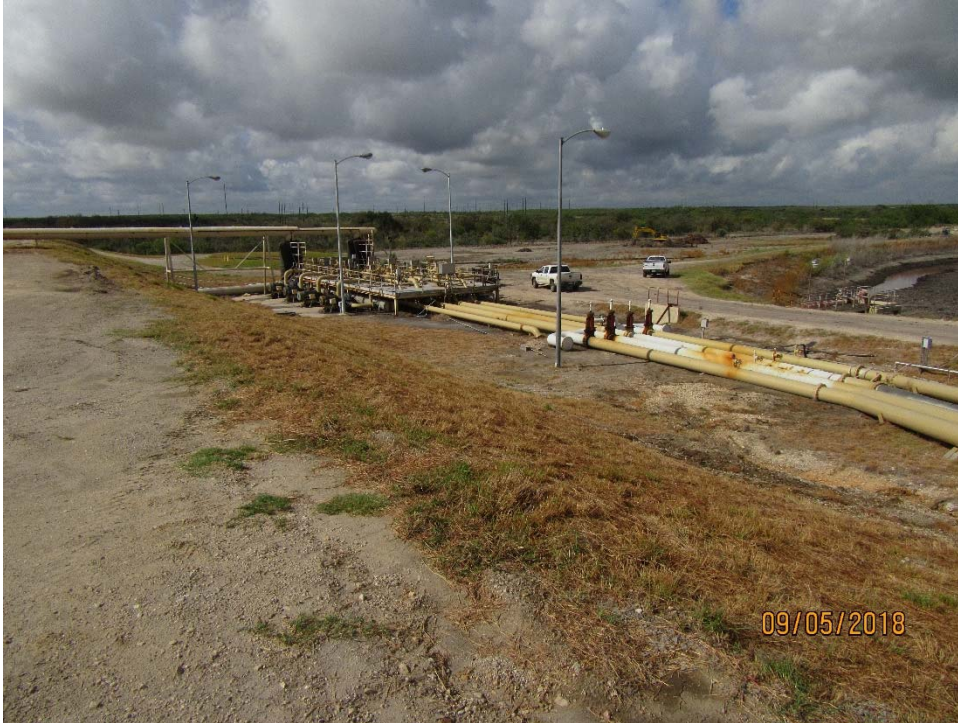
PHOTO 29:

The view is to the southwest toward the pump area, on the west side of the Ash Pond. This photograph was taken during a dry period. Erosional areas at this location are being corrected as part of the slope repair work.

Accuracy of measuring water depth and volume of ash within unit. Pond A boundary/limits needs to be reestablished.	The existing gage works well to obtain water levels. For bathymetric surveys, SMECI utilizes operational knowledge, periodically lowers the water level for drone surveys, and/or performs depth to ash measurements from a jon boat. At the time of this inspection, it is estimated Pond A is 65% filled with ash. Pond A is scheduled for removal of 158,000 cy of material. It is estimated Pond B is 20% filled with ash. The Pond A boundary will be reestablished as part of the Ash removal process. See Photo No. 28
Scour/erosion around weir structures/pipes.	This is a routine operations maintenance matter. Material has been added to this area and along the central berm. See Photo No. 28
Maintain the pump station area.	This is a routine operations maintenance matter. Ash material has been recently removed from this area to improve drainage to the sump. See Photo No. 29

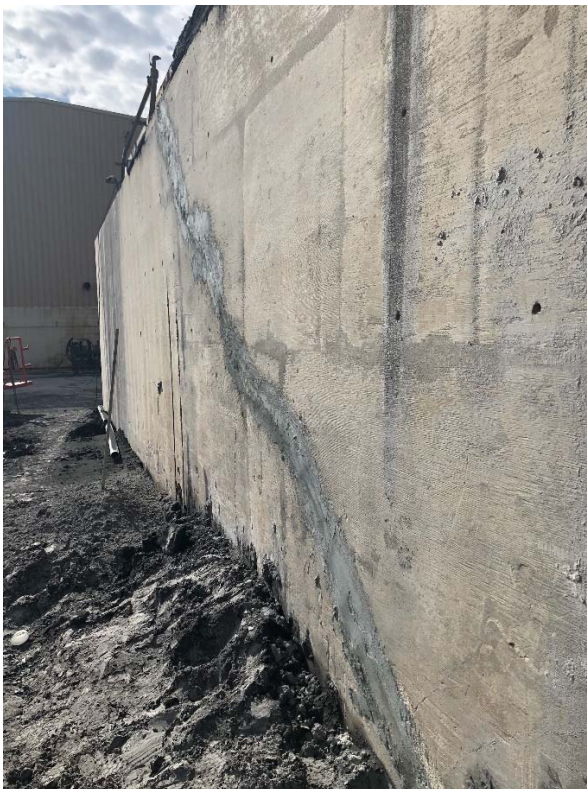
PHOTO 30:

This view is of the repaired crack in the concrete retaining wall at the Ash Pile area. The diagonal crack in the concrete was repaired during the outage week of October 22-26, 2018. Drainage is to the north and west on the northern and western sides of the concrete wall.

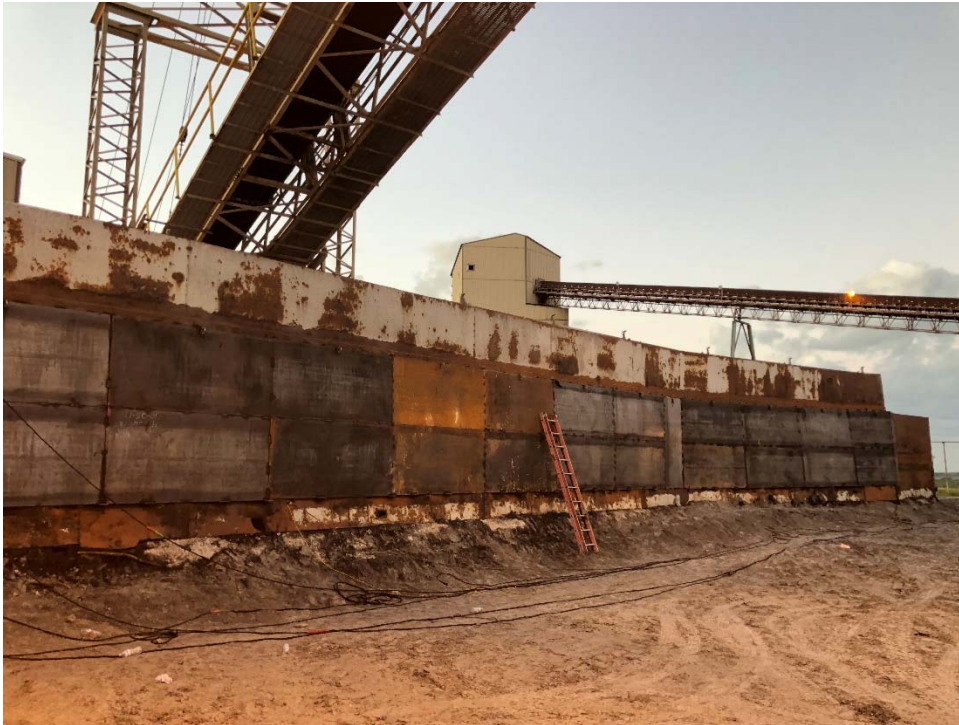
PHOTO 31:

This view of the southern side of the metal retaining wall at the Ash Pile shows the addition of steel plate onto the existing wall. The steel plate was welded onto the existing I-beams to cover any leakage from the interior steel wall. The wall was repaired during the plant outage of October 22-26, 2018.

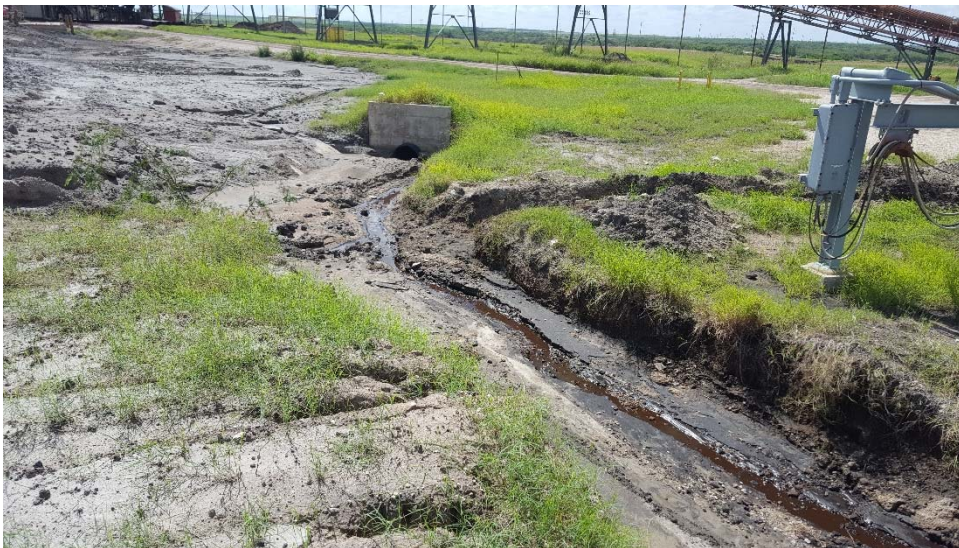
PHOTO 32:

Drainage along the western edge of the Ash Pile area. Minor erosion was observed along the edges of the drainageway.

Summary of Prior Deficiency/Observation*	Maintenance and Corrective Measures
Corrosion and structural cracks on the concrete wall.	The concrete wall serves to contain ash and scrubber sludge where it is blended together to be hauled to the mine. The crack does not impede the function of the wall and was repaired during the October 22-26 facility outage. See Photo No. 30
Concrete retaining wall present only on east side and a steel retaining wall/ baffle wall is used on the south side to contain the Sludge/Ash Pile.	Walls are currently functioning as designed. SMECI repaired the southern steel wall during the October 22-26 facility outage. Inspections will continue to be performed and repairs will be conducted as applicable. See Photo No. 31
Erosion gullies observed along the drainage channel.	This is a routine maintenance matter. SMECI excavated the ditch as part of their routine maintenance in August 2018. See Photo No.32

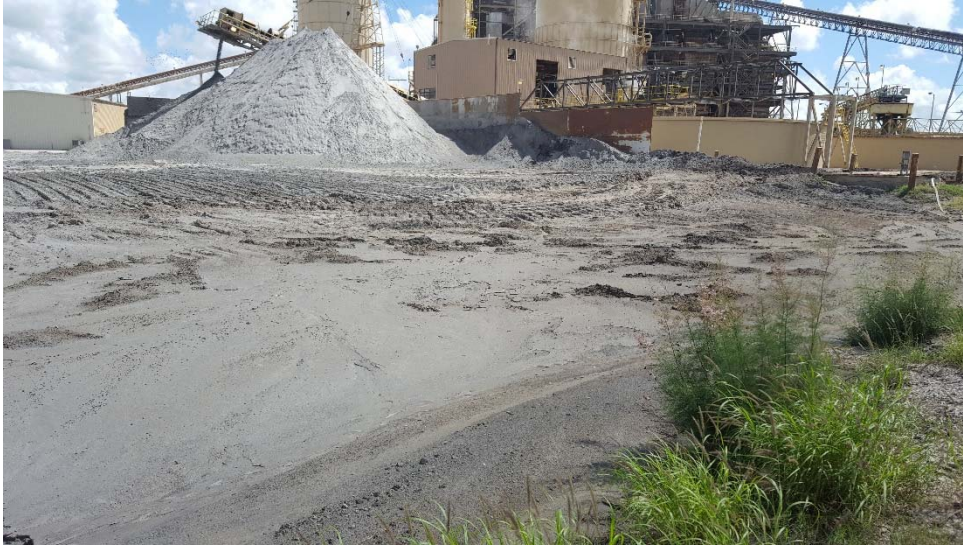
PHOTO 33:

View to the southeast of the Ash Pile area. Ash is removed with a front-end loader and then placed onto large haul trucks.

Sludge pile is exposed resulting in minor erosion.	This is a routine maintenance matter. See Photo No. 33
Storm water runoff not draining properly. Storm water runoff ditches are present on west/north side. Run on drainage behind the concrete wall has no contact with the sludge waste.	This is a routine operations maintenance matter. SMECI excavated the ditches/drainageway as part of their routine maintenance in August 2018. See Photo No. 34
Rutting along haul roads.	This is a routine operations maintenance matter. Rutting was not observed at the time of the site visit. See Photo No. 35
Storm water structures need repair.	This is a routine operations maintenance matter. General repairs were made to storm water structures in August 2018 and are routinely maintained and repaired on an as-needed basis. See Photo No. 36

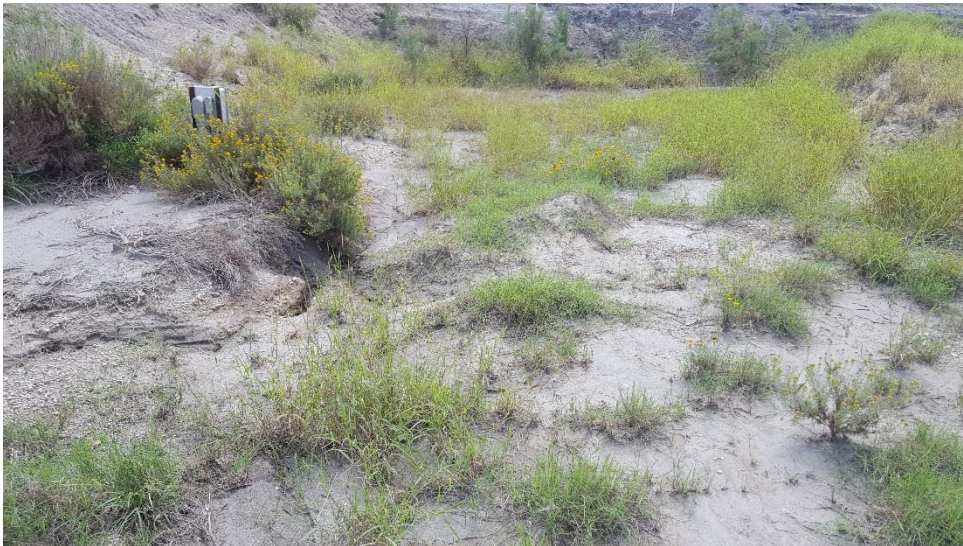
PHOTO 36:

This is the drainage to the south along the eastern side of the haul road. This drainageway is scheduled to be cleaned out during the facility outage, to allow better storm water drainage.
