**Geotechnical Engineering Study
Ash Water Transport and Equalization Ponds
San Miguel Electric Cooperative Power Plant
Atascosa County, Texas**

Arias Job No. 2016-581

October 11, 2016

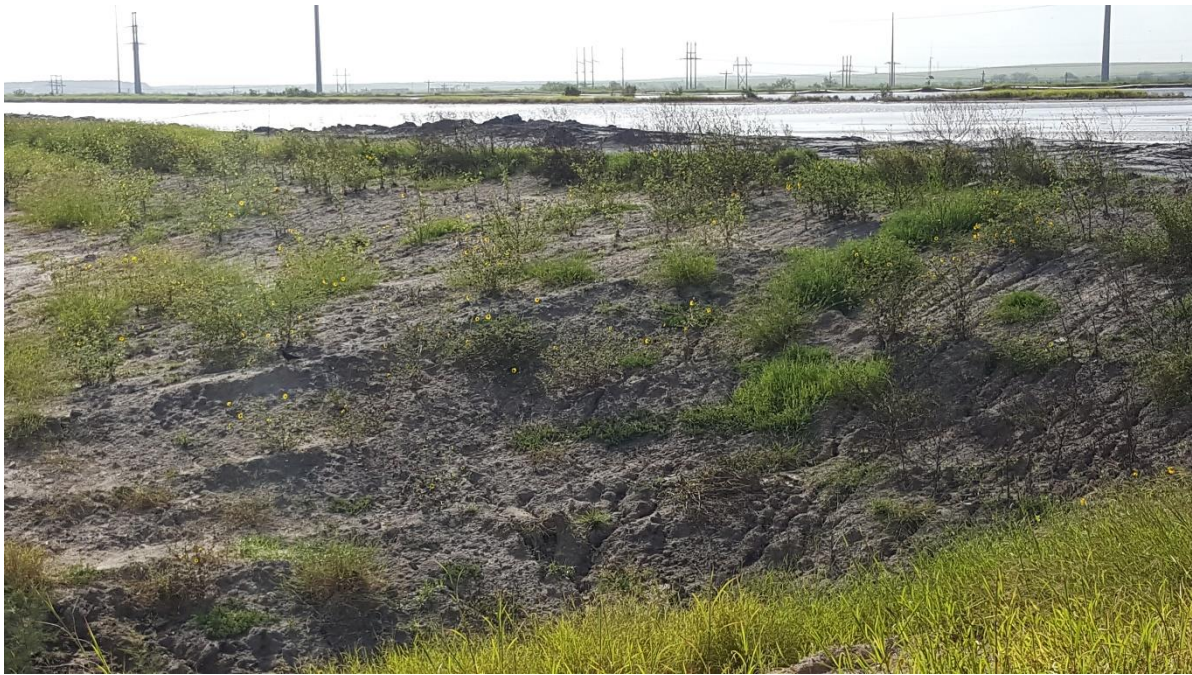
Photo 1 – View looking southeast of west end of north downstream slope of Ash Water Transport Pond.

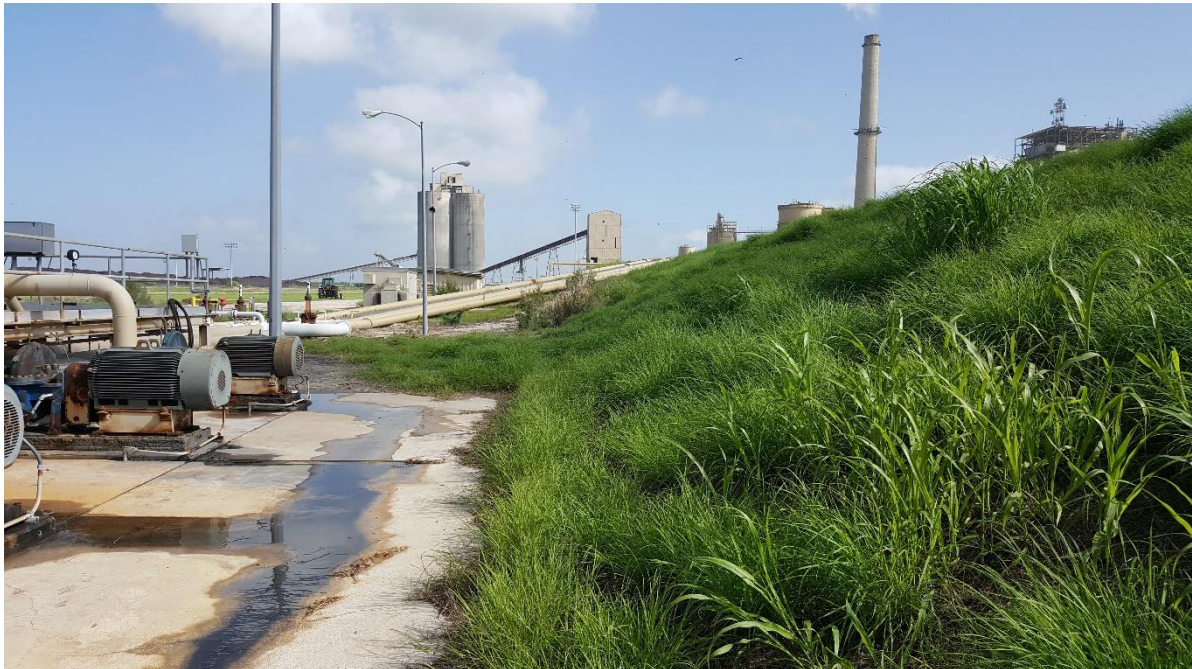
As depicted in Photos 2 to 4 in Appendix B, the west downstream slope in the area of Cross Section 1B appears to have been cut steeper in the bottom portion and minor water seepage is evidenced by a limited amount of ponded water and the presence of cattails. The factors of safety are sufficiently above 1.0 that the slope is in a stable condition. However, Arias recommends that remedial action be taken as summarized previously in Table 2, and presented in greater detail in the next section of this report. *In summary, Arias recommends the following remedial action for the west downstream slope in the area of **Cross Section 1B**:*

Photo 2 – View looking north along downstream slope of cattails/wet/steep section in bottom portion of slope.

1. Grades should be raised in portions of the embankment crest that are below the required maximum surcharge pool level of Elevation 316 feet as evidenced by the surveyed cross sections and the need for temporary berms/dikes along the upstream crest (Photo 7 in Appendix B depicts this condition at the south slope). In the interim, employ means to lower the pool level.
2. Bushes should be removed from slopes and long grass should be cut (see Photo 13 in Appendix B).
3. Downstream slopes should be flattened to a 3H:1V or flatter.

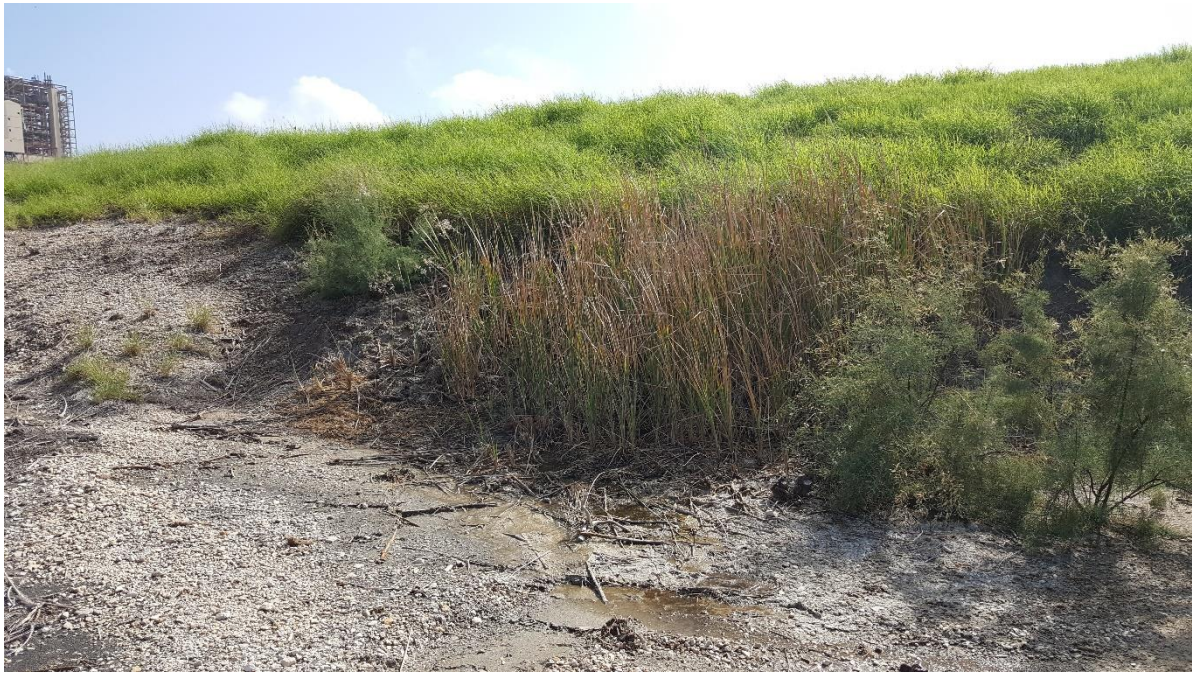
Photo 3 – Close up view of Photo 2 of cattails in steep toe area where seepage is occurring.

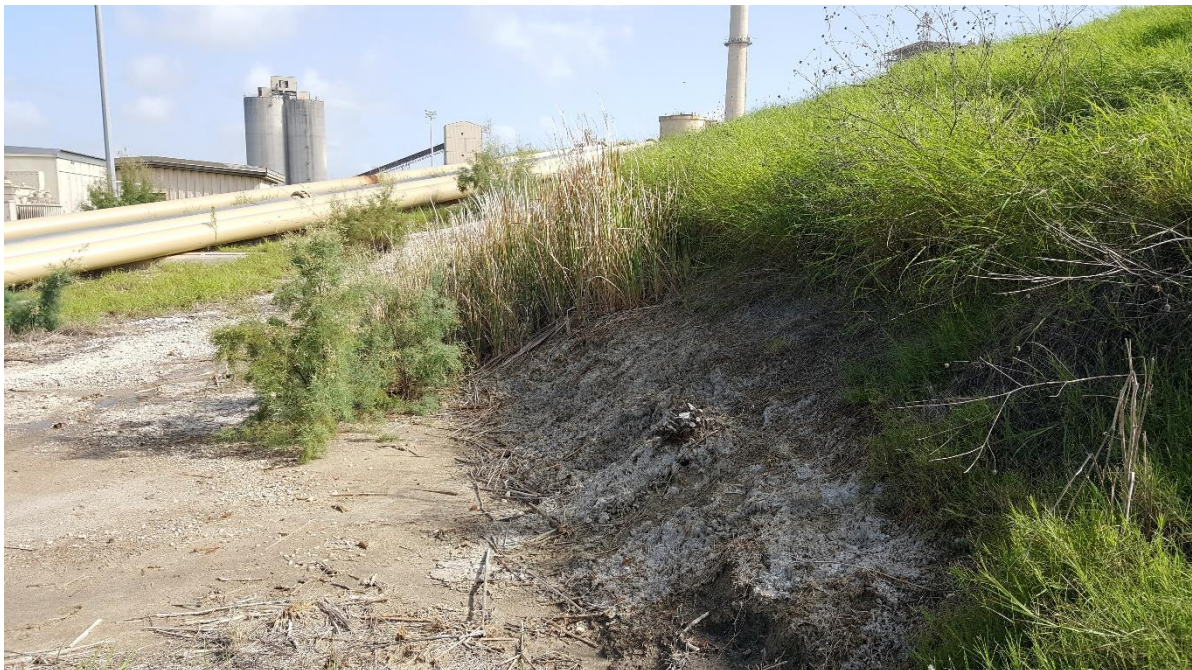
Photo 4 – Close up view of Photo 2 of cattails, stump in ground and steepened bottom part of slope.

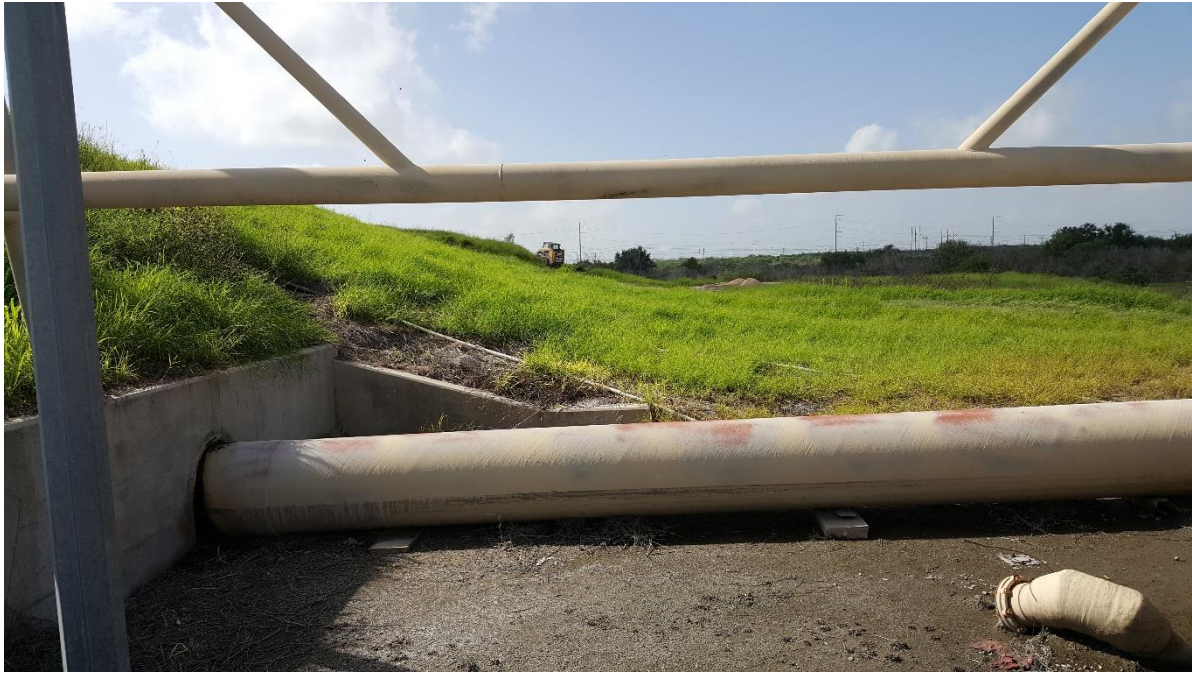
Photo 5 – View looking south at excess fill on west downstream slope by bulldozer.

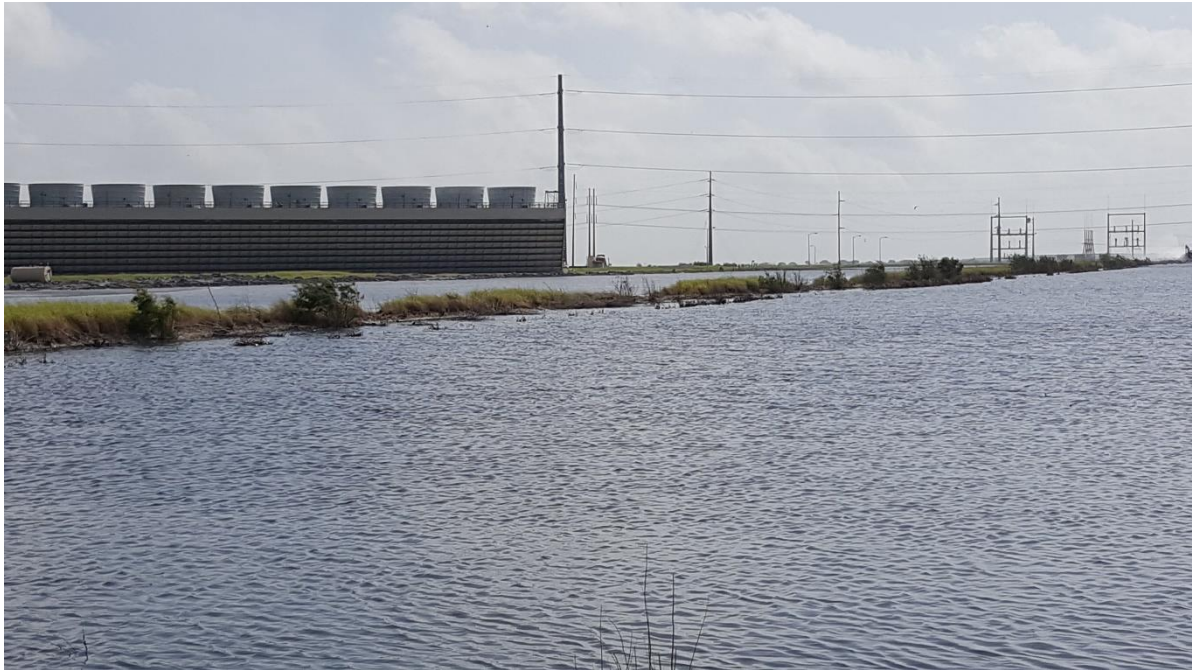
Photo 6 – View looking northeast at splitter dike with excessive bushes and grass.

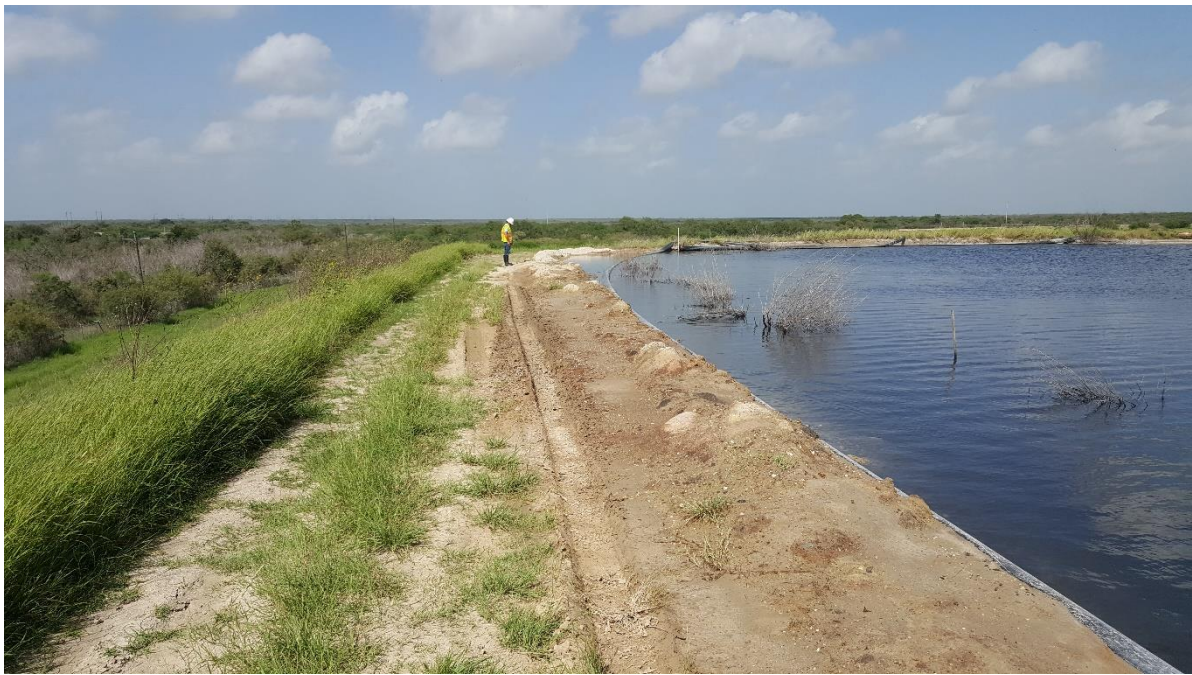
Photo 7 – View looking west at south slope where there is rutting at crest, temporary berm due to high water level in pond and bushes on upstream slope.

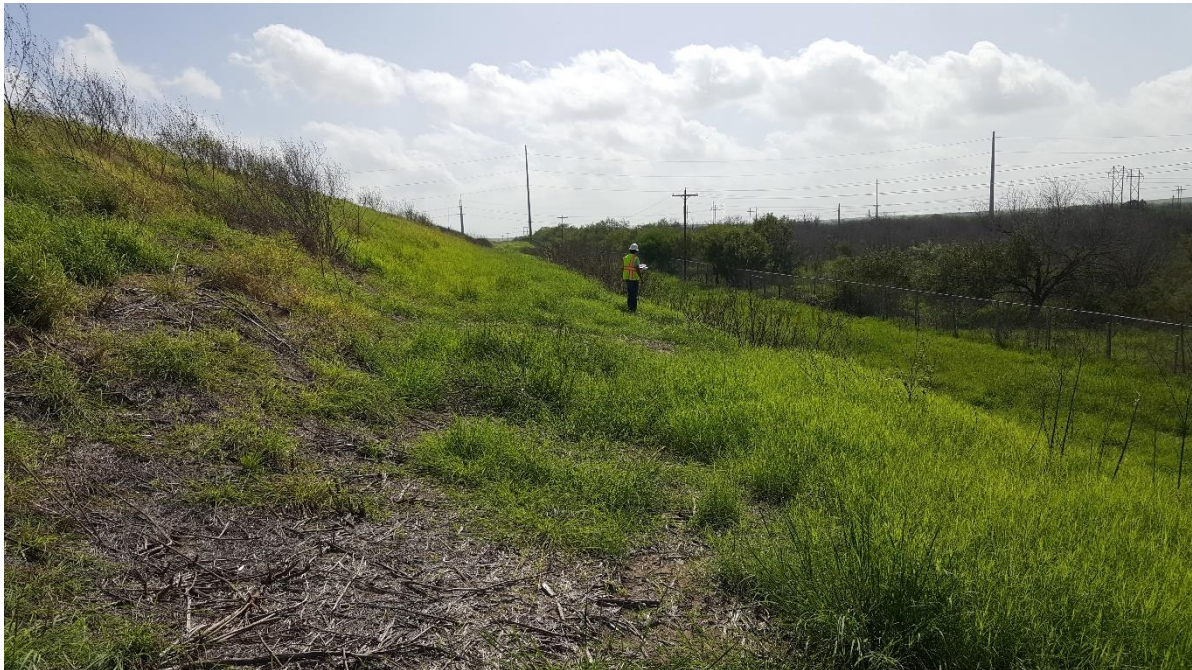
Photo 8 – View looking east at western portion of south downstream slope where bench was previously cut for access road up the slope.

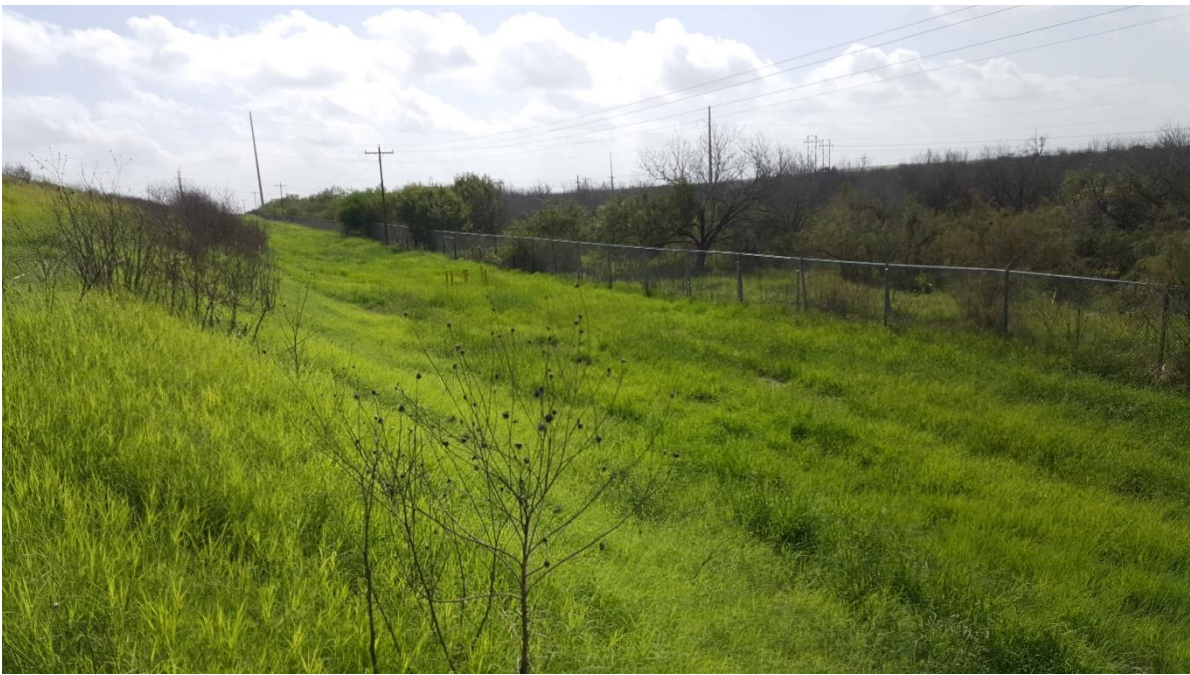
Photo 9 – View looking east at western bottom portion of south downstream and beyond where monitor well can be seen.

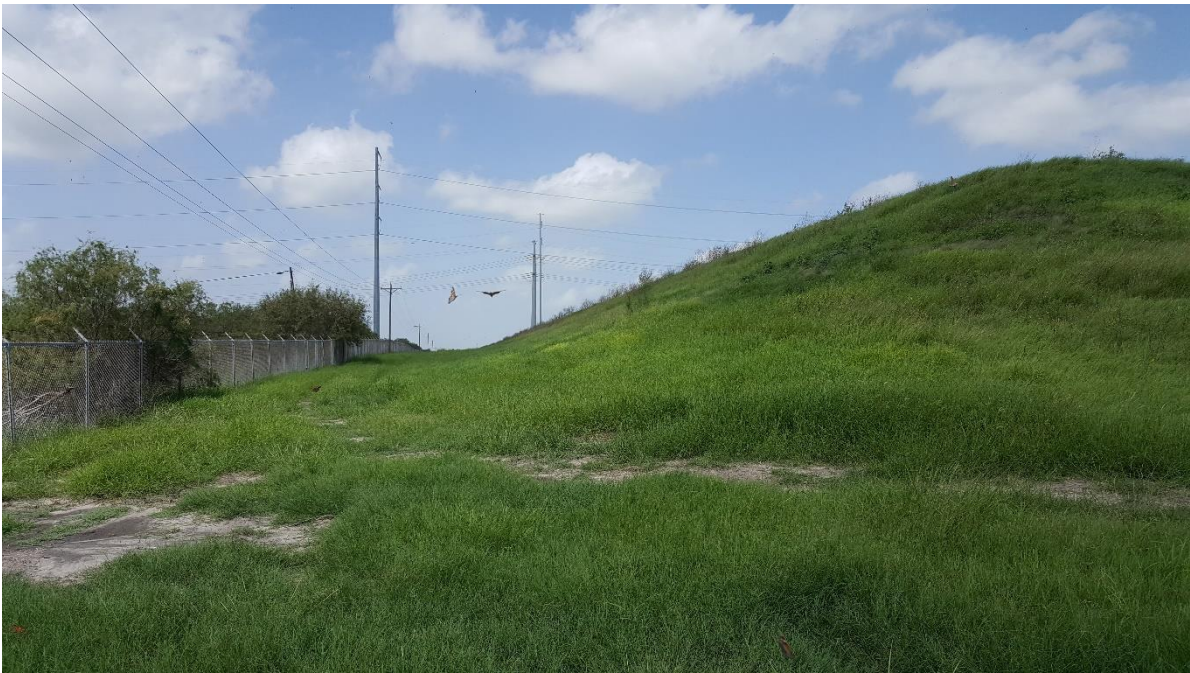
Photo 10 – View looking west at south downstream slope and southeast corner of pond.

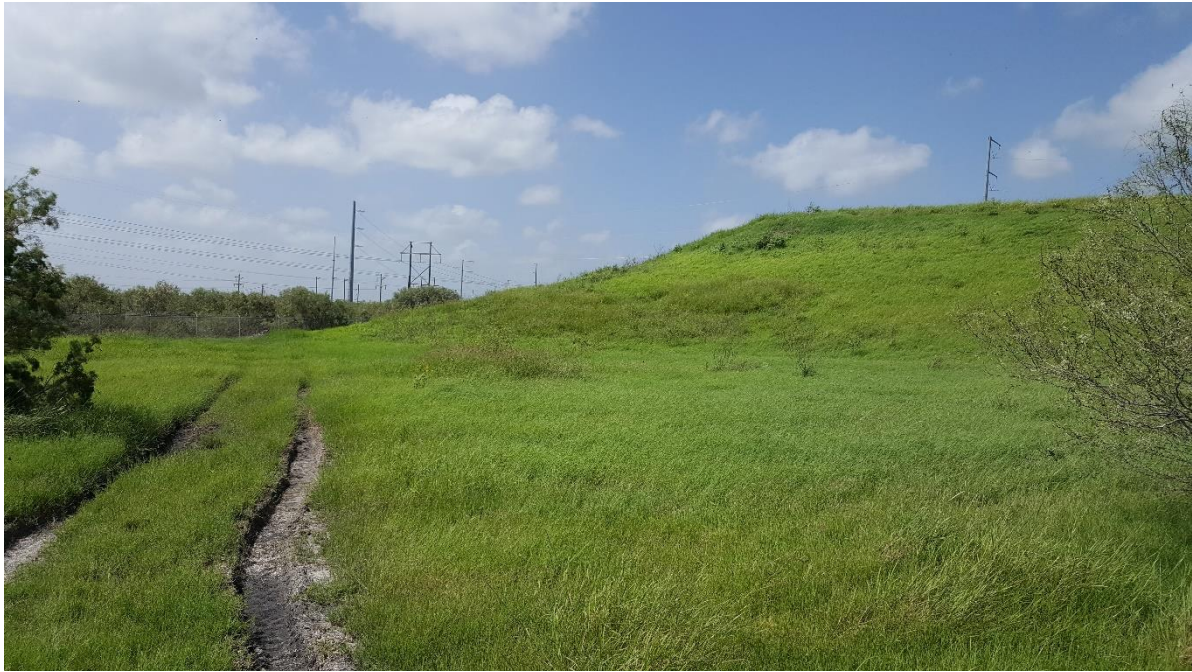
Photo 11 – View looking southwest at east downstream slope and southeast corner of pond.

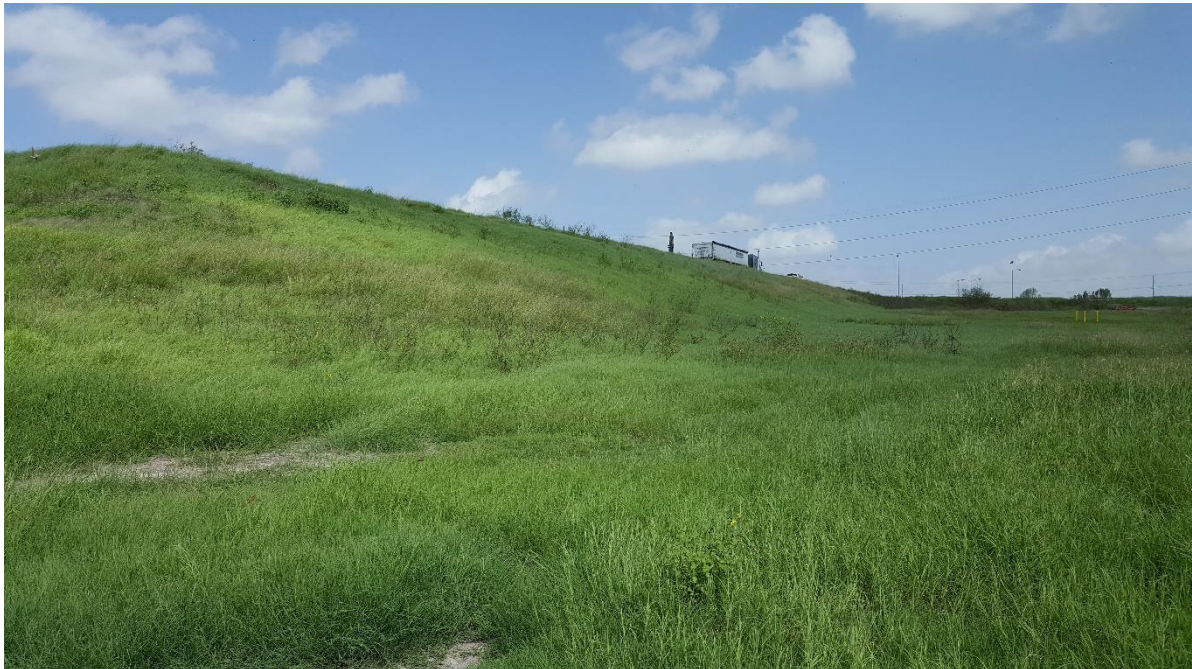
Photo 12 – View looking northwest at east downstream slope and southeast corner of pond.

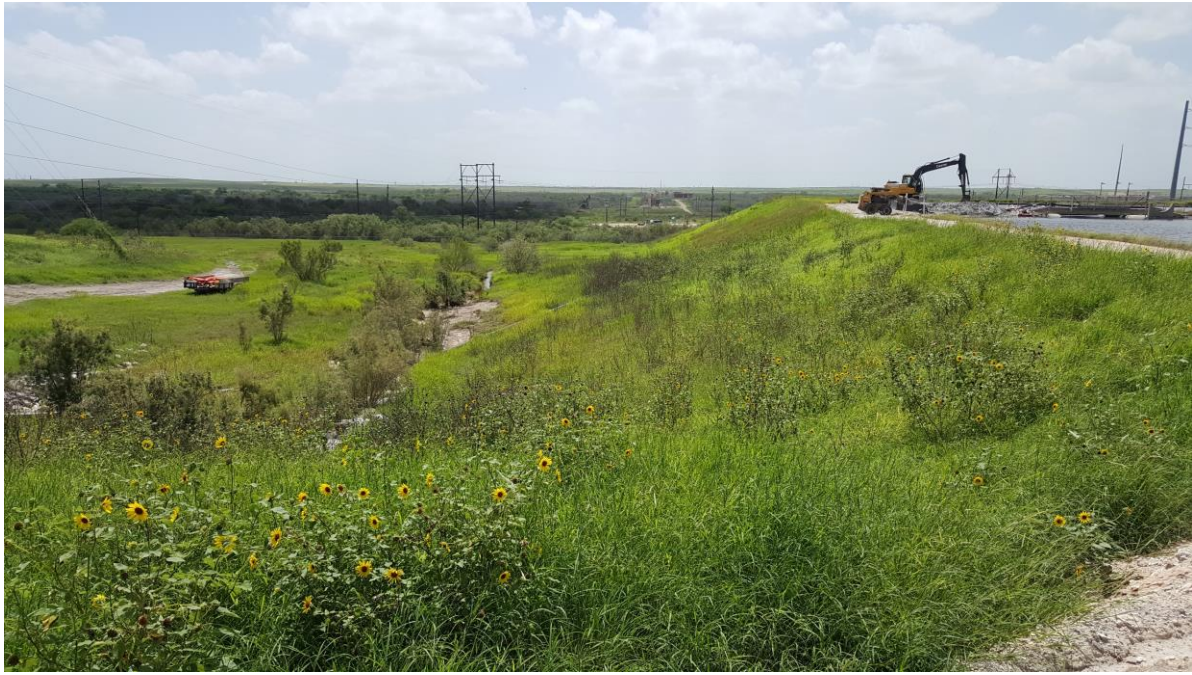
Photo 13 – View looking south along east downstream slope and drainage swale at toe of slope.

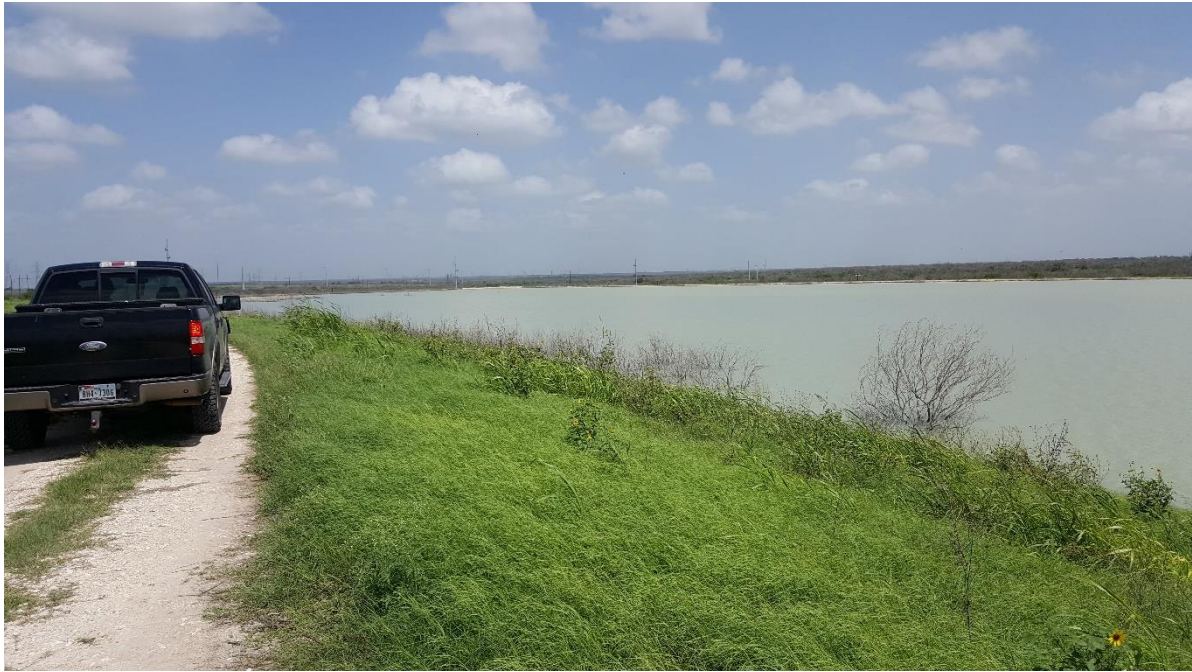
Photo 14 – View looking northeast at Equalization Pond from west side in central portion of bushes in upstream slope within pond.

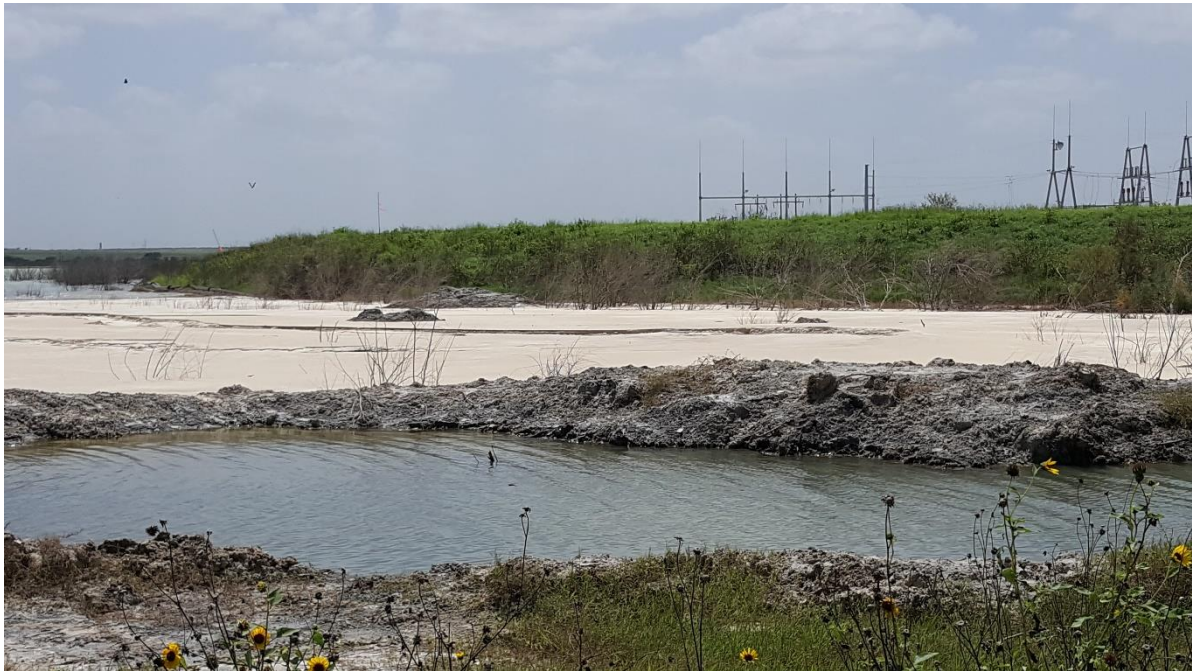
Photo 15 – View looking south from northeast corner of pond at bushes in pond and on upstream west slope.

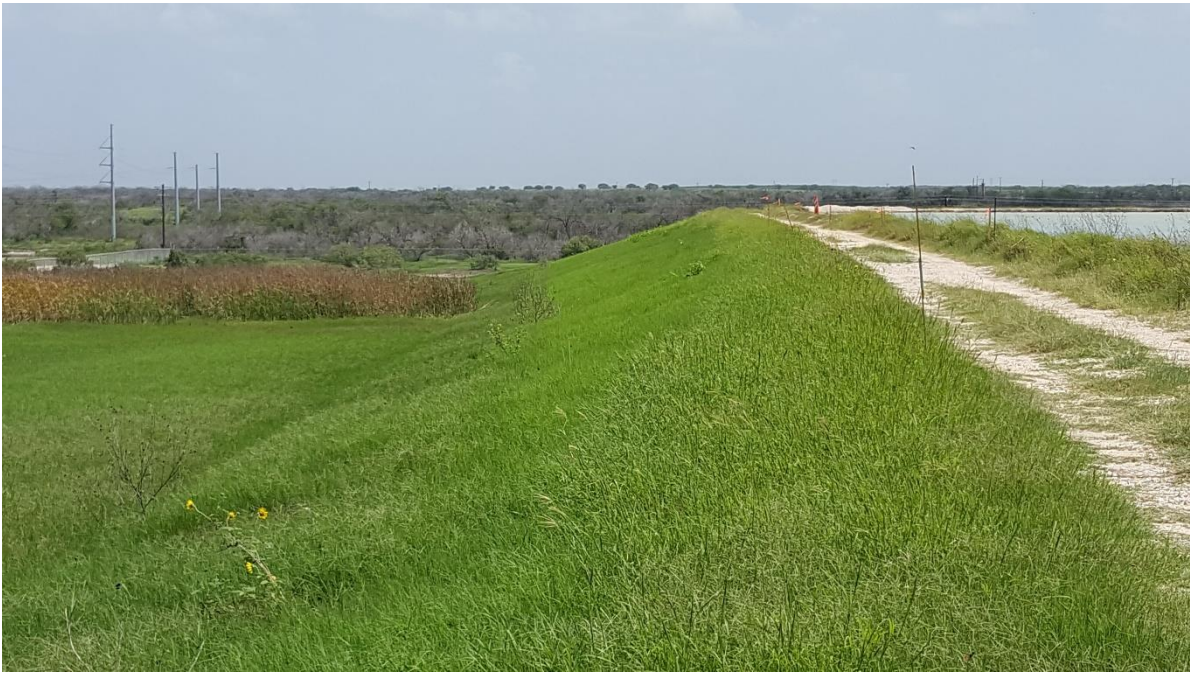
Photo 16 – View looking east from near northwest corner of pond at north embankment.

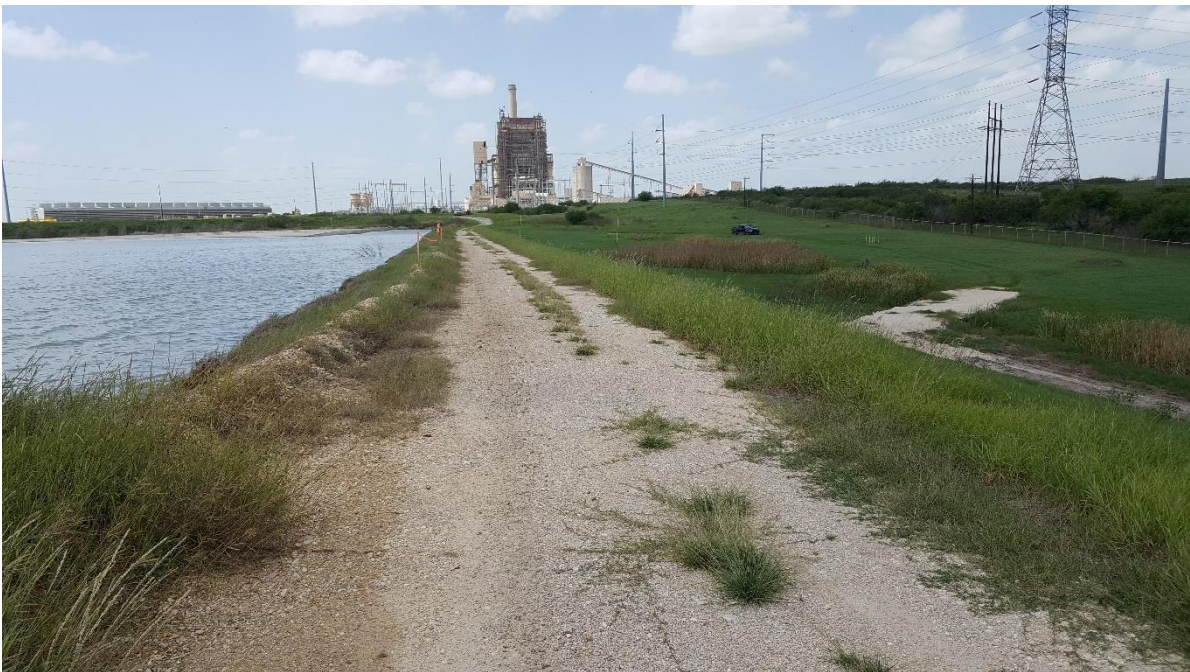
Photo 17 – View looking west from near northeast corner of pond at temporary dike along upstream crest.

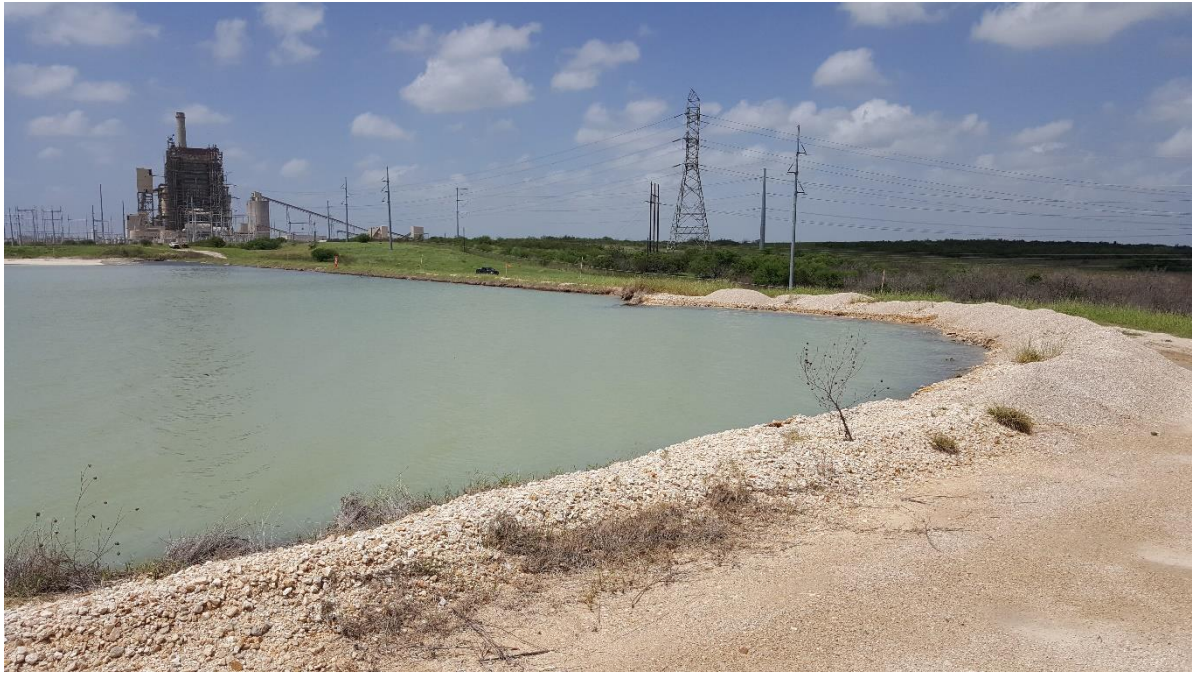
Photo 18 – View looking northeast at temporary dike along upstream crest in northeast corner of pond.

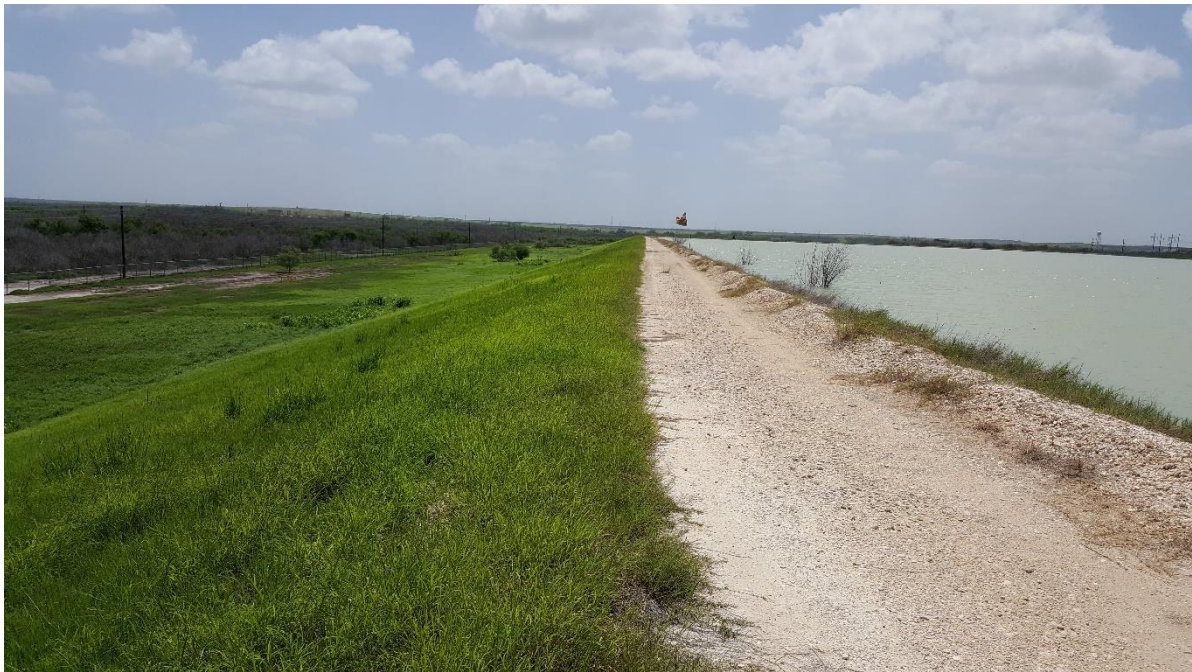
Photo 19 – View looking south at east embankment and temporary dike along upstream crest of pond.

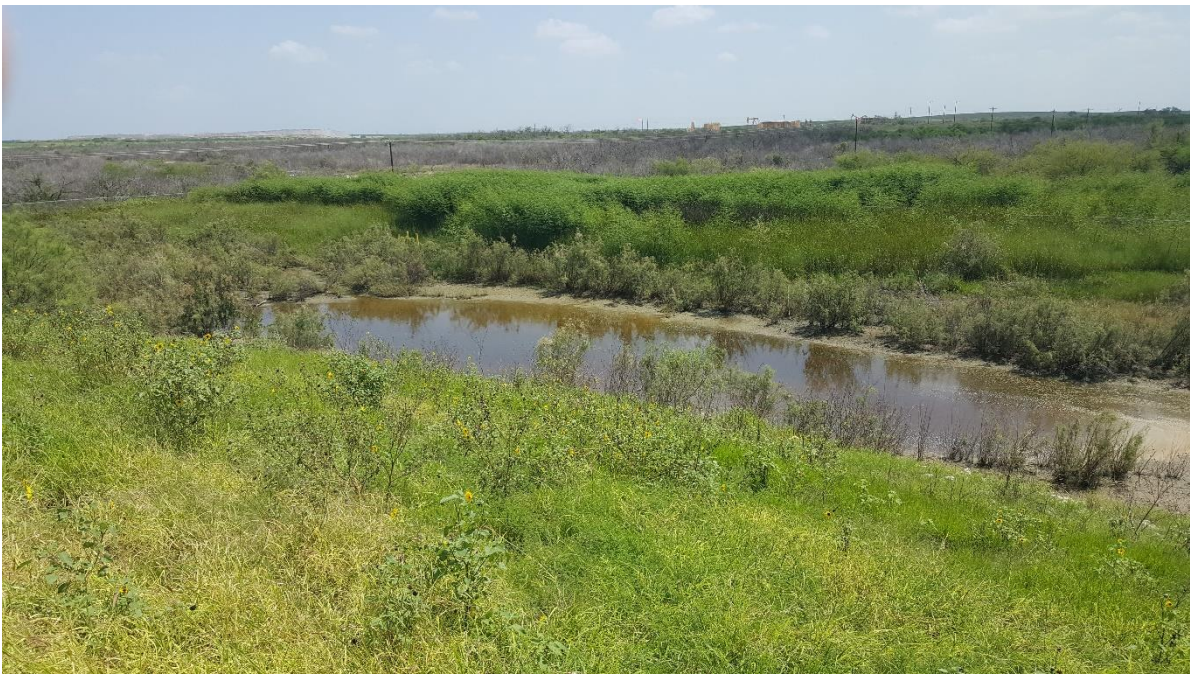
Photo 20 – View looking southeast from crest of south embankment at ponded water and bushes on downstream slope.

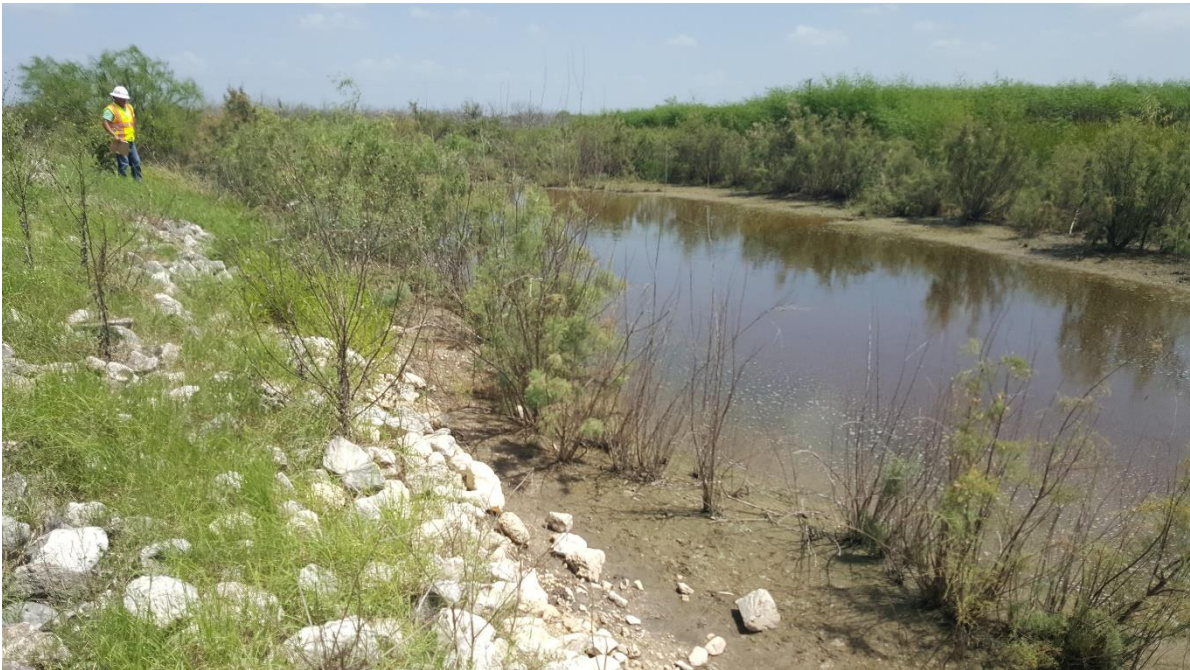
Photo 21 – View looking east at stone riprap and bushes on toe portion of south downstream slope and ponded water beyond slope toe.

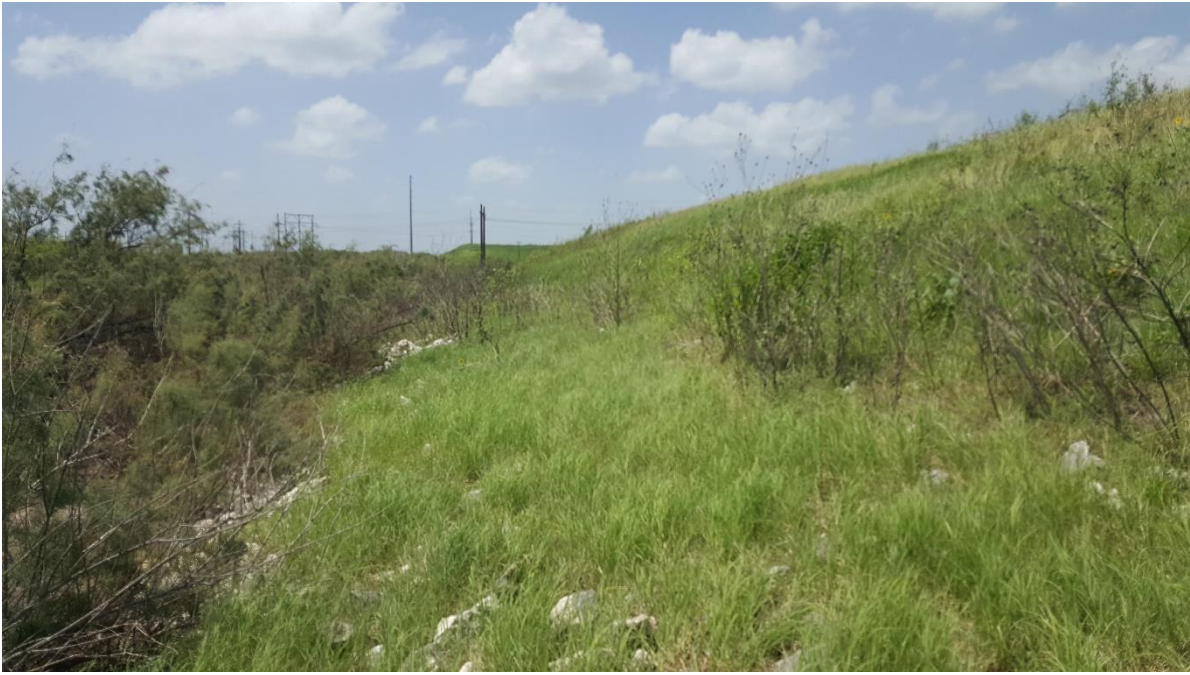
Photo 22 – View looking west at stone riprap and bushes on toe portion of south downstream slope.
