**ANNUAL INSPECTION REPORT FOR COAL COMBUSTION RESIDUALS (CCR) UNITS  
SAN MIGUEL ELECTRIC COOPERATIVE POWER PLANT**

**Wood Environment & Infrastructure Solutions, Inc.**

**January 10, 2019**

**Wood Project No.: 6706160039**

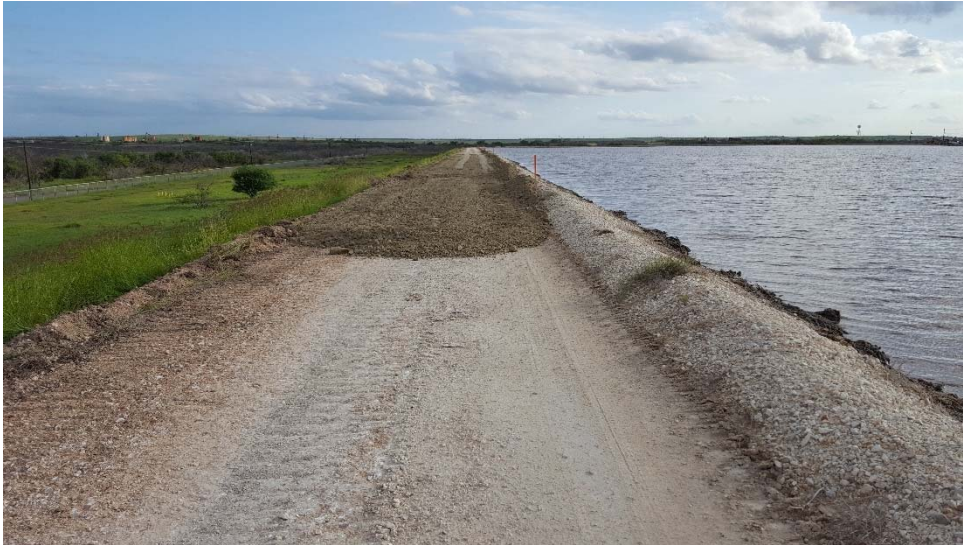
**PHOTO 1:**

This is the first lift of clay soils being added to the eastern crest of the Equalization Pond to bring it to a 296 foot elevation. The view of the crest is to the south along the crest. The crest was leveled and wet rutted materials were removed and replaced with clay soils.

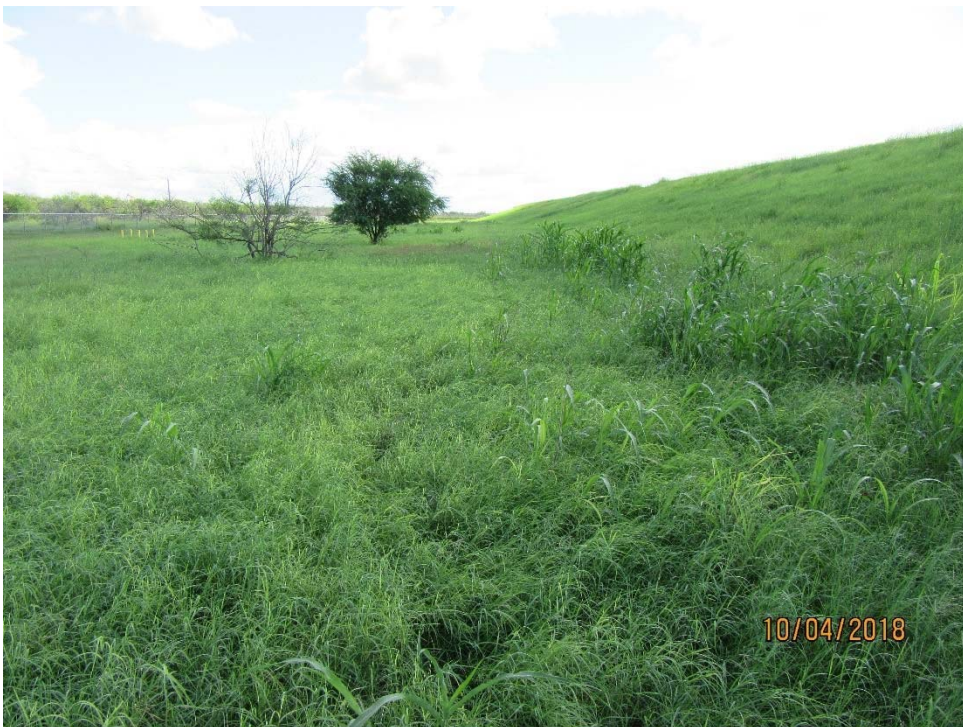
**PHOTO 4:**

This photograph is looking to the south along the eastern flank of the Equalization Pond and shows the vegetative cover following recent precipitation events. No trees or brush were observed along the slope.

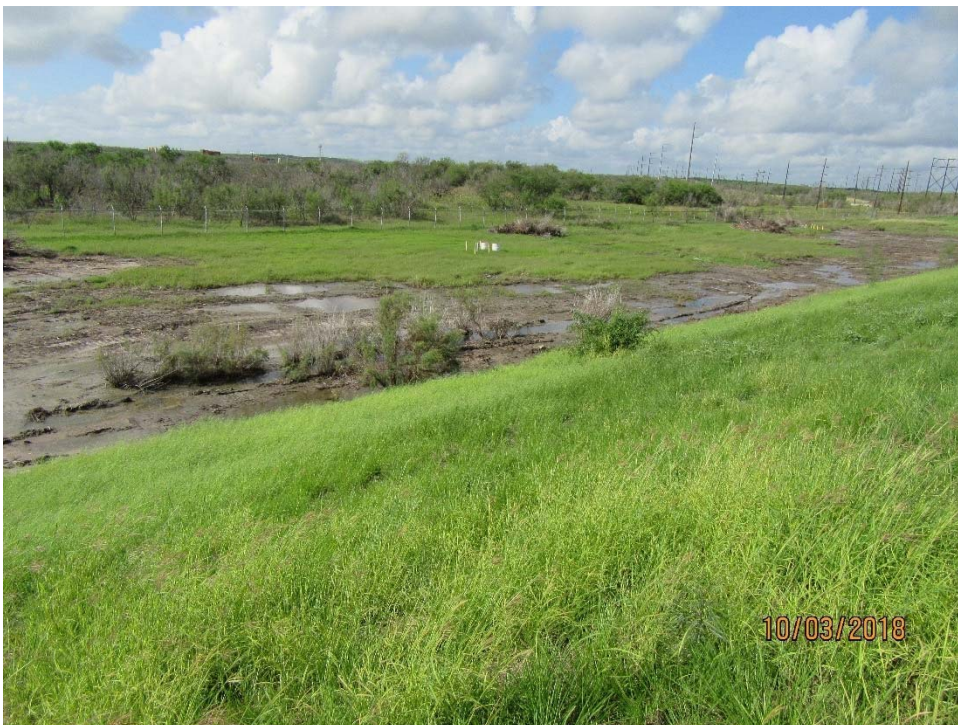
**PHOTO 8:**

Two small bushes remain on the southern slope of the Equalization Pond embankment, all other brush has been removed. The area in the background is the streambed after recent rainfall events. Small amounts of ponded rain water were observed in shallow depressions.

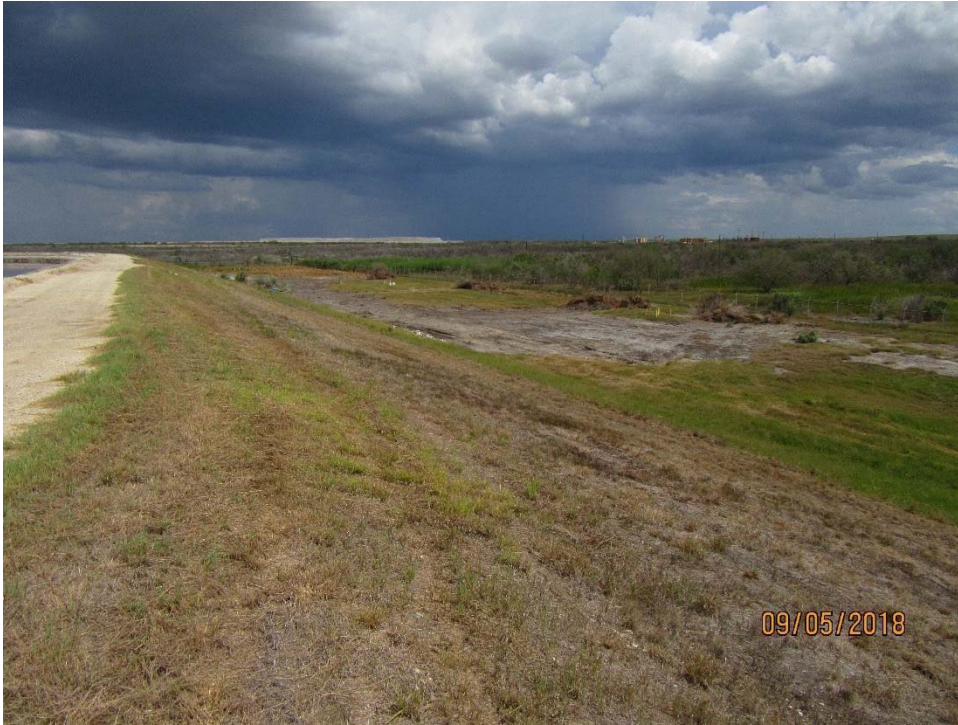
**PHOTO 9:**

This photograph is looking to the southeast from the crest of the berm near the southwestern corner of the Equalization pond berm. This shows the streambed along the toe of the berm to be nearly dry after a period of no rainfall and the vegetation to be brown. No water was observed at the toe of the berm.

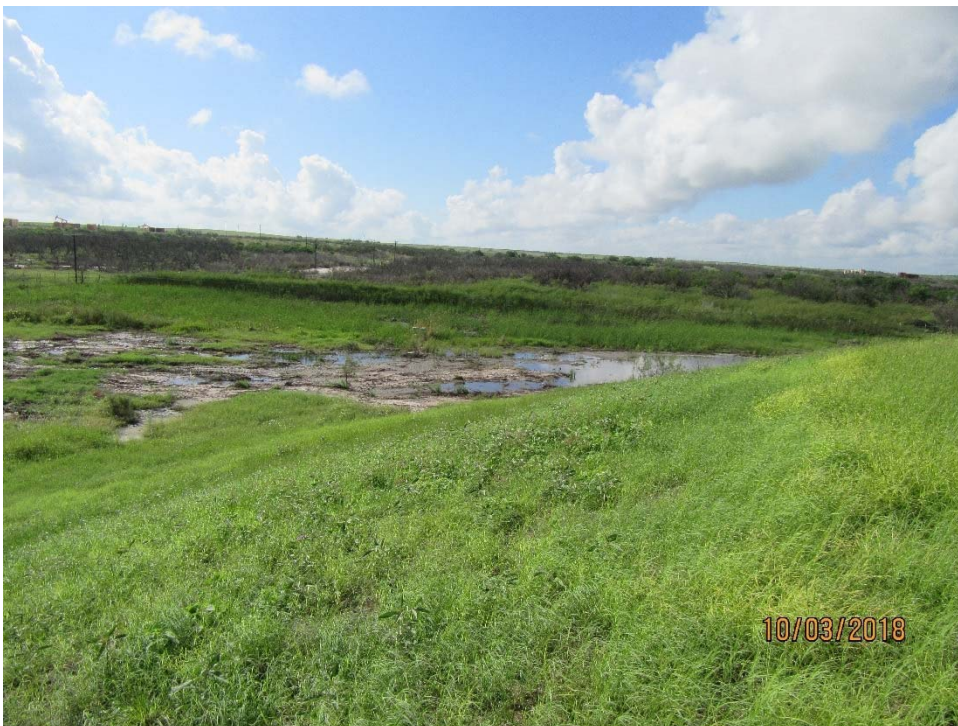
**PHOTO 10:**

This photograph shows ponded water near the toe of the berm after a heavy rainfall event. No seeps were observed along the toe of the berm during a walking inspection of the toe of the berm.

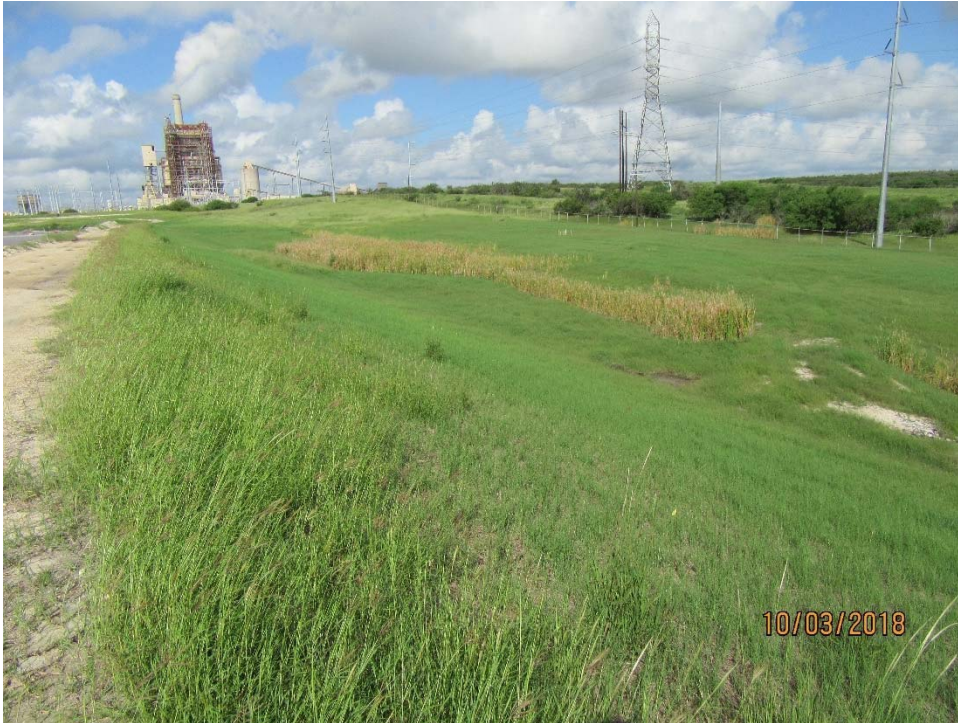
**PHOTO 11:**

Looking to the west along the northern slope of the Equalization Pond embankment. A crossing with a culvert is visible near the right side of the photograph. Water tends to pond upstream of the culvert which is partially responsible for the cattail growth. Slope softening was not observed.

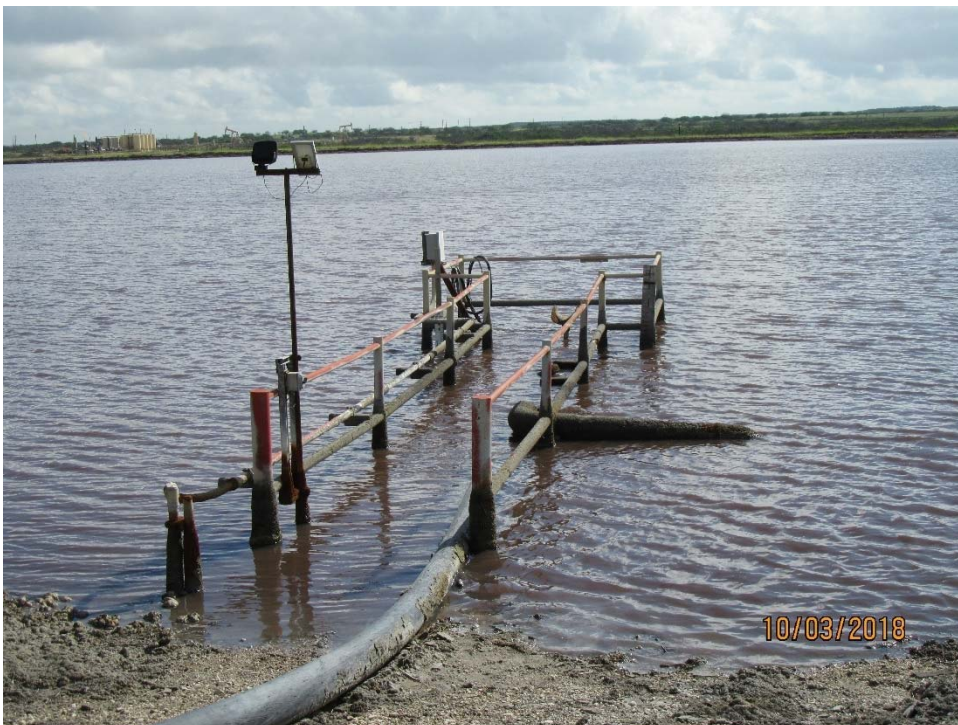
**PHOTO 12:**

The Equalization Pond gauge is readily visible on the north side of the pier near the end of the pier.

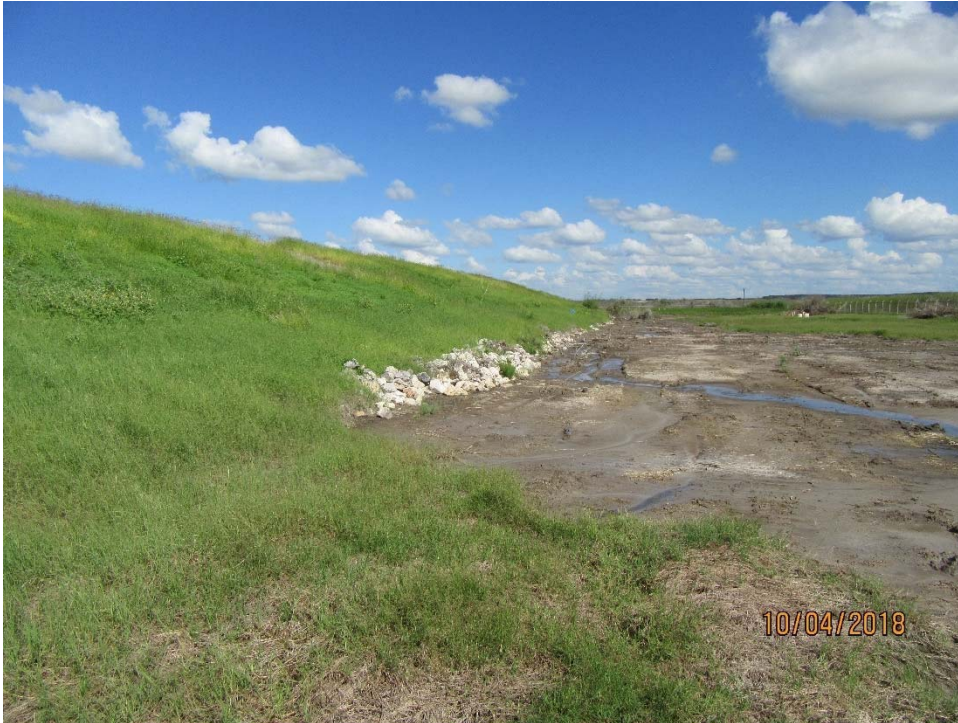
**PHOTO 13:**

Rip rap was realigned during the removal of brush near the toe of the Equalization Pond embankment. Rip rap was observed to be grass covered for several feet up the embankment. This picture was taken after a rainfall event which is the source of the pooled water.

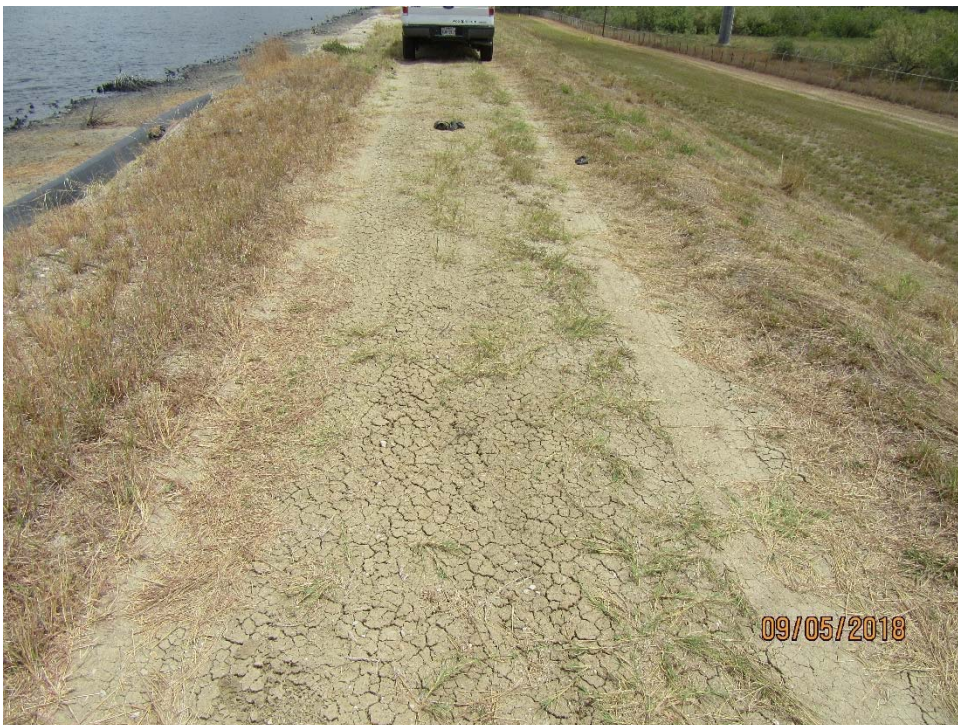
**PHOTO 14:**

This is a view to the east along the southern crest of the Ash Pond B embankment. This was a relatively dry period and negligible rutting was observed on the crest of the berm. Rutting on the southeastern and northwestern corners of the Ash Ponds had been addressed by applying clay soils to the effected areas.

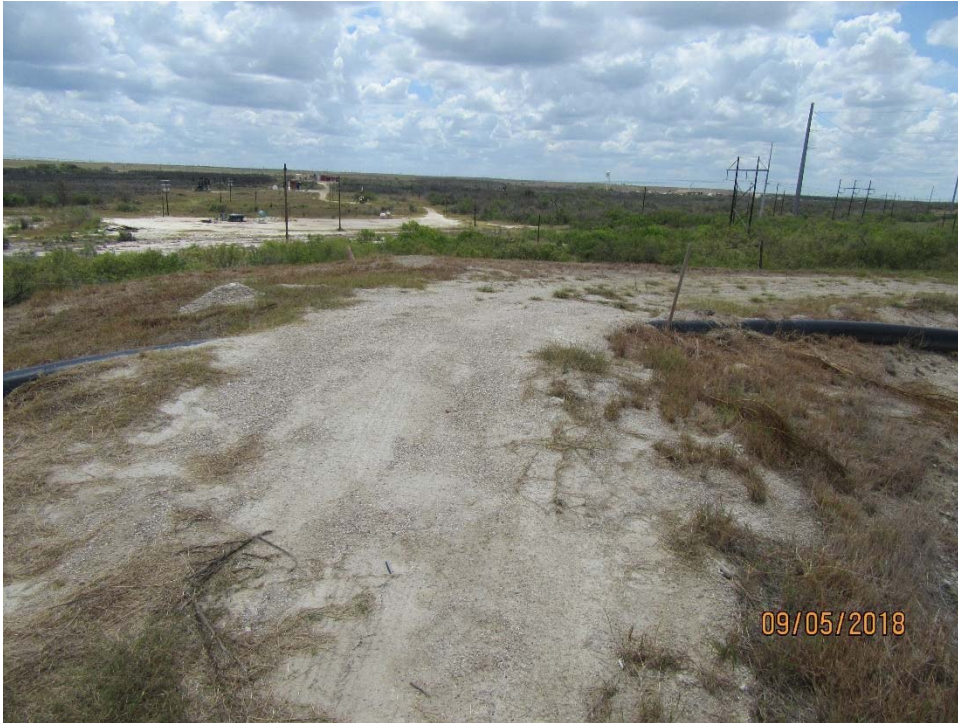
**PHOTO 15:**

The southeastern corner of Ash Pond B looking to the south. This area was not rutted and has clay soils placed in this area.

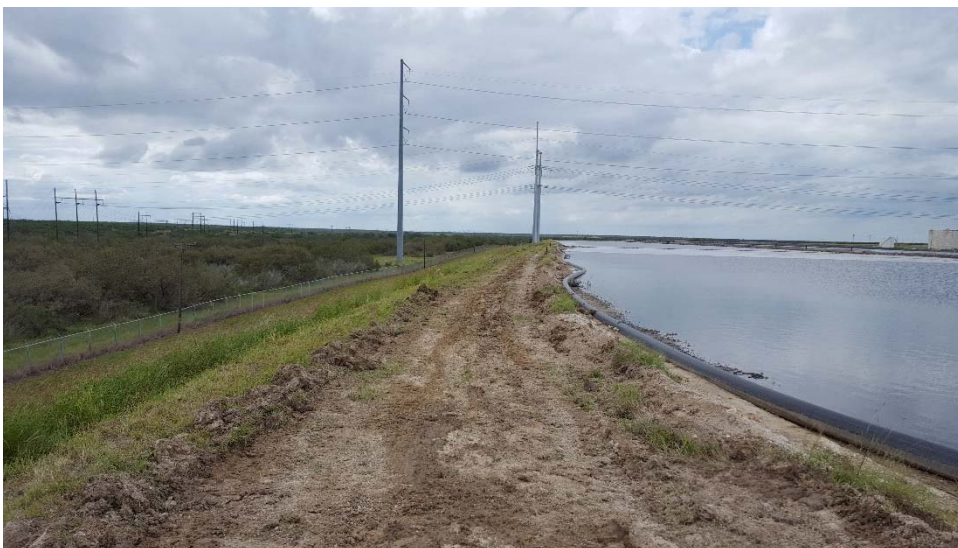
**PHOTO 16:**

Looking to the west along the crest of the Ash Pond B. A temporary berm had been placed along the crest and will be incorporated into the ongoing crest repairs. Only minor erosion of the interior embankment was observed and the clay liner was not exposed.

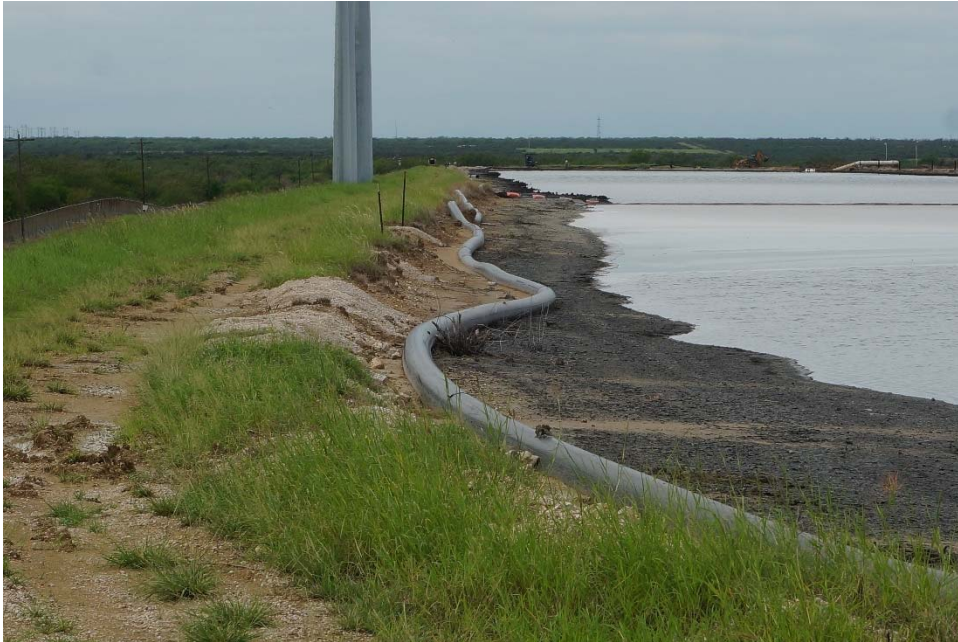
**PHOTO 17:**

This view is to the west along the crest of Ash Pond B embankment. All brush and vegetation was removed from the embankment. The shoreline showed only minor erosion.

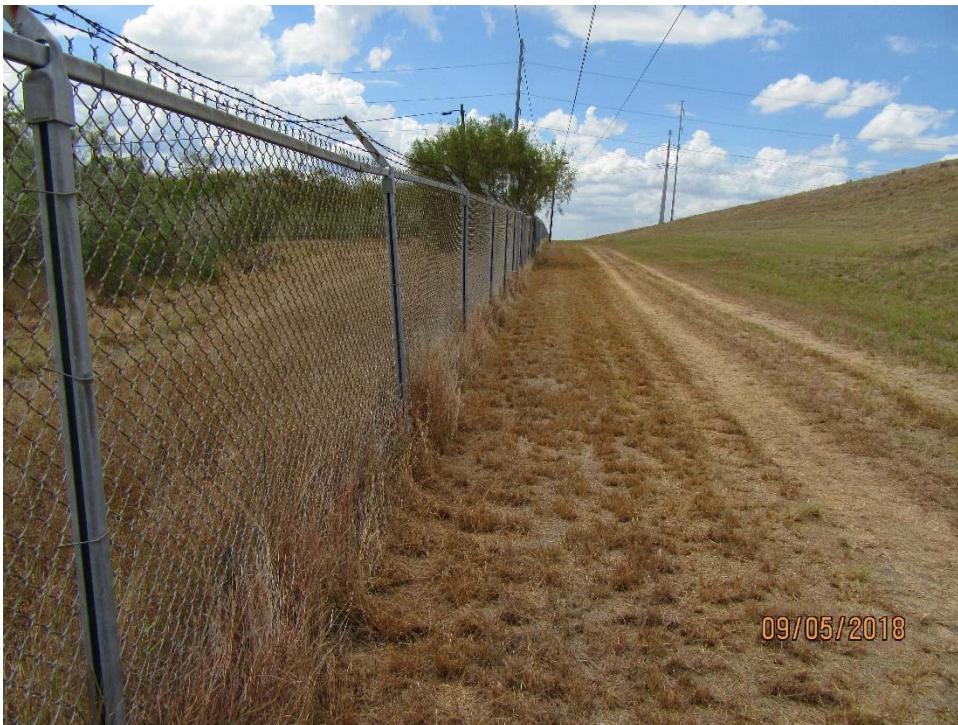
**PHOTO 18:**

Looking to the west along the toe of the Ash Pond's southern side. All brush has been removed from the slope. No seeps or erosion were observed in this area and the berm is well vegetated.

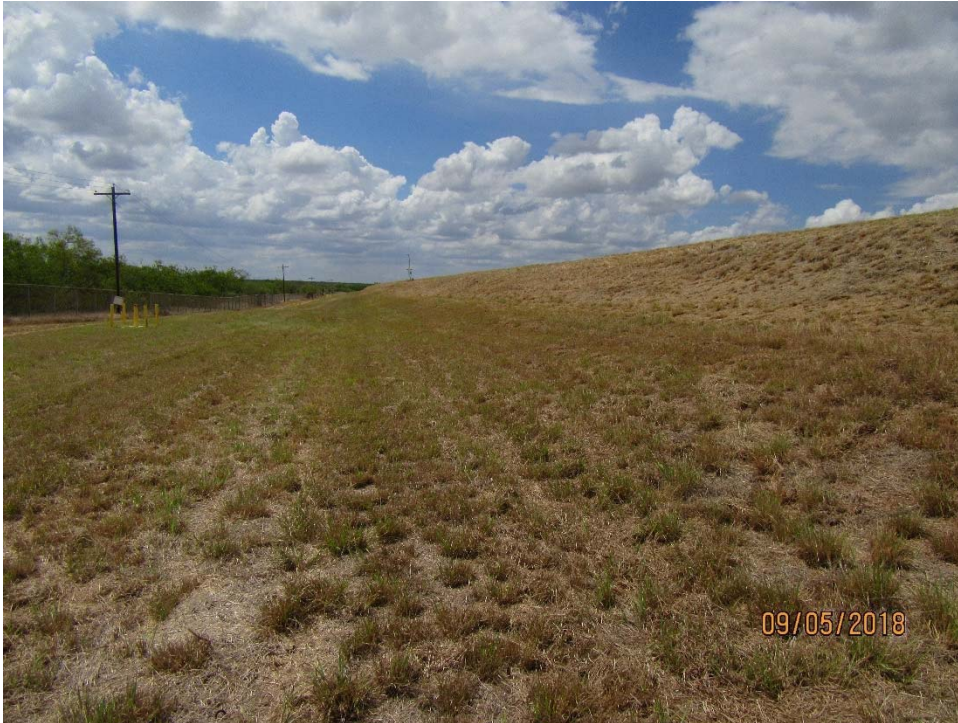
**PHOTO 19:**

Looking to the west from near the midpoint of the southern side of the Ash Ponds. No seeps were observed in this area. Only minor erosional rills were observed along the southern edge of the embankment in this area. These erosional rills are scheduled to be addressed as part of the ongoing crest repairs.

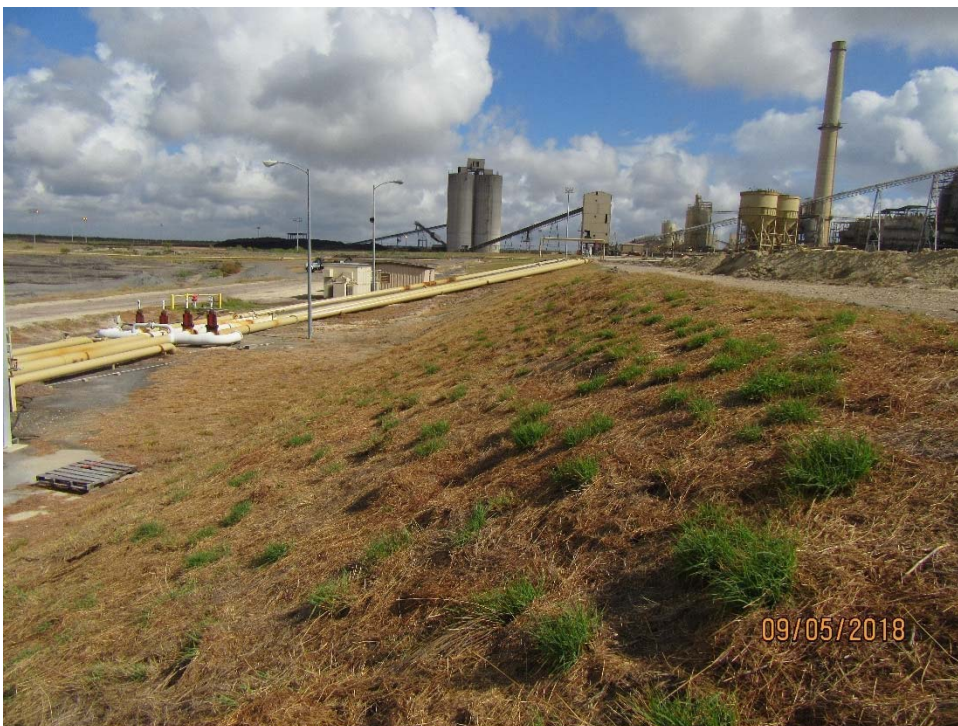
**PHOTO 20:**

This view is to the north along the western slope of the Ash Ponds embankment. This was a dry period and vegetation was sparse.

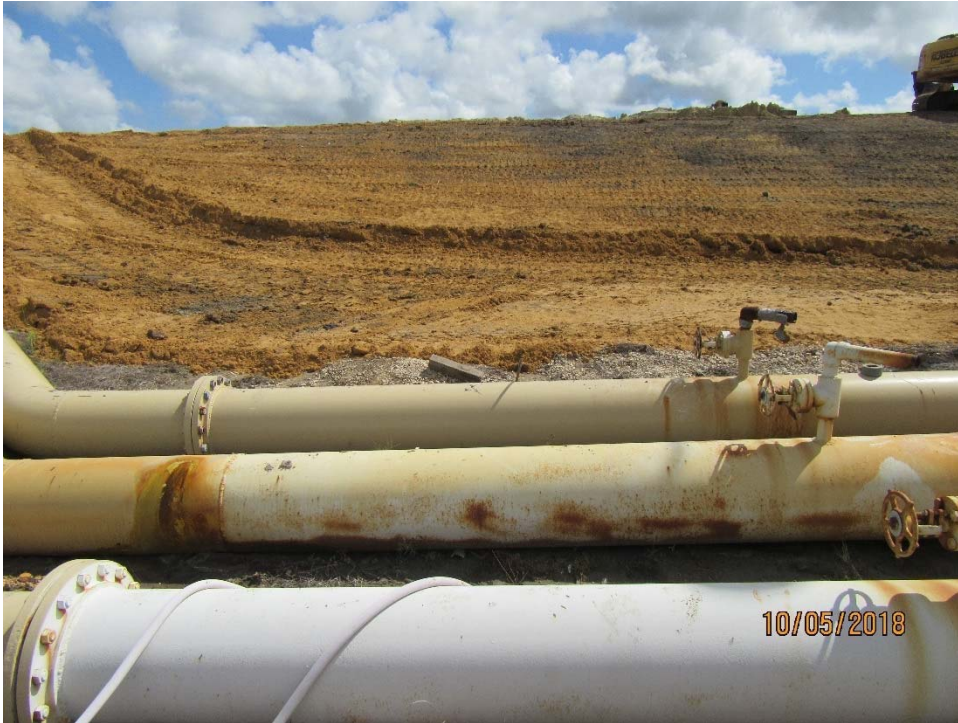
**PHOTO 21:**

This photograph is looking to the east and shows the western slope of the Ash Ponds embankment during ongoing repairs. The slope was leveled and a key was installed in the foreground beyond the piping in preparation for the installation of the toe drain. Rain events have postponed this work.

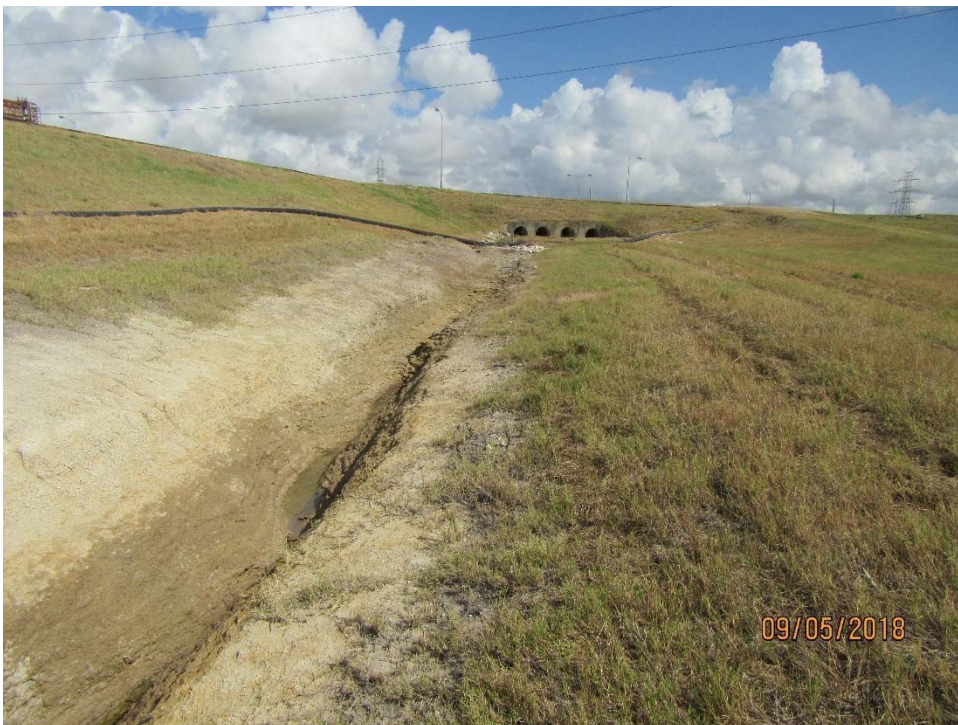
**PHOTO 22:**

This photograph is looking to the north along the drainageway east of the Ash Ponds. The drainageway was recently cleaned out and channelized to enhance drainage.

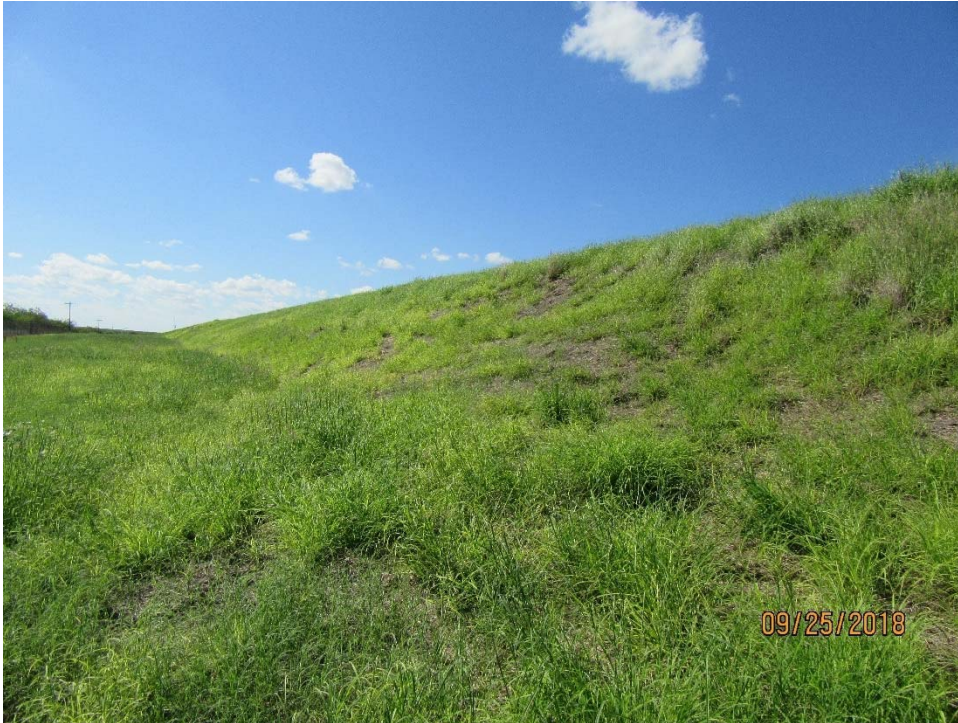
**PHOTO 23:**

Looking to the west at the southern side of the Ash Ponds southern embankment. This is the area of small erosion rills near the crest of the embankment. This area will be addressed as part of the ongoing crest repairs. The photograph was taken after recent rain events.

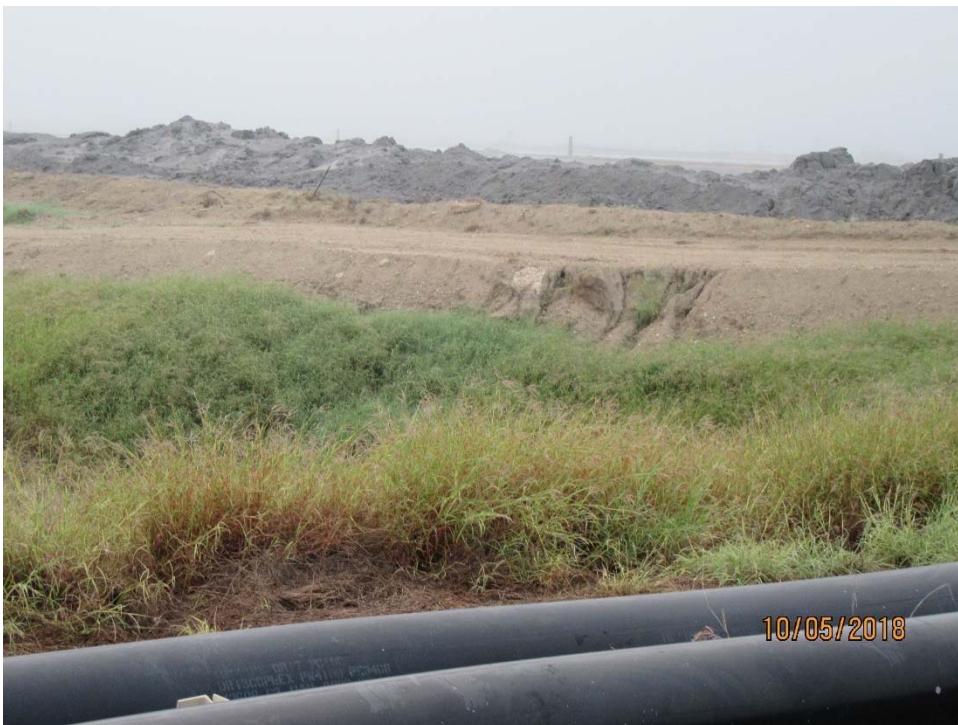
**PHOTO 24:**

This photograph is looking to the south at the northwestern corner of Ash Pond A. The erosional gully in the foreground is on a temporary road constructed specifically for ash removal activities. The road will be removed upon completion of the ash removal.

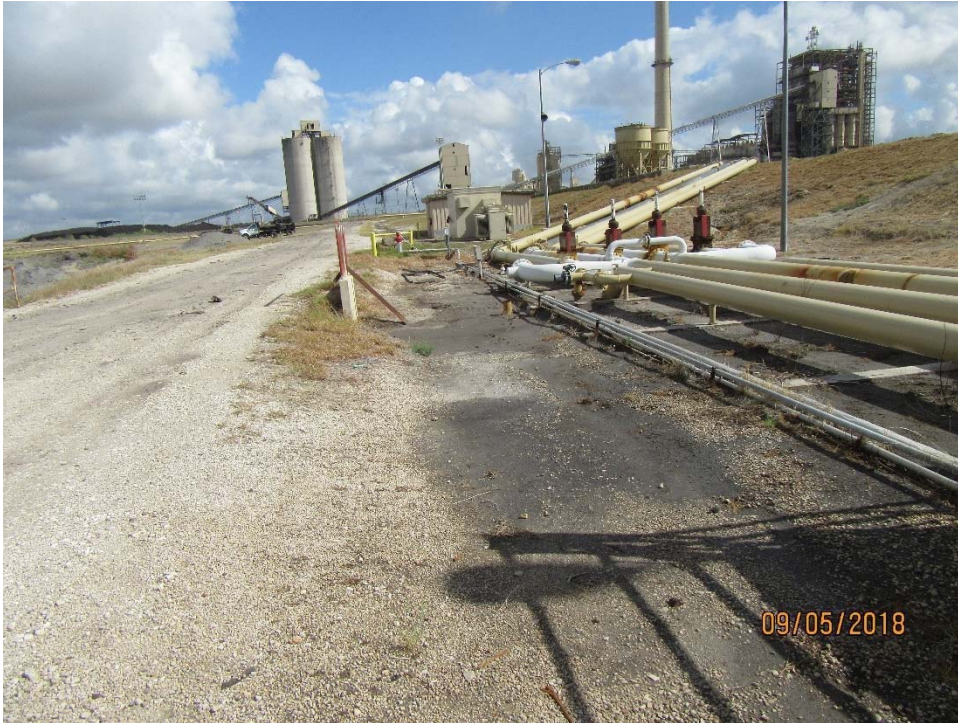
**PHOTO 25:**

This photograph is looking to the north along the western side of the Ash Pond area. Some ponding of storm water was observed along the access road to the pump area and along the piping leading to the pump area. No ponding was observed at the toe of the berm.

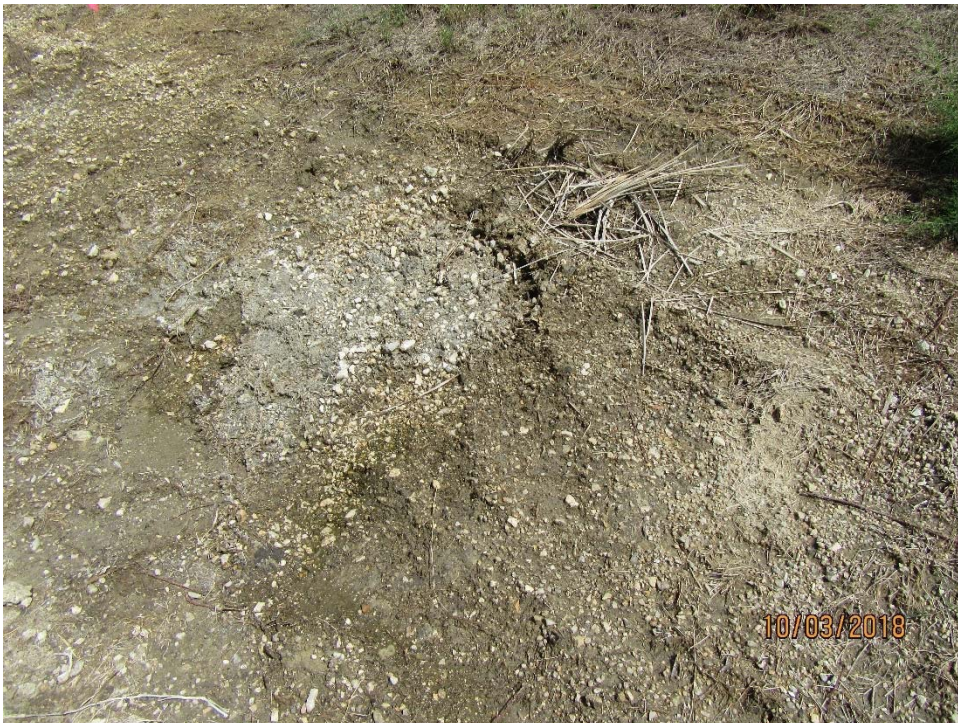
**PHOTO 26:**

A small area of dead cattails was observed along the western slope of the Ash Ponds. This is the same area depicted in earlier reports (Arias). There was no seepage at the time the photograph was taken. There was some small gravel present on the surface of the ground along the slope.

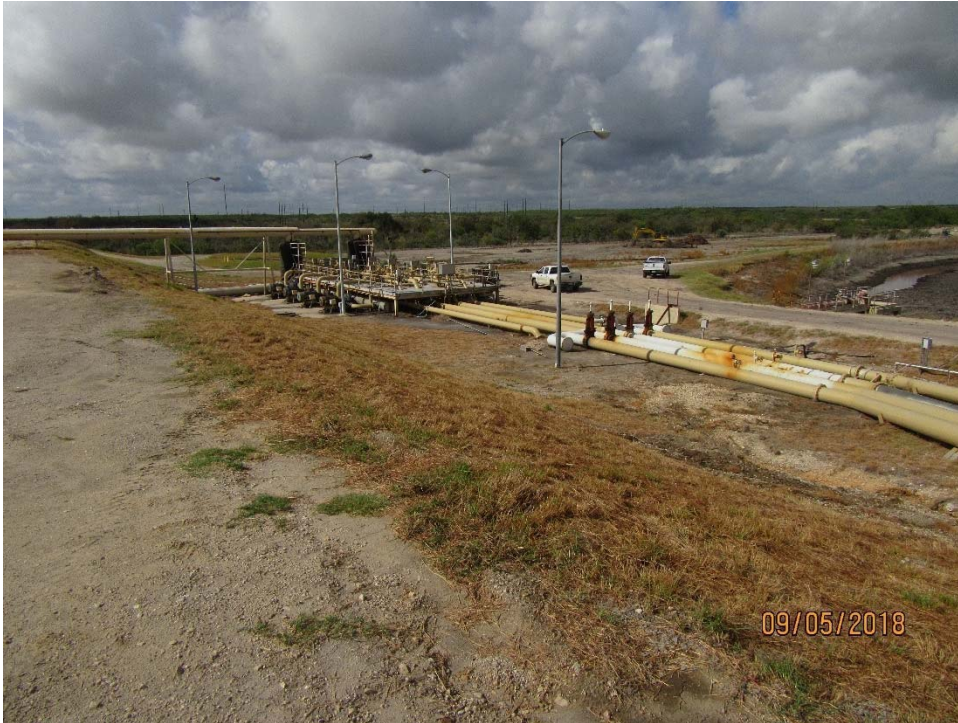
**PHOTO 29:**

The view is to the southwest toward the pump area, on the west side of the Ash Pond. This photograph was taken during a dry period. Erosional areas at this location are being corrected as part of the slope repair work.

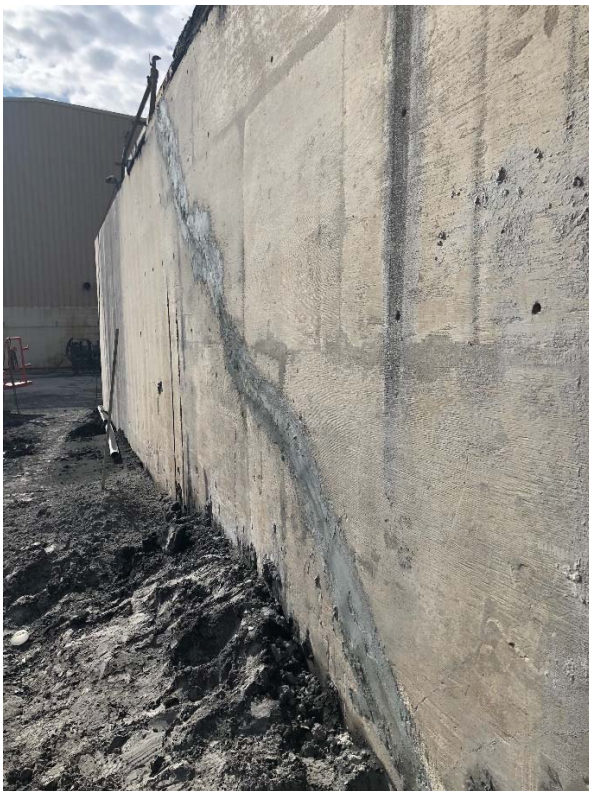
**PHOTO 30:**

This view is of the repaired crack in the concrete retaining wall at the Ash Pile area. The diagonal crack in the concrete was repaired during the outage week of October 22-26, 2018. Drainage is to the north and west on the northern and western sides of the concrete wall.

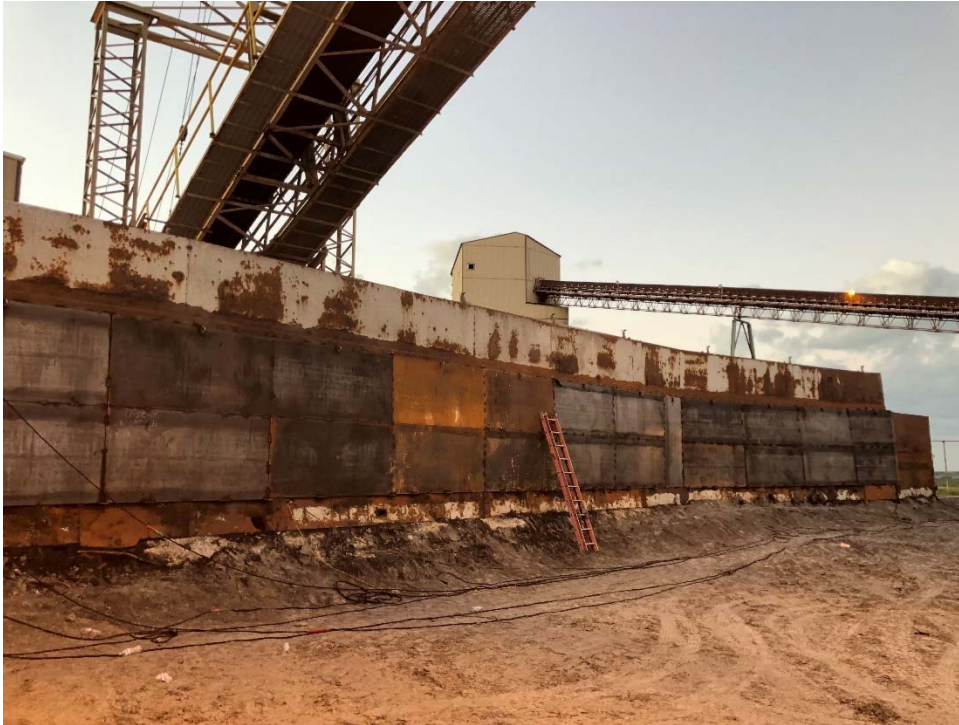
**PHOTO 31:**

This view of the southern side of the metal retaining wall at the Ash Pile shows the addition of steel plate onto the existing wall. The steel plate was welded onto the existing I-beams to cover any leakage from the interior steel wall. The wall was repaired during the plant outage of October 22-26, 2018.

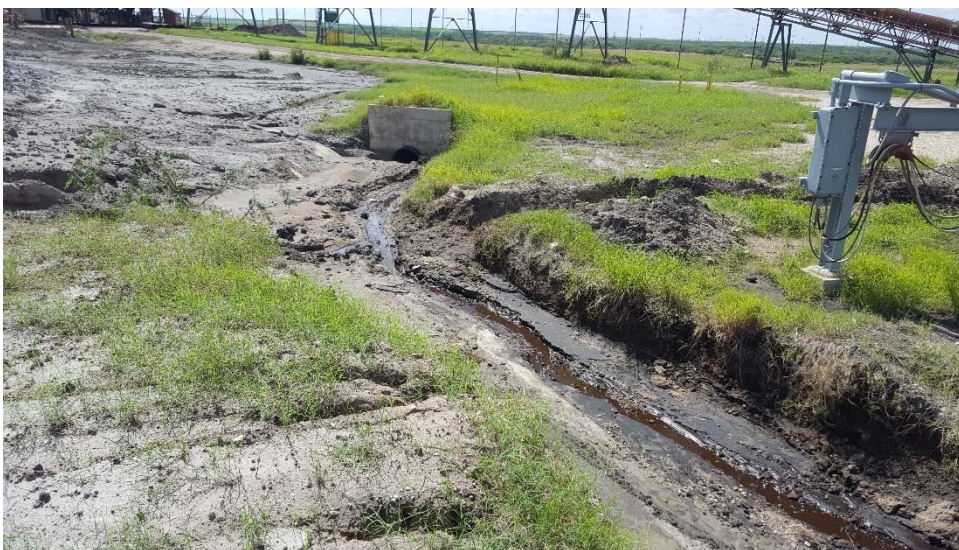
**PHOTO 32:**

Drainage along the western edge of the Ash Pile area. Minor erosion was observed along the edges of the drainageway.

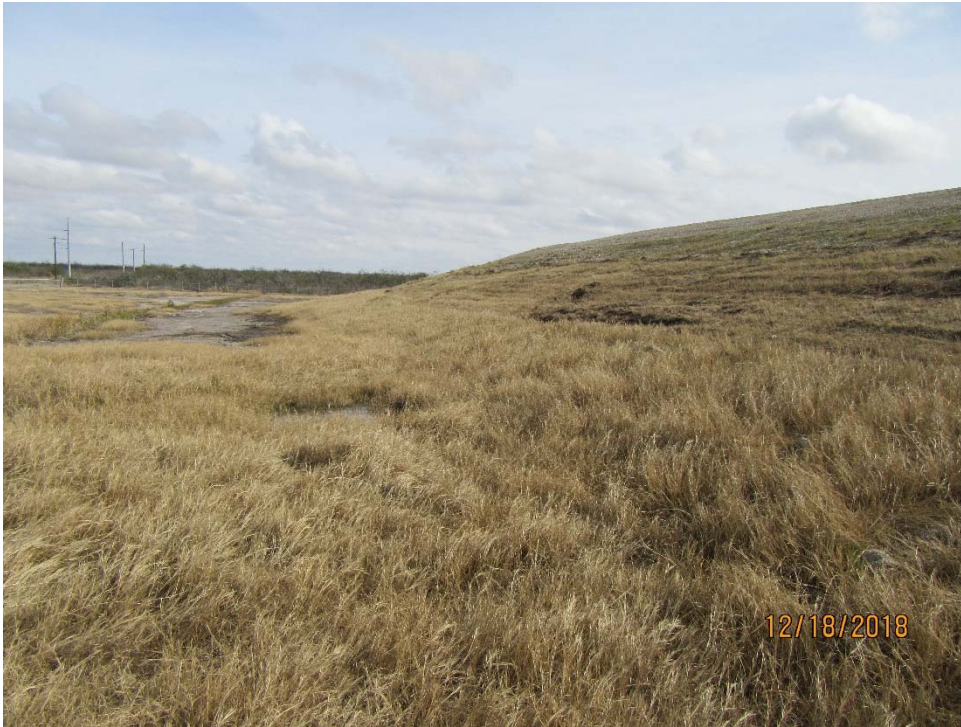
**PHOTO 1:**

Looking to the east along the northern slope of the Equalization Pond. The Equalization Pond slopes were recently mowed for the Annual Inspection. Recent December rainfall made the slopes soft in isolated areas. The December 18-19, Annual Inspection was conducted under partly cloudy conditions.

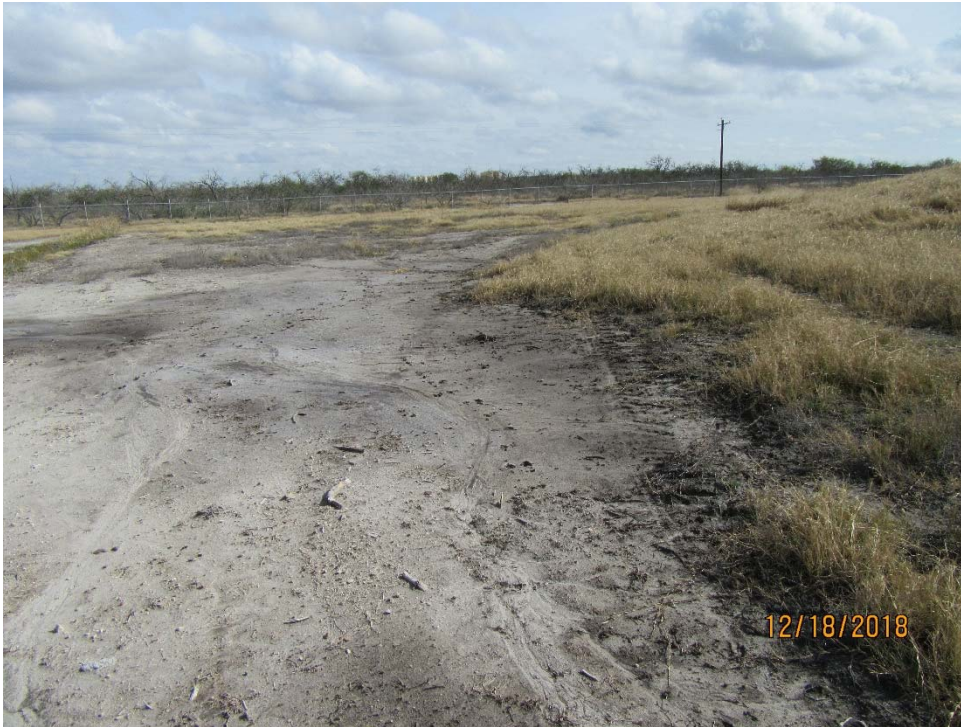
**PHOTO 3:**

The area at the northeastern corner of the Equalization Pond was slightly damp, likely from recent rainfall. This view is to the east from the northern side of the toe of the berm.

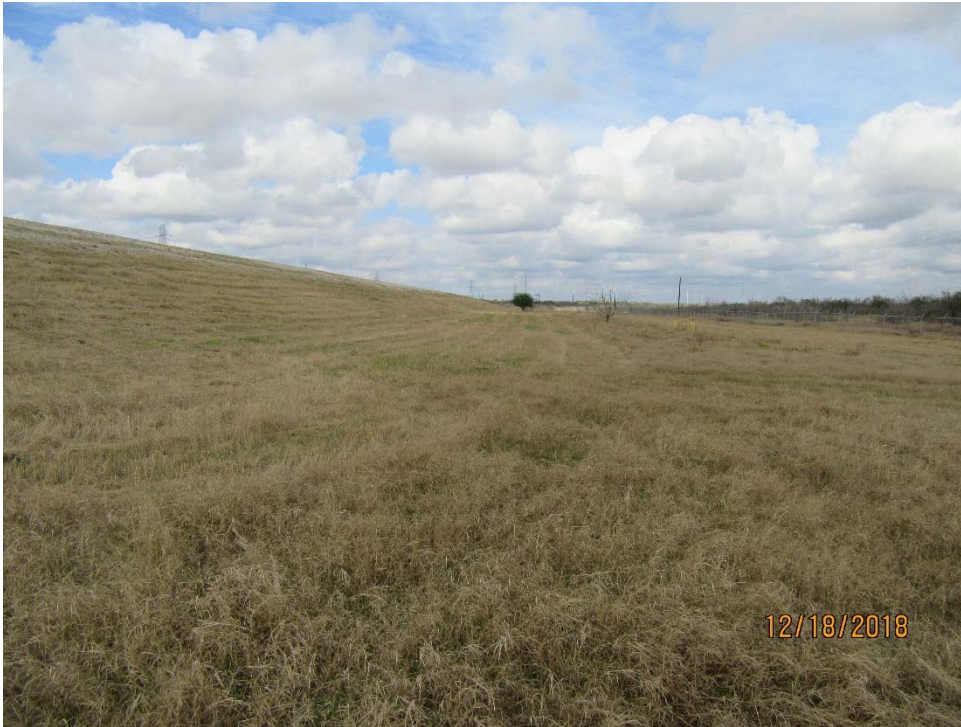
**PHOTO 5:**

Looking to the north along the toe of the Equalization Pond from near the southeastern corner of the Equalization Pond showing the general vegetative cover along the eastern berm.

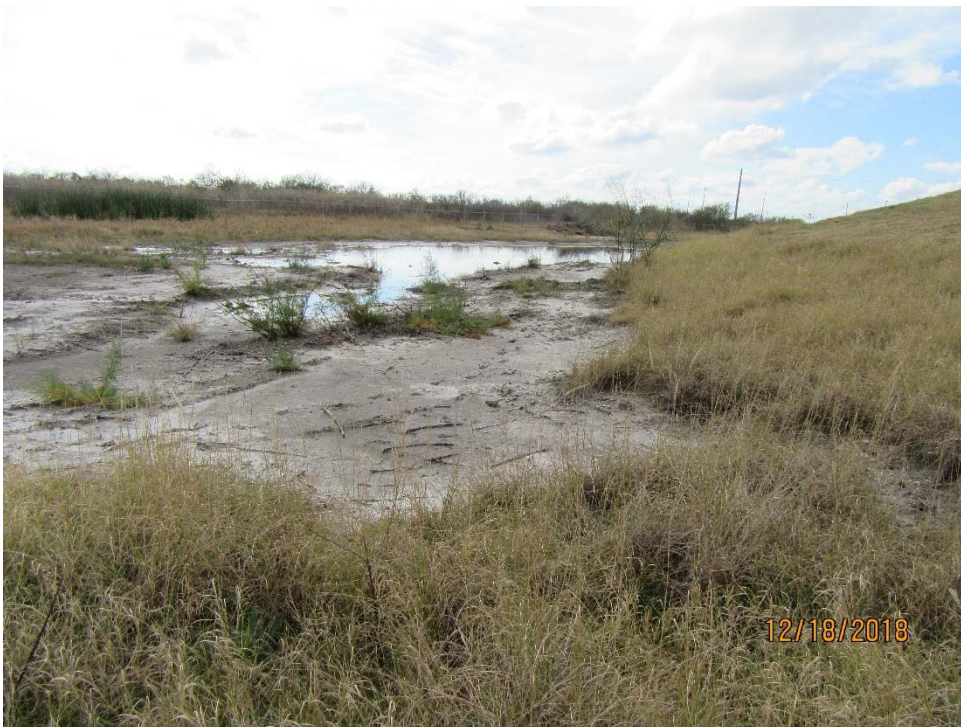
**PHOTO 6:**

Looking to the southwest at the southeastern corner of the Equalization Pond along the toe of the berm. Pounded runoff from recent rainfall was observed. No visible seeps were observed from the toe of the berm.

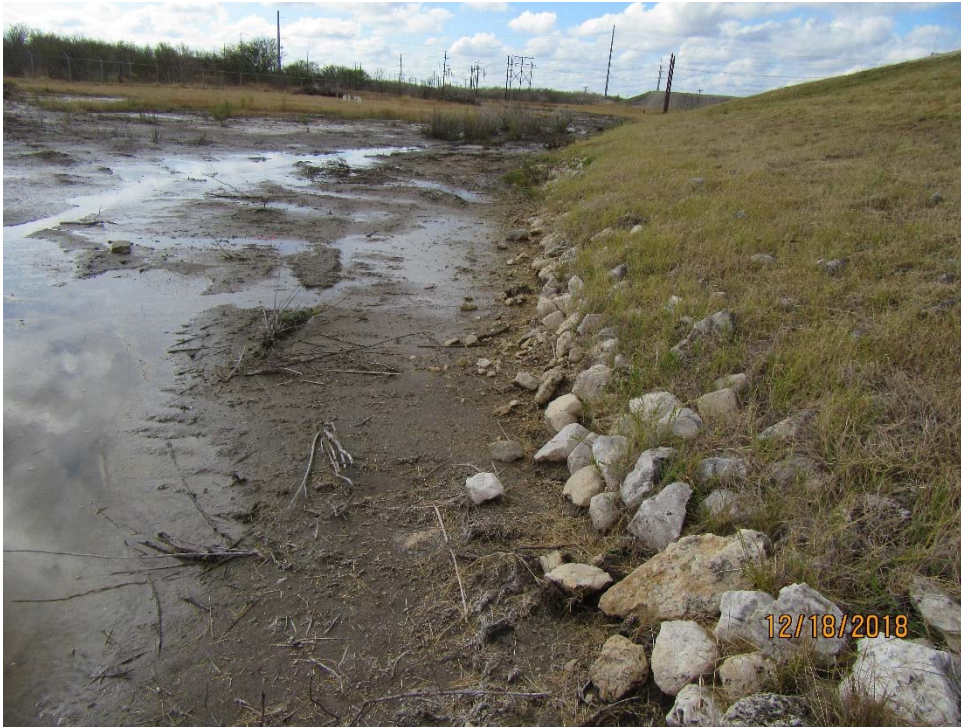
**PHOTO 7:**

Rip rap located along the toe of the Equalization Pond berm. The drainageway channel was located adjacent to the toe of the berm. Most woody vegetative grown was removed during the summer of 2018 within the channel, but some of the plants within the drainageway have begun to regrow. No woody plant growth was observed along the slope of the berm at the time of the site visit.

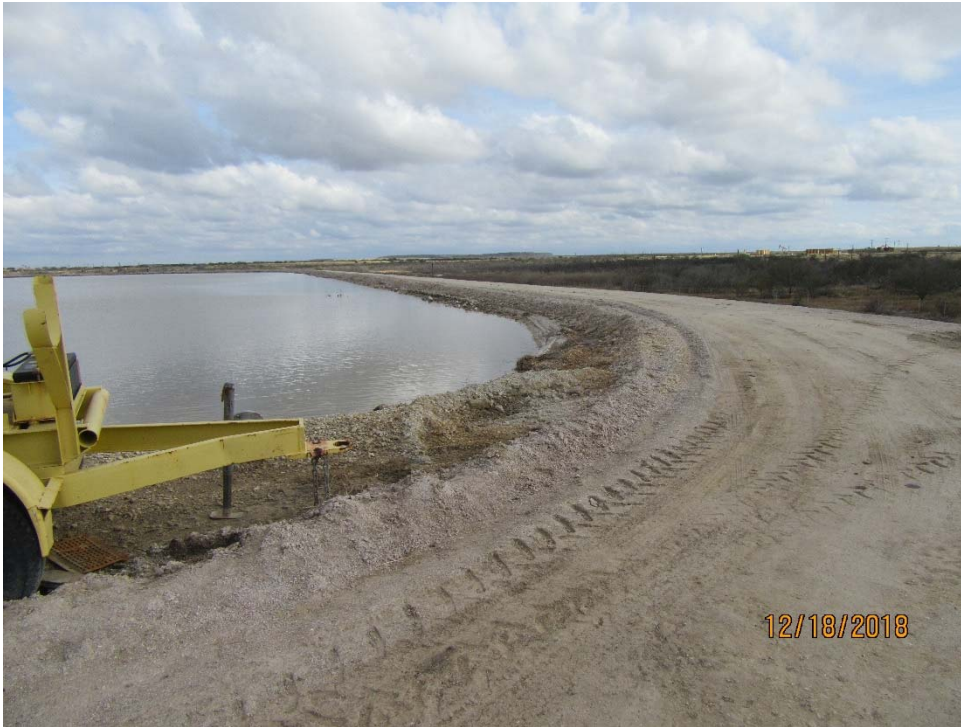
**PHOTO 9:**

The southern portion of the crest of the Equalization pond berm looking to the east-southeast. The crest was surveyed in the Fall of 2018 to ensure an elevation of 295 feet above mean sea level (amsl). Any areas below 295 feet amsl were augmented with compacted clay soils to the required elevation.
