**ANNUAL INSPECTION REPORT FOR COAL COMBUSTION RESIDUALS (CCR) UNITS  
SAN MIGUEL ELECTRIC COOPERATIVE POWER PLANT**

**Wood Environment & Infrastructure Solutions, Inc.**

**January 10, 2019**

**Wood Project No.: 6706160039**

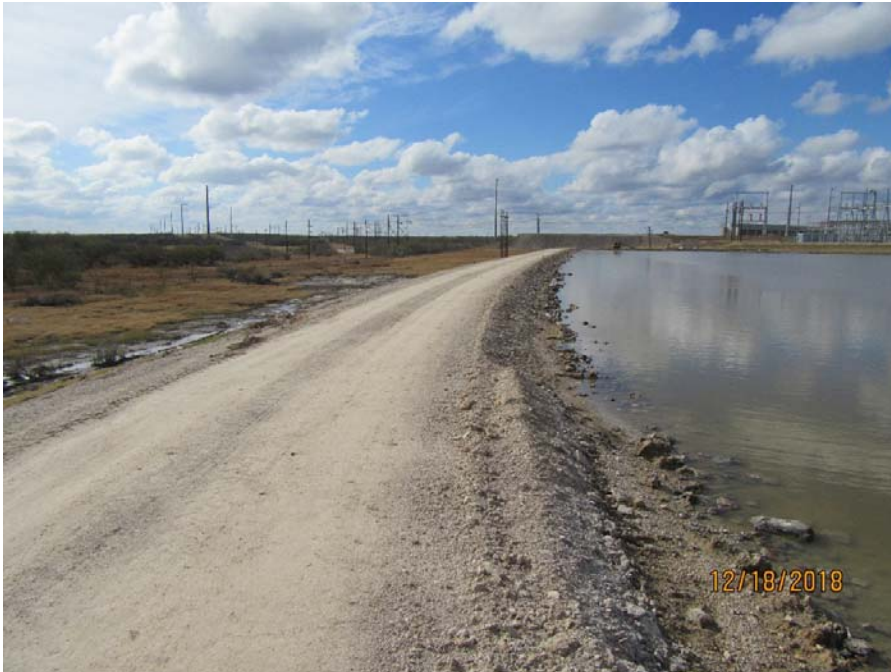
**PHOTO 11:**

Looking to the west along the crest of the berm of the Equalization Pond. The drainageway adjacent to the toe of the berm is visible within the left hand side of the photograph. No cracks or rutting was observed along the crest of the berm.

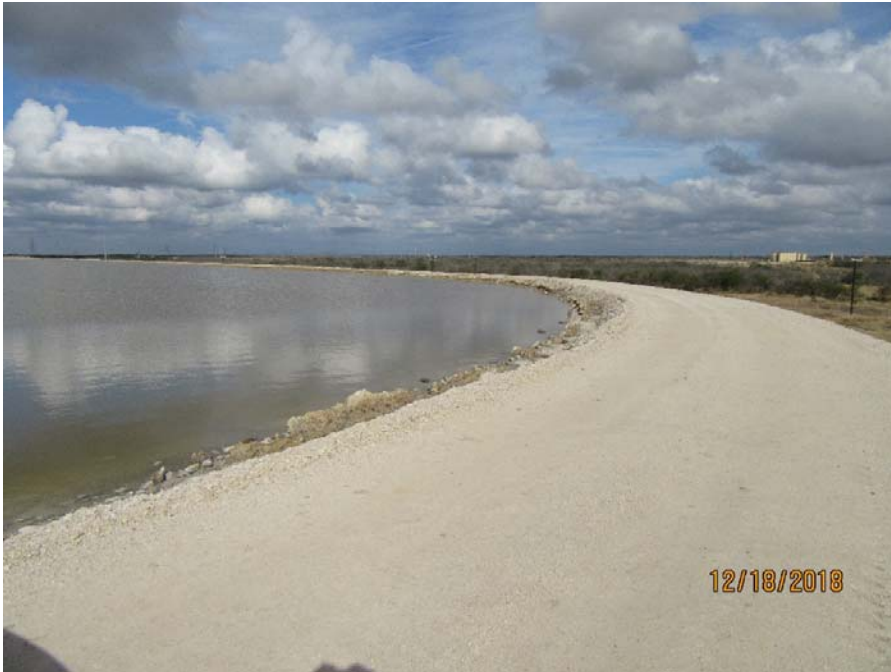
**PHOTO 13:**

View to the east-northeast along the roadway along the top of the berm. No cracking or rutting was observed along the crest. No vegetative growth was noted along the interior of the crest.

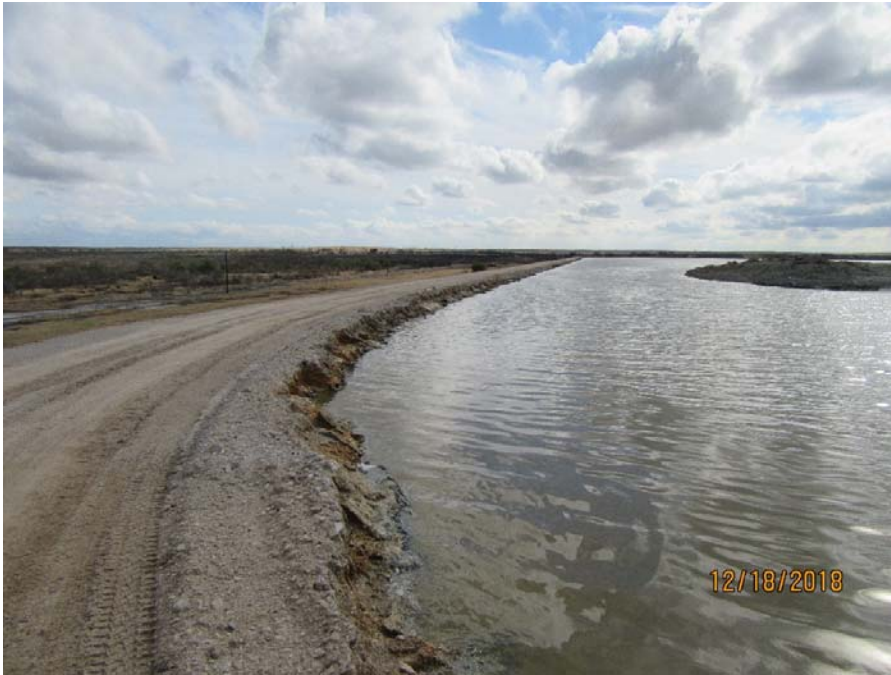
**PHOTO 15:**

Looking to the south along the crest of the berm on the eastern side of the Equalization Pond. No vegetative growth was noted along the interior of the berm.

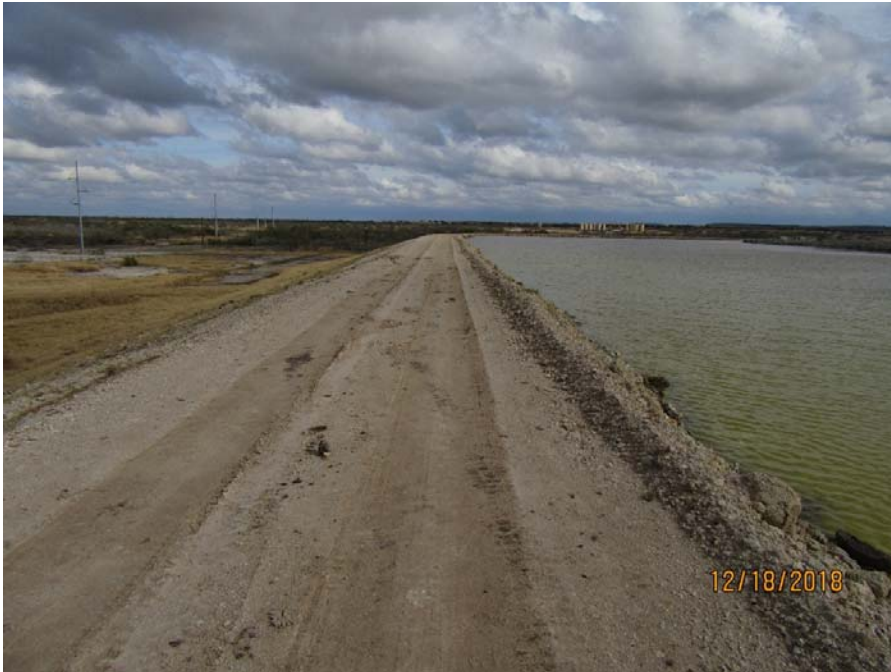
**PHOTO 17:**

Looking to the east along the crest of the berm on the northern side of the Equalization Pond. Not cracks or rutting was observed along the crest.

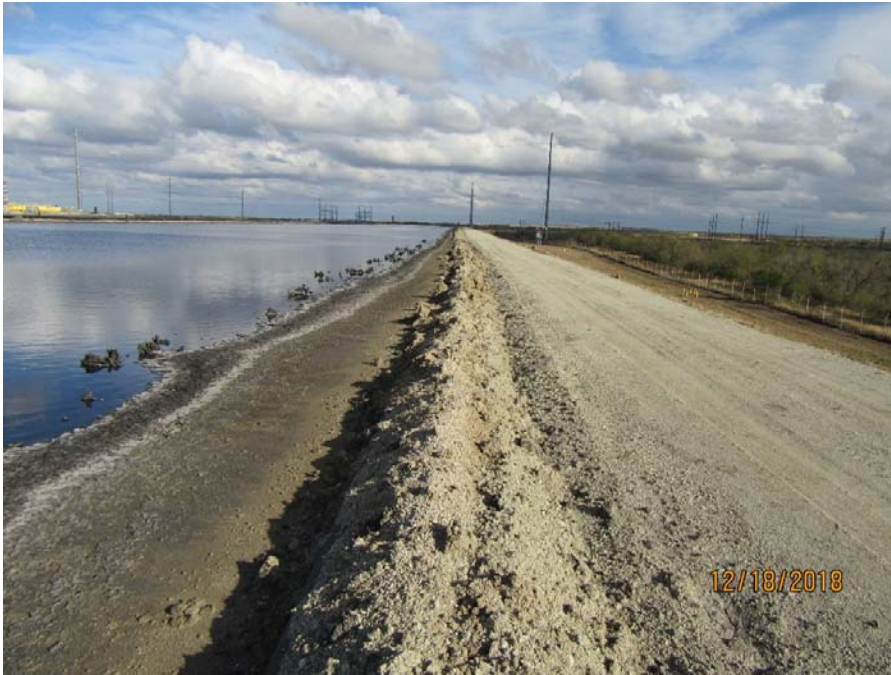
**PHOTO 9:**

Another photograph of the interior of the berm along the southern side of Ash Pond B showing the remnants of the temporary berm previously placed on the berm. No cracks or ruts were observed along the berm during the Annual Inspection.

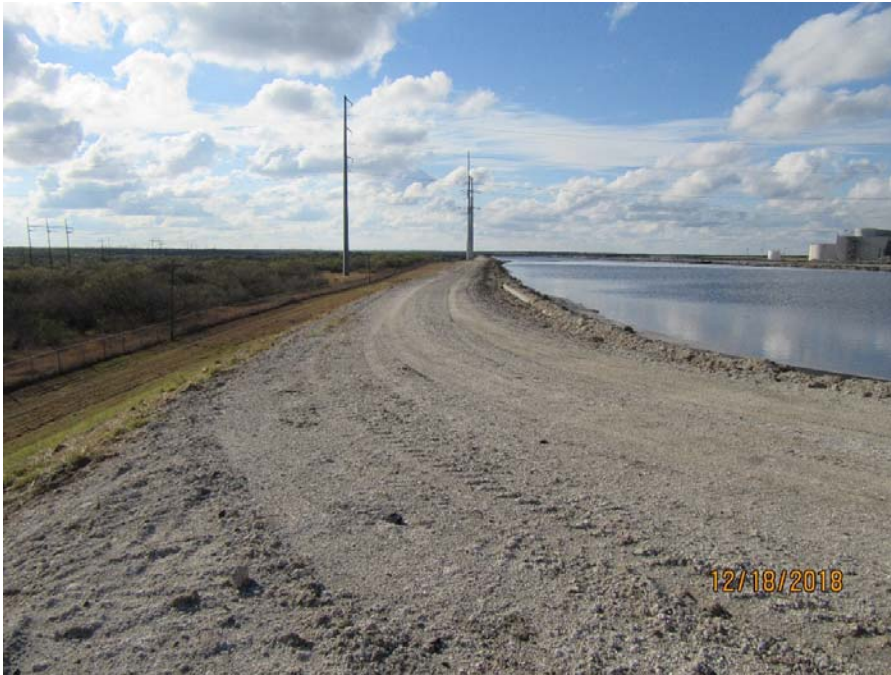
**PHOTO 15:**

Looking to the west along the crest of the newly enhanced crest of the berm along the southern side of Ash Pond B. No vegetative growth was observed along the interior of the crest berm.

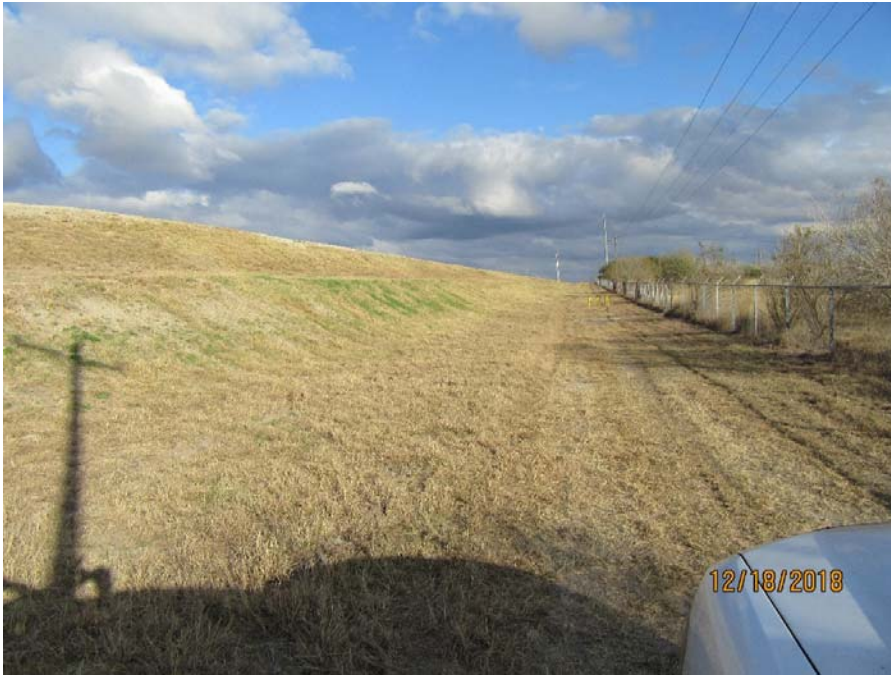
**PHOTO 19:**

This view is to the east from the base of the southwestern corner of the Ash Ponds. No seeps or structural collapses were observed along the base of the Ash Pond berms.

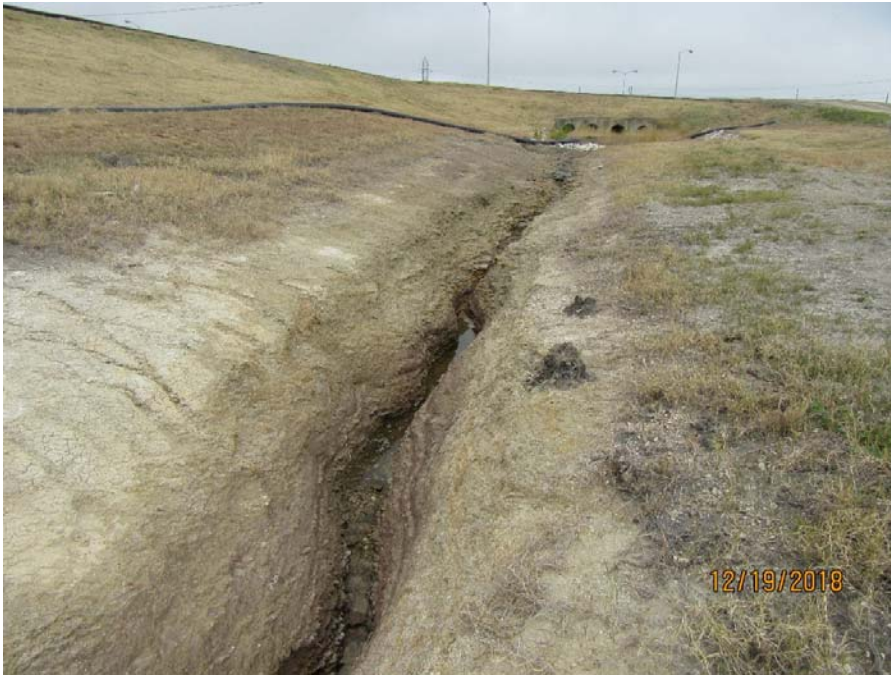
**PHOTO 25:**

The drainageway to the east of the toe of the eastern side of the Ash Ponds. The drainageway has cut into native soils. No seeps were observed in this area. The view is to the north.

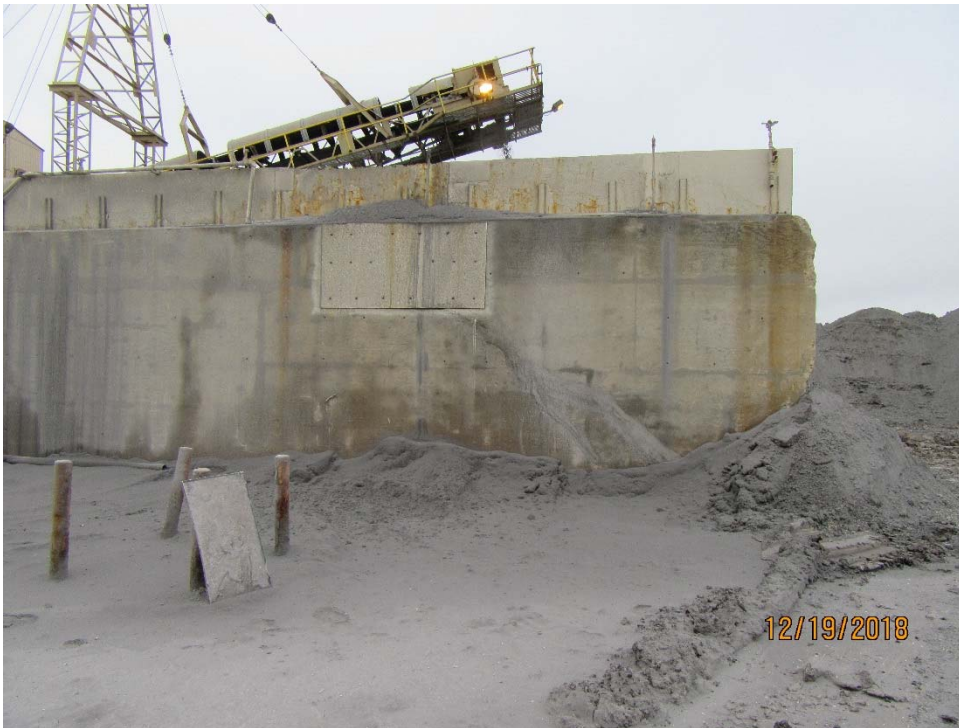
**PHOTO 1:**

Looking to the west at the concrete wall portion of the Ash Pile Containment. The upper portion of the crack in the concrete was covered with a steel plate and attached to a second plate of the opposite side. The continuation of the crack to the lower right was cleaned and filled. A sprinkler system is attached to the top of the wall, but was not operating at the time of the inspection.

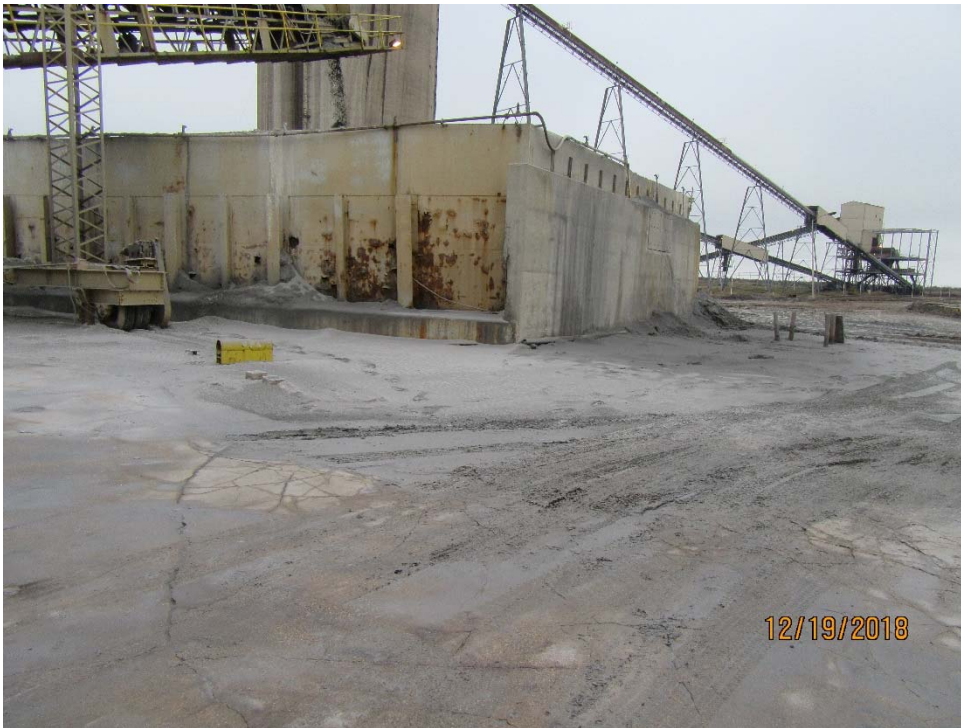
**PHOTO 3:**

The view is to the northwest of the eastern side of the containment area.
