# Inspections: Damaged Pole Report

Service Request 25-00237190 Sector:          Gateway          Primary

Location on Service Request 6100 Moravia Park dr

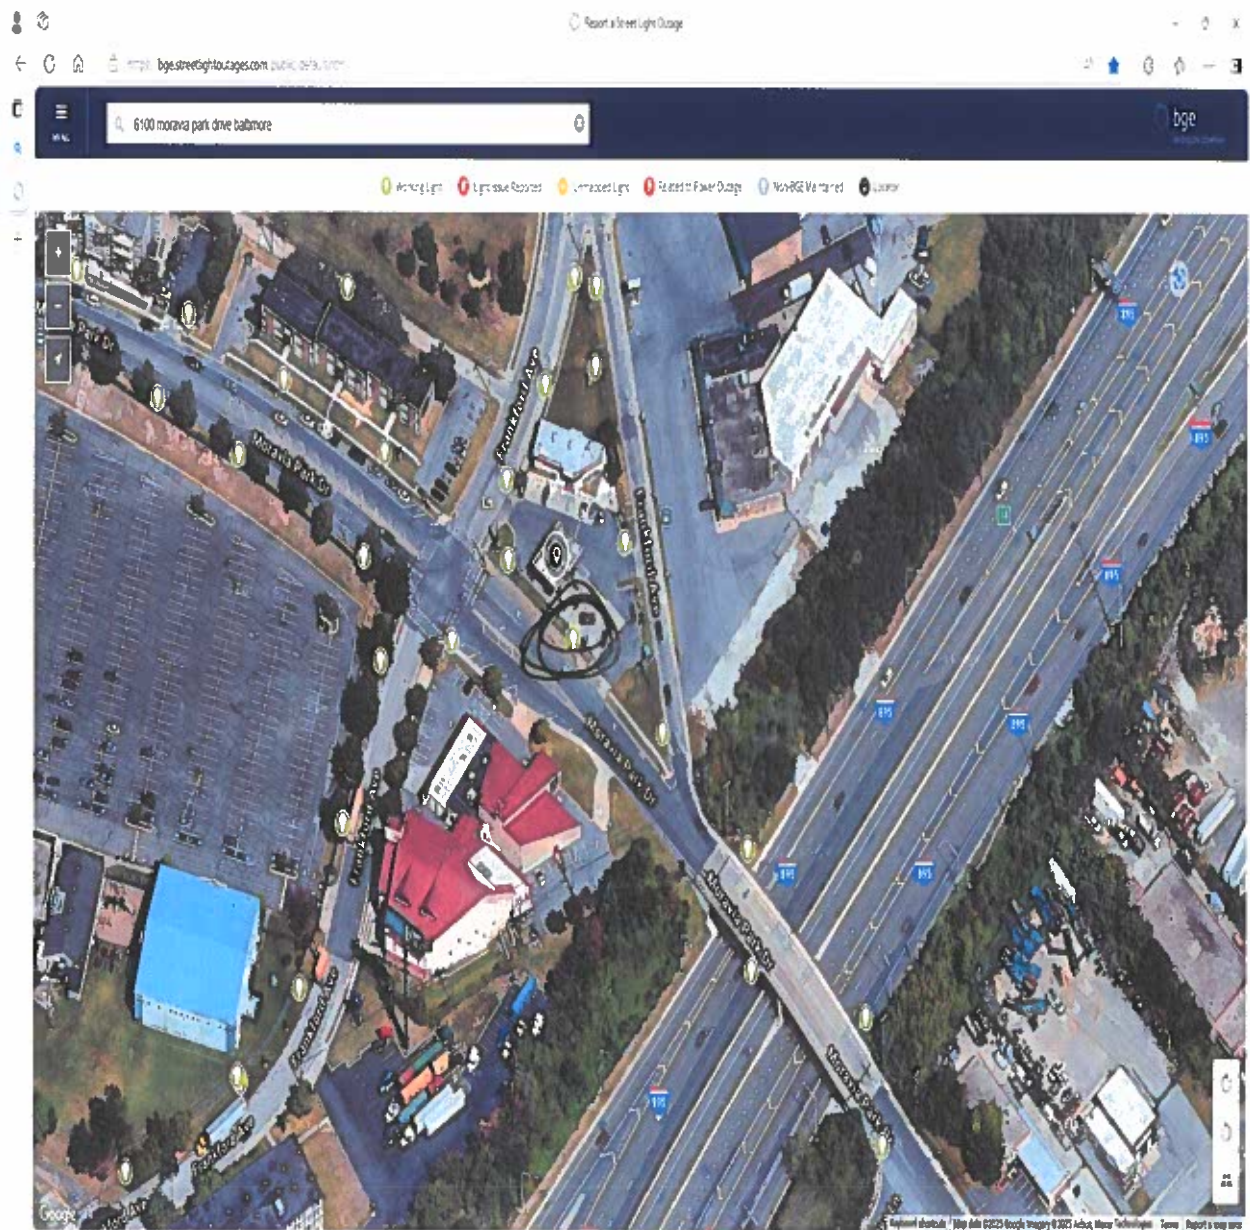
Deteriorated ☒  
Missing ☒  
Damaged ☐  
Arm/Fixture Missing ☐  
Other ☐

Damaged ☐  
Missing ☒

Good ☒  
Bad: ☐  
Bolts ☒  
Wires ☒  
Conduit ☒

25 Foot Aluminum pole  
cobra head  
LED
