Inspections: Damaged Pole Report

Service Request: 25-00336228 Sector: \_\_\_\_\_ Gateway: \_\_\_\_\_ Primary: \_\_\_\_\_

Location on Service Request: 3901 GreenSpring Ave

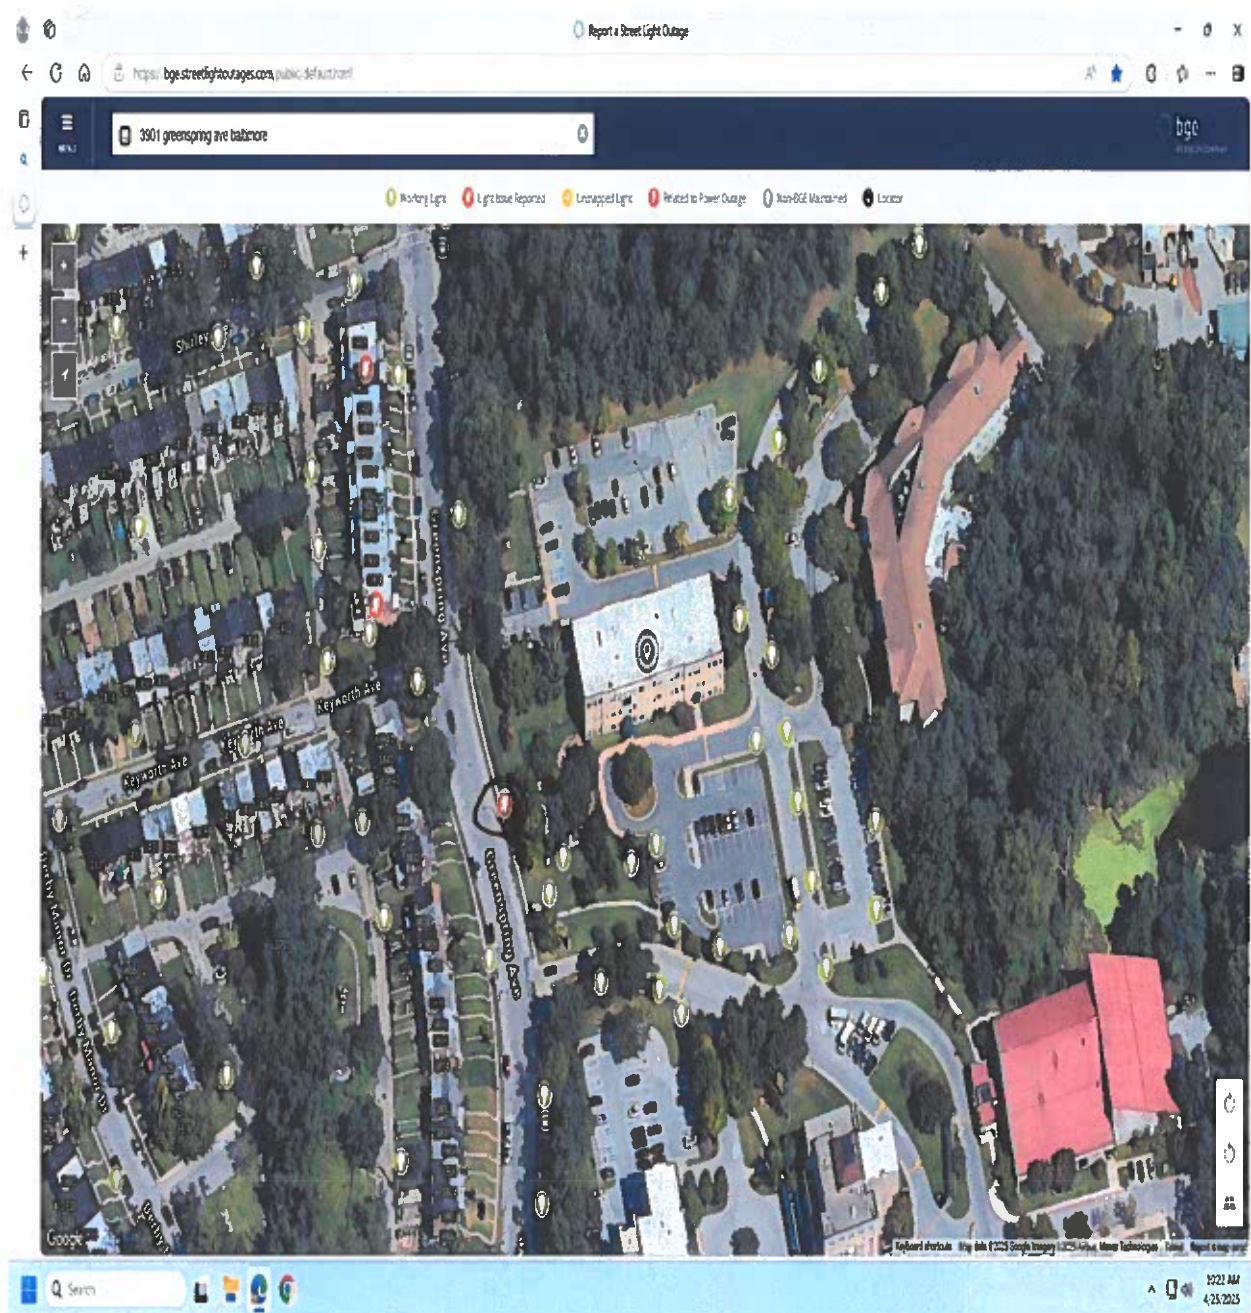
Deteriorated ☒

**NEEDS  
NEW BASE**

30 Foot Aluminum pole  
Cobra Head  
LED
