# Inspections: Damaged Pole Report

Service Request: 25-00360246 Sector: \_\_\_\_\_ Gateway: \_\_\_\_\_ Primary: \_\_\_\_\_

Location on Service Request: 4019 Frankford Ave

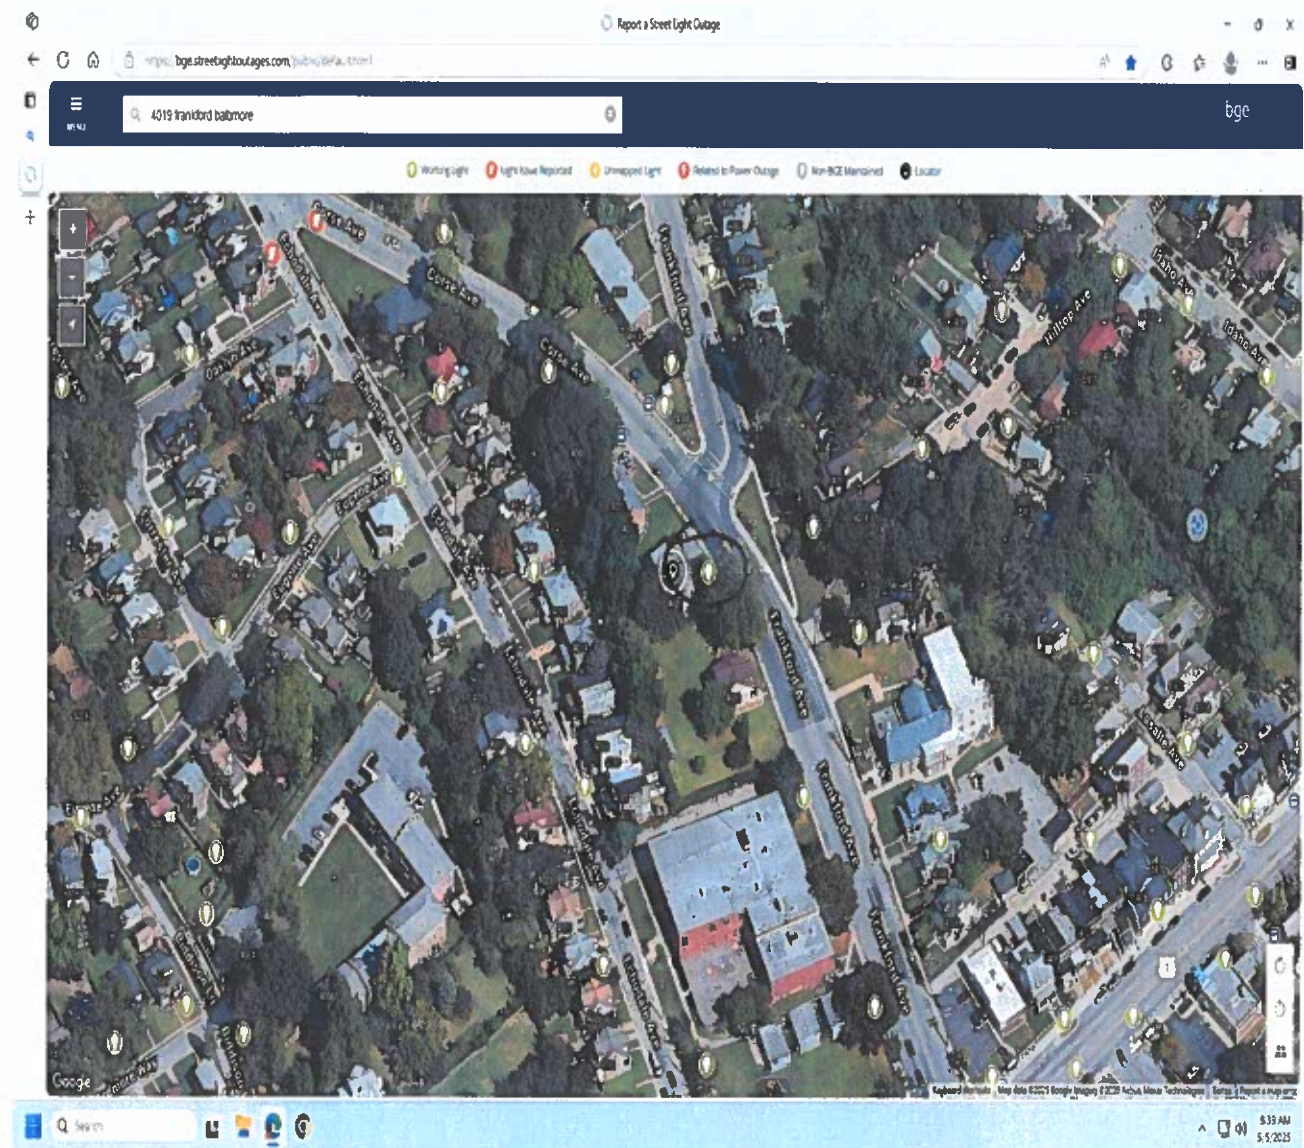
Deteriorated ☒

Missing ☒

25 Foot Aluminum pole  
Cobra Head  
LED
