Inspections: Damaged Pole Report

Service Request: 25-00360313 Sector: \_\_\_\_\_ Gateway: \_\_\_\_\_ Primary: \_\_\_\_\_

Location on Service Request: 6603 PULASKI HWY

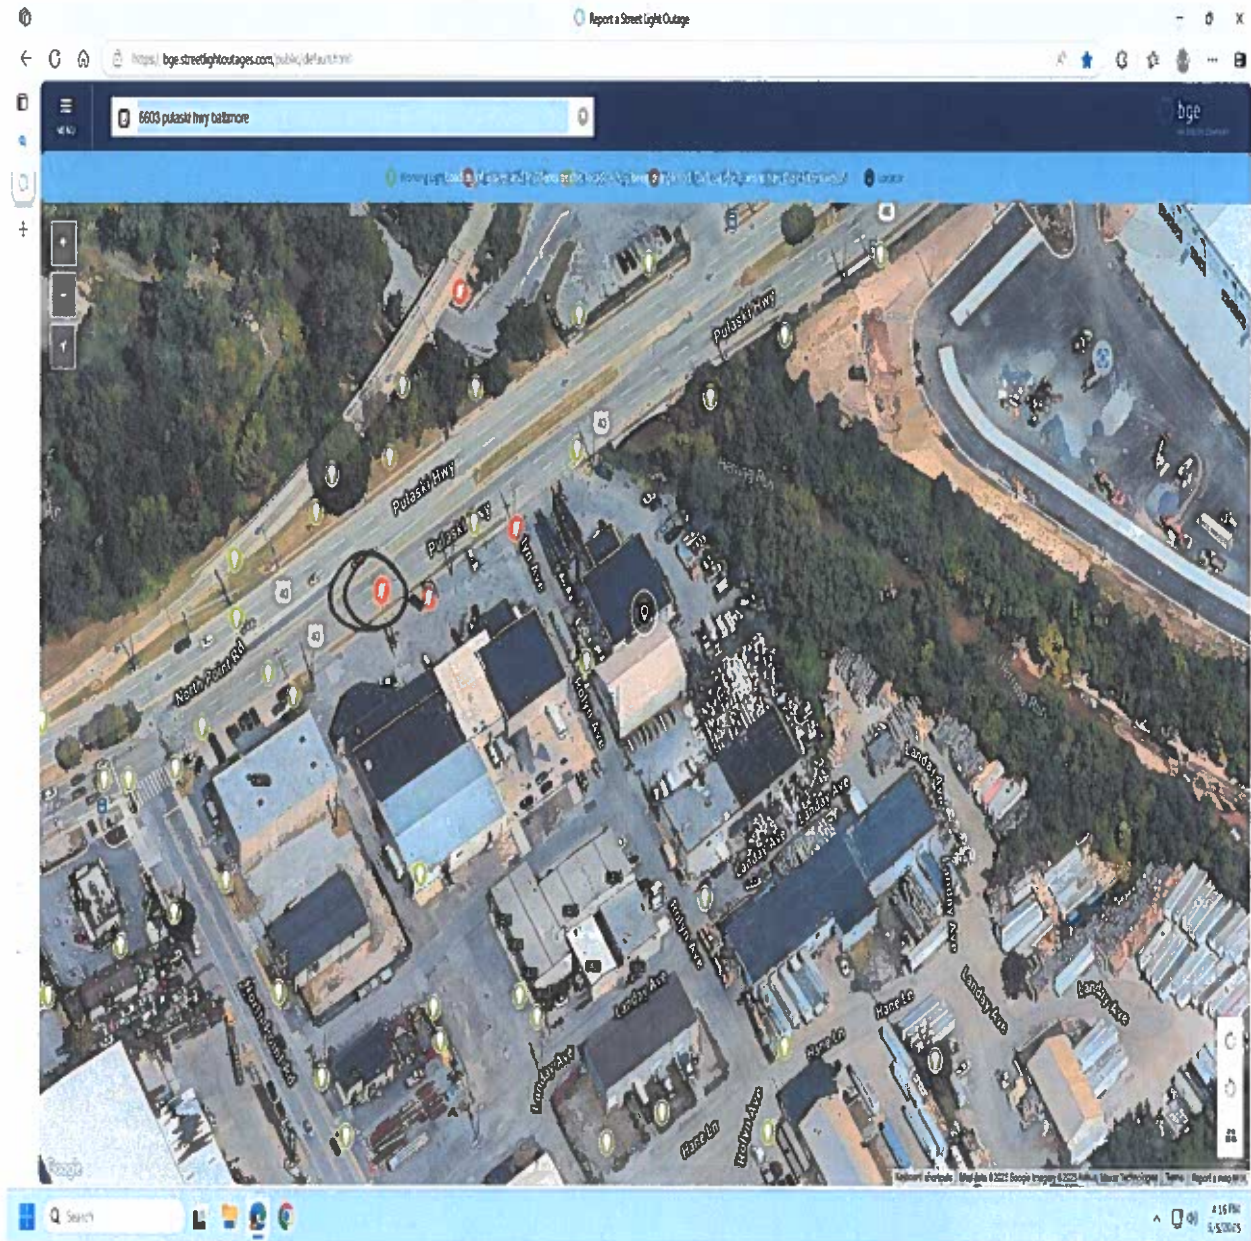
Deteriorated \_\_\_\_\_  
Missing ☒  
Damaged \_\_\_\_\_  
Arm/Fixture Missing \_\_\_\_\_  
Other \_\_\_\_\_

NEEDS  
New Base

30 Foot Aluminum pole  
Cobra Head  
LED
