# Inspections: Damaged Pole Report

Service Request: 25-00533555 Sector: \_\_\_\_\_ Gateway: \_\_\_\_\_ Primary: \_\_\_\_\_

Location on Service Request: 5914 YORK RD

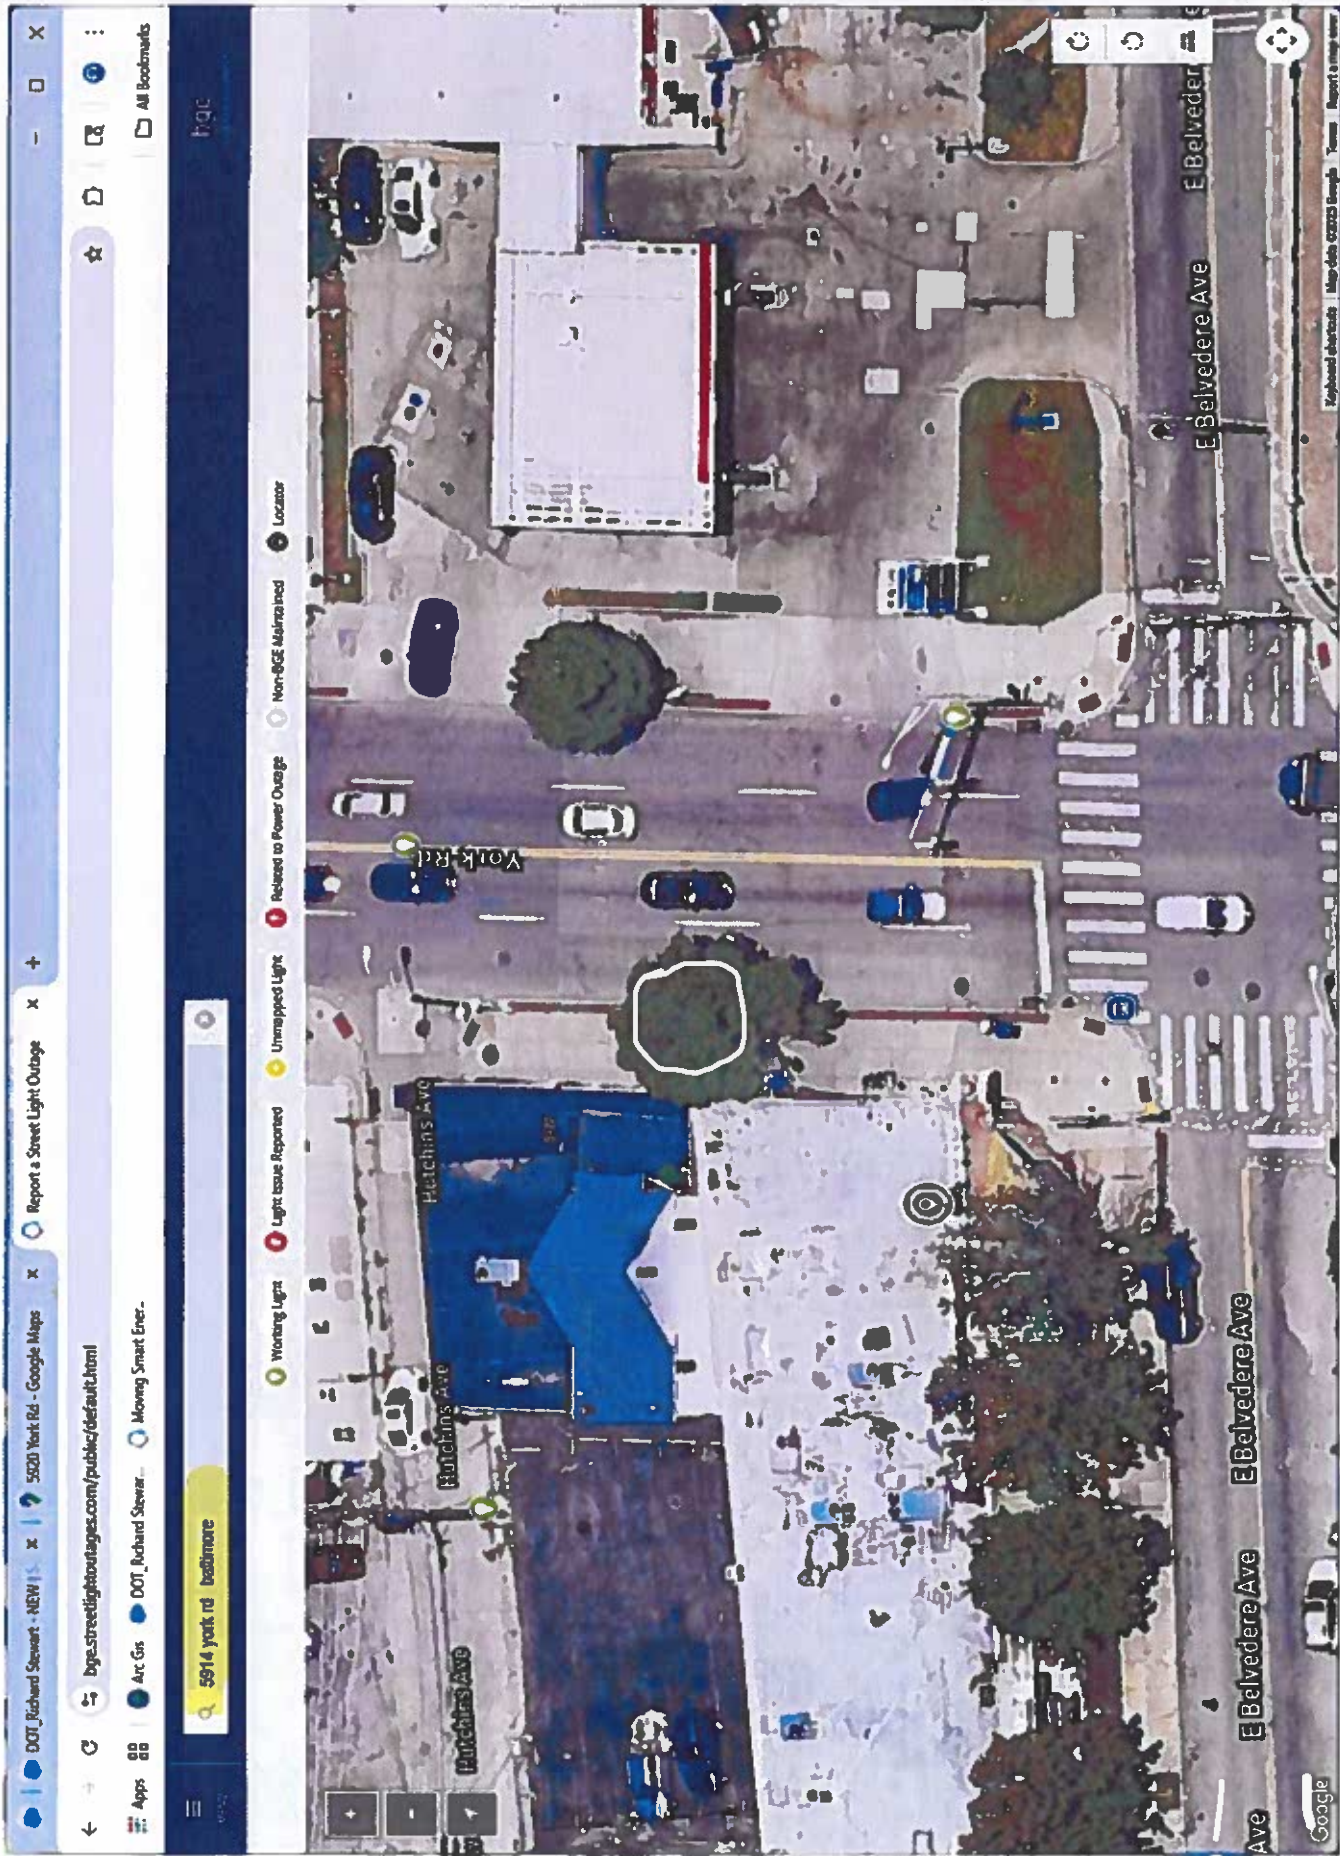
Missing ✓

Homeland pole Acorn fixture
