Inspections: Damaged Pole Report

Service Request: 25-00548454 Sector: \_\_\_\_\_ Gateway: \_\_\_\_\_ Primary: \_\_\_\_\_

Location on Service Request: 4845 Bel Air Rd

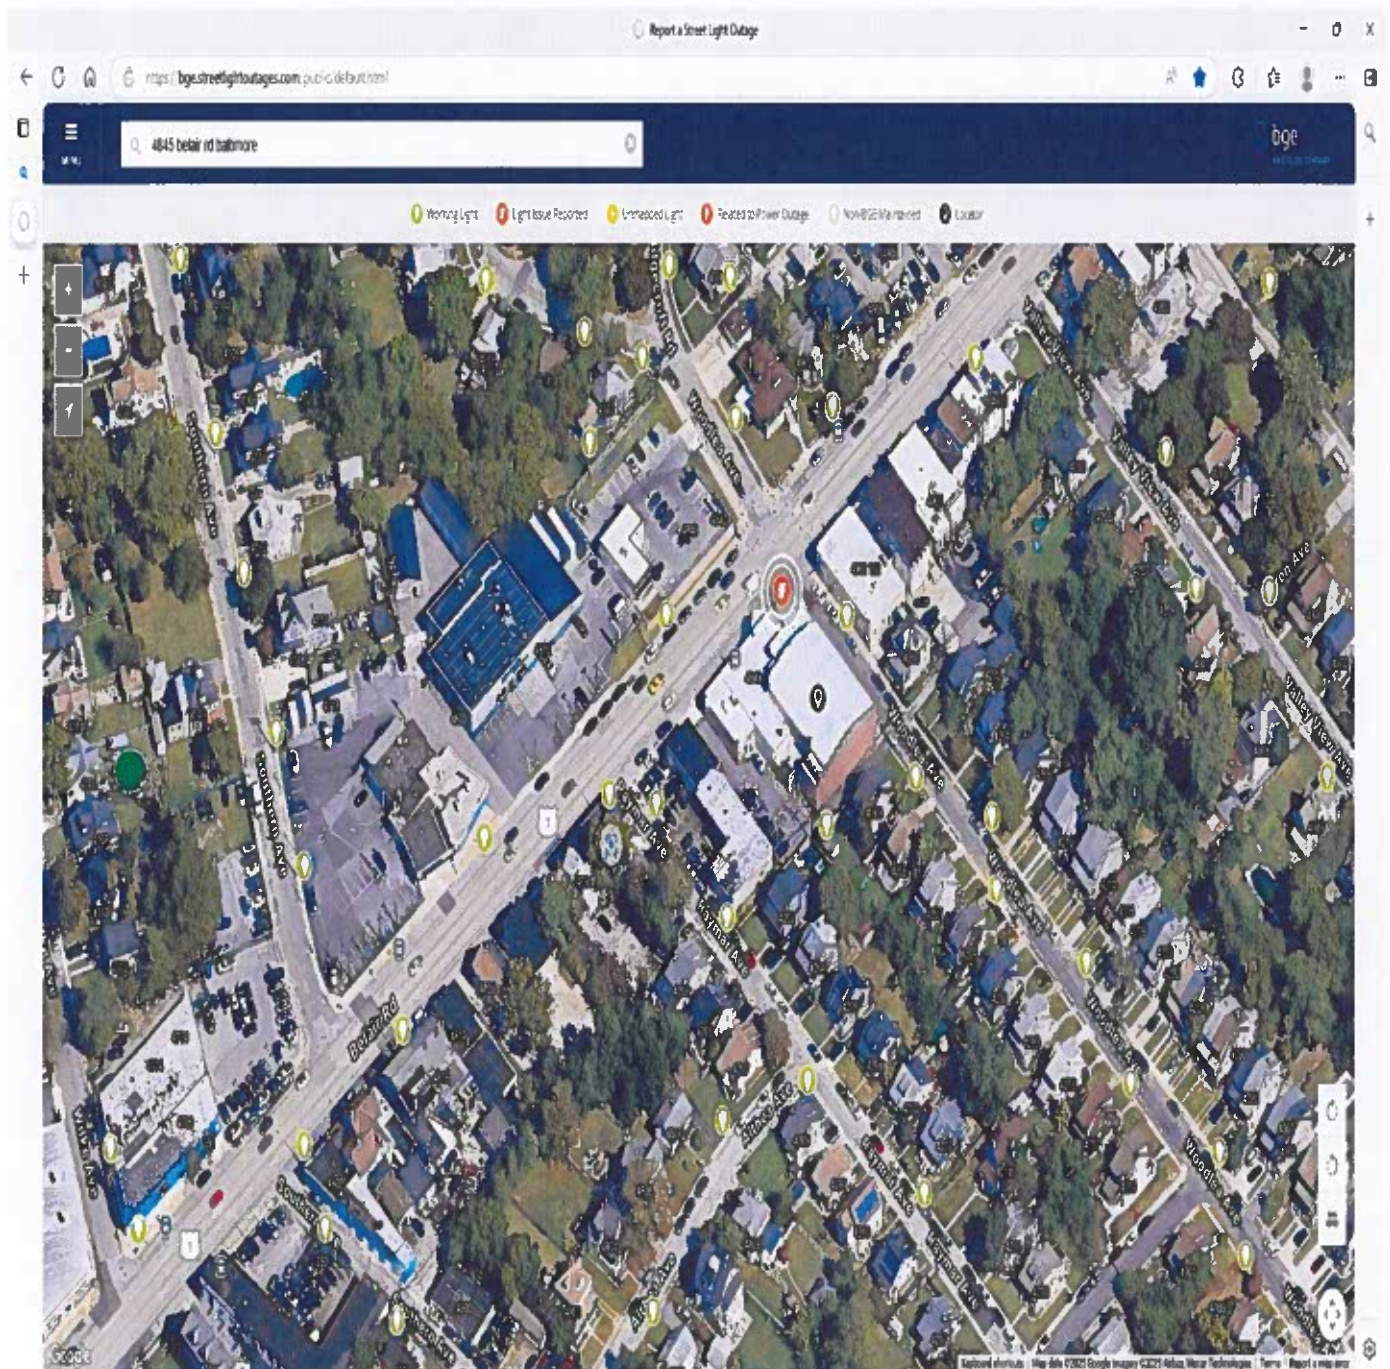
30 Foot Aluminum pole  
Cobra Head  
LED
