# Inspections: Damaged Pole Report

Service Request: 25-00547043 Sector: \_\_\_\_\_ Gateway: \_\_\_\_\_ Primary: \_\_\_\_\_

Location on Service Request: 607 Somerset Rd

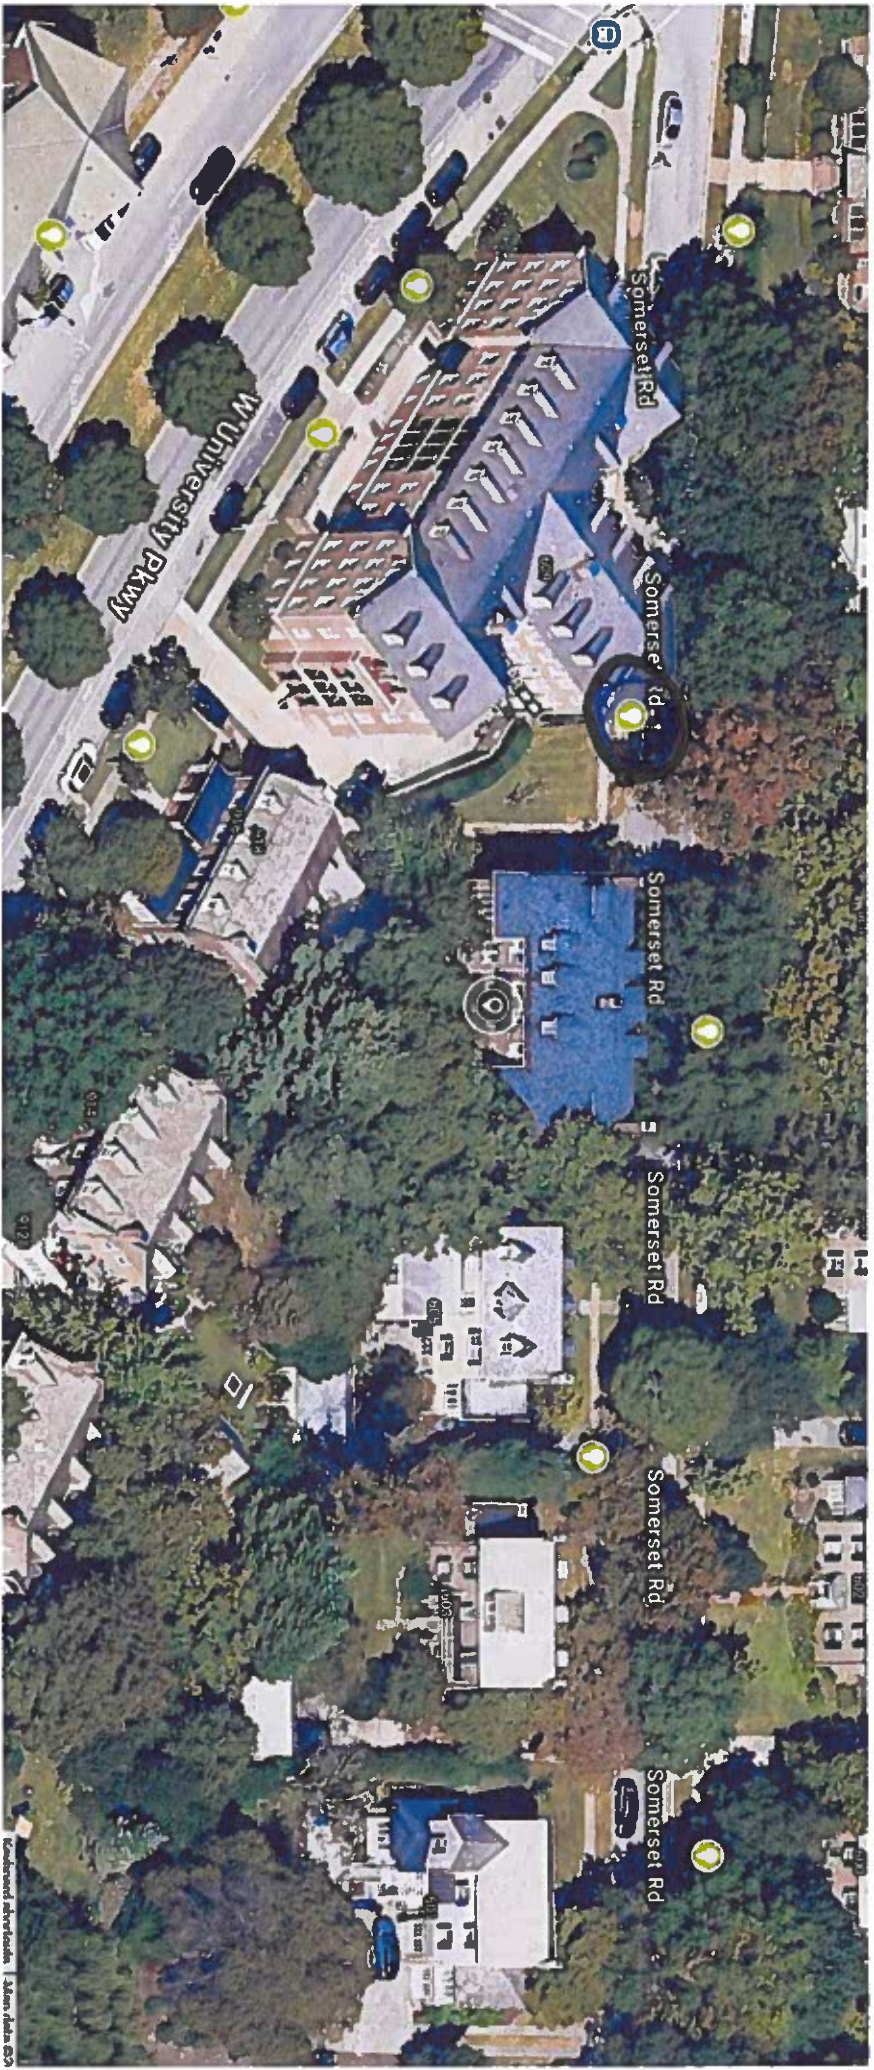
607 Somerset

Missing ☒

**Location:** 607 SOMERSET RD, Baltimore City, 21210  
**Location Details:** There is a streetlight that is leaning towards the street. It appears the connections at the base have corroded so that it is no longer stable.  
**Description:**
