Inspections: Damaged Pole Report

Service Request: 25-00362069 Sector \_\_\_\_\_ Gateway \_\_\_\_\_ Primary \_\_\_\_\_

Location on Service Request: 3917 Loch Raven Blvd

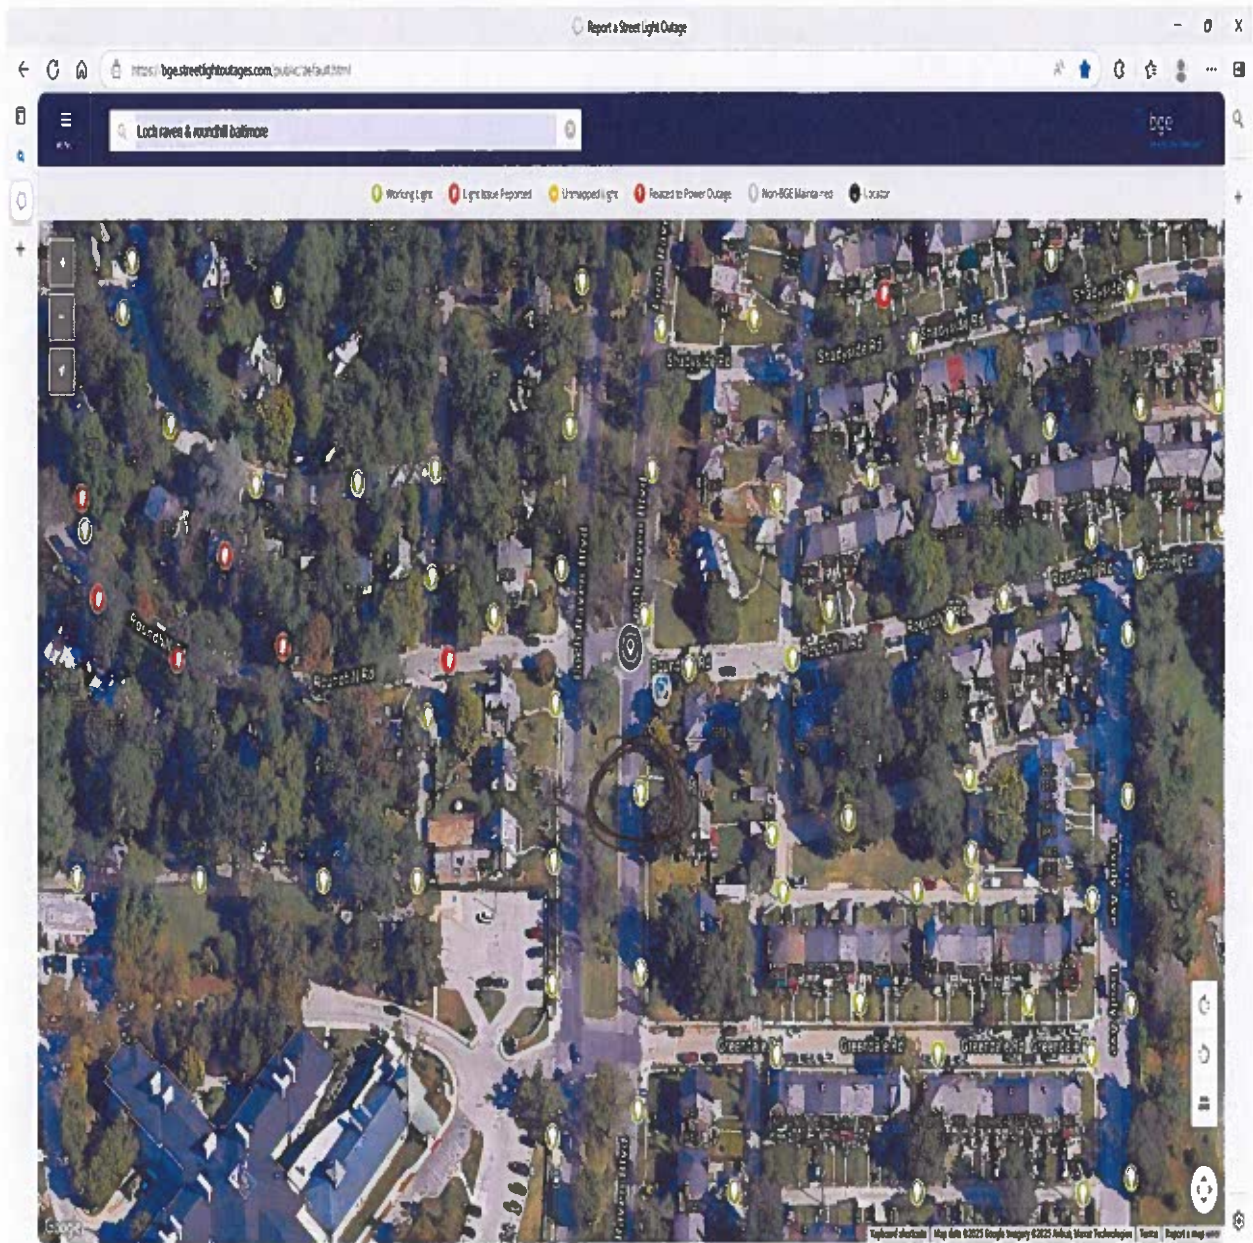
30 Foot Aluminum pole  
Cobra Head  
LED
