# Inspections: Damaged Pole Report

Service Request: 25-00355854 Sector: \_\_\_\_\_ Gateway: \_\_\_\_\_ Primary: \_\_\_\_\_

Location on Service Request: 2107 Barclay St

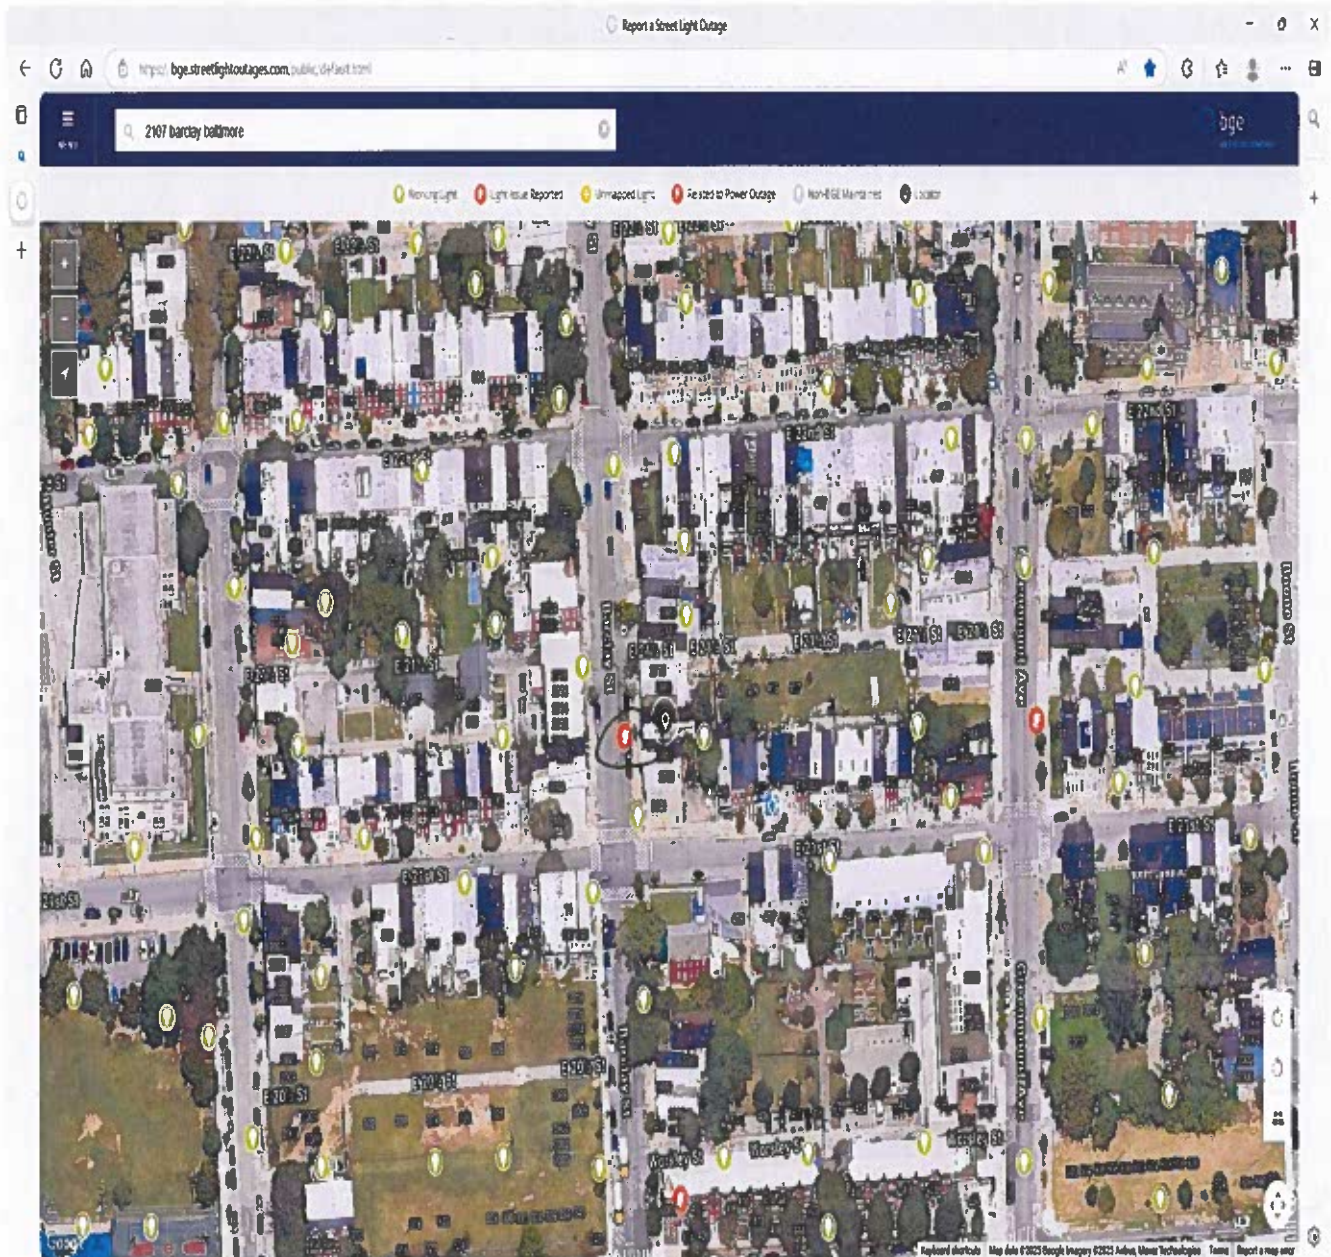
Deteriorated ☒

Missing ☒

Bolts ☒  
Wires ☒  
Conduit ☒

25 Foot Aluminum  
pole  
Cobra Head  
LED
