Inspections: Damaged Pole Report

Service Request: 25-00556829 Sector: \_\_\_\_\_ Gateway: \_\_\_\_\_ Primary: \_\_\_\_\_

Location on Service Request: 1508 E. Madison St

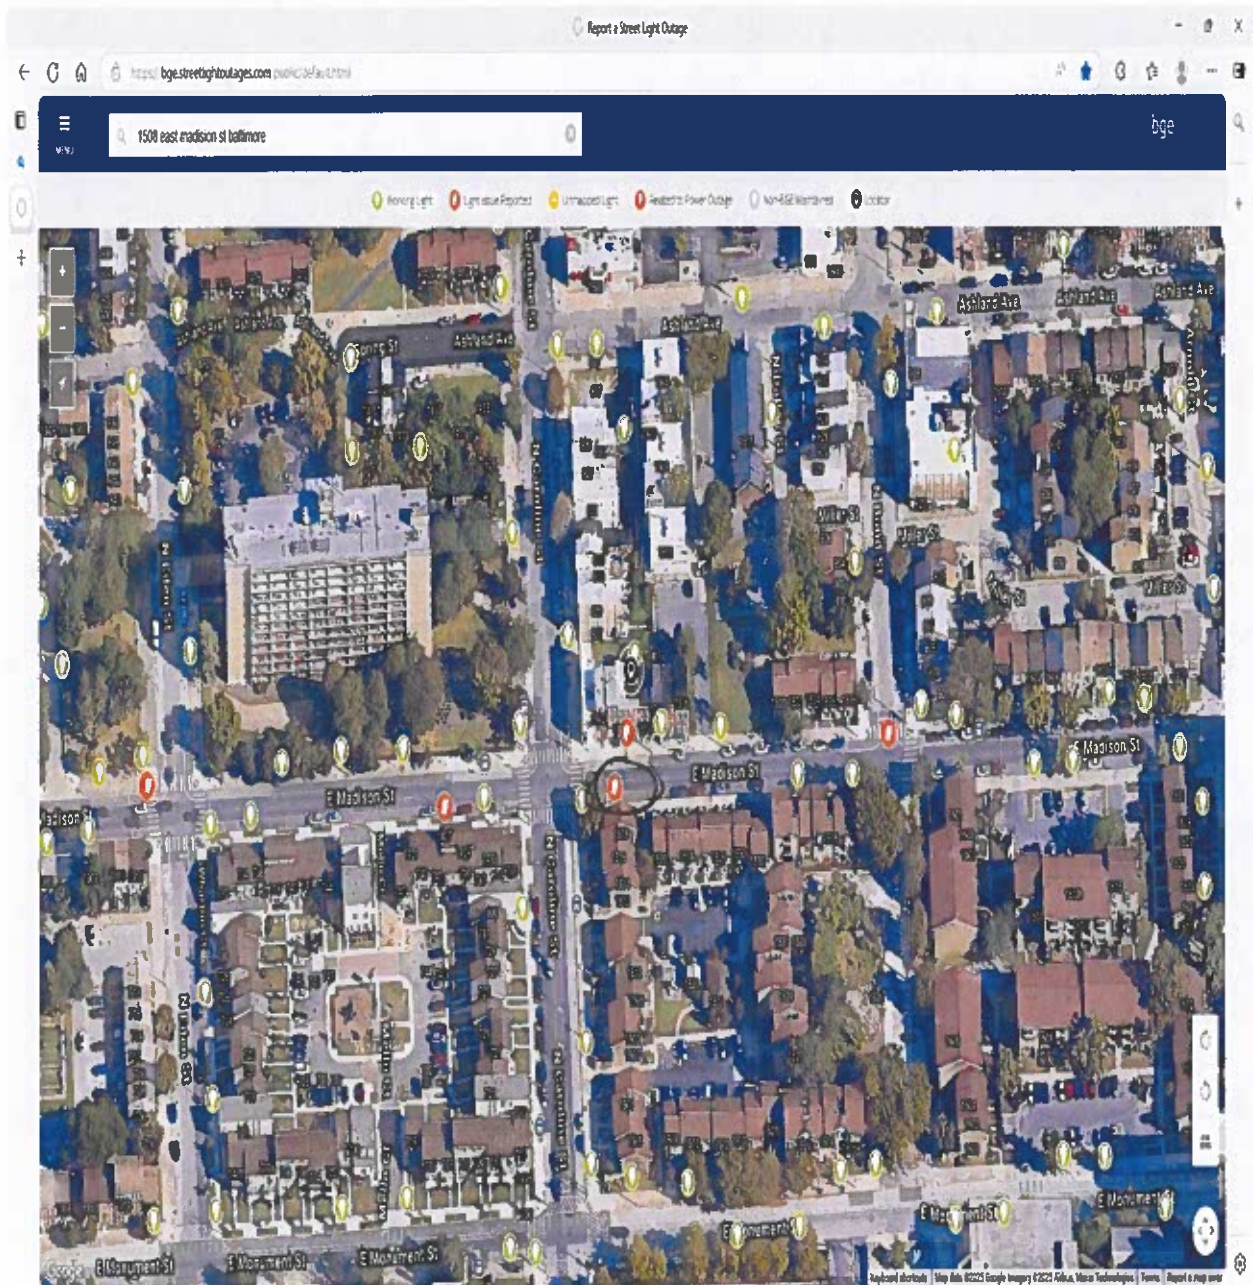
Home land  
pole  
Acorn Fixture
