# Inspections: Damaged Pole Report

Service Request: 25-00576001 Sector: \_\_\_\_\_ Gateway: \_\_\_\_\_ Primary: \_\_\_\_\_

Location on Service Request: 4600 ANN TANA Ave

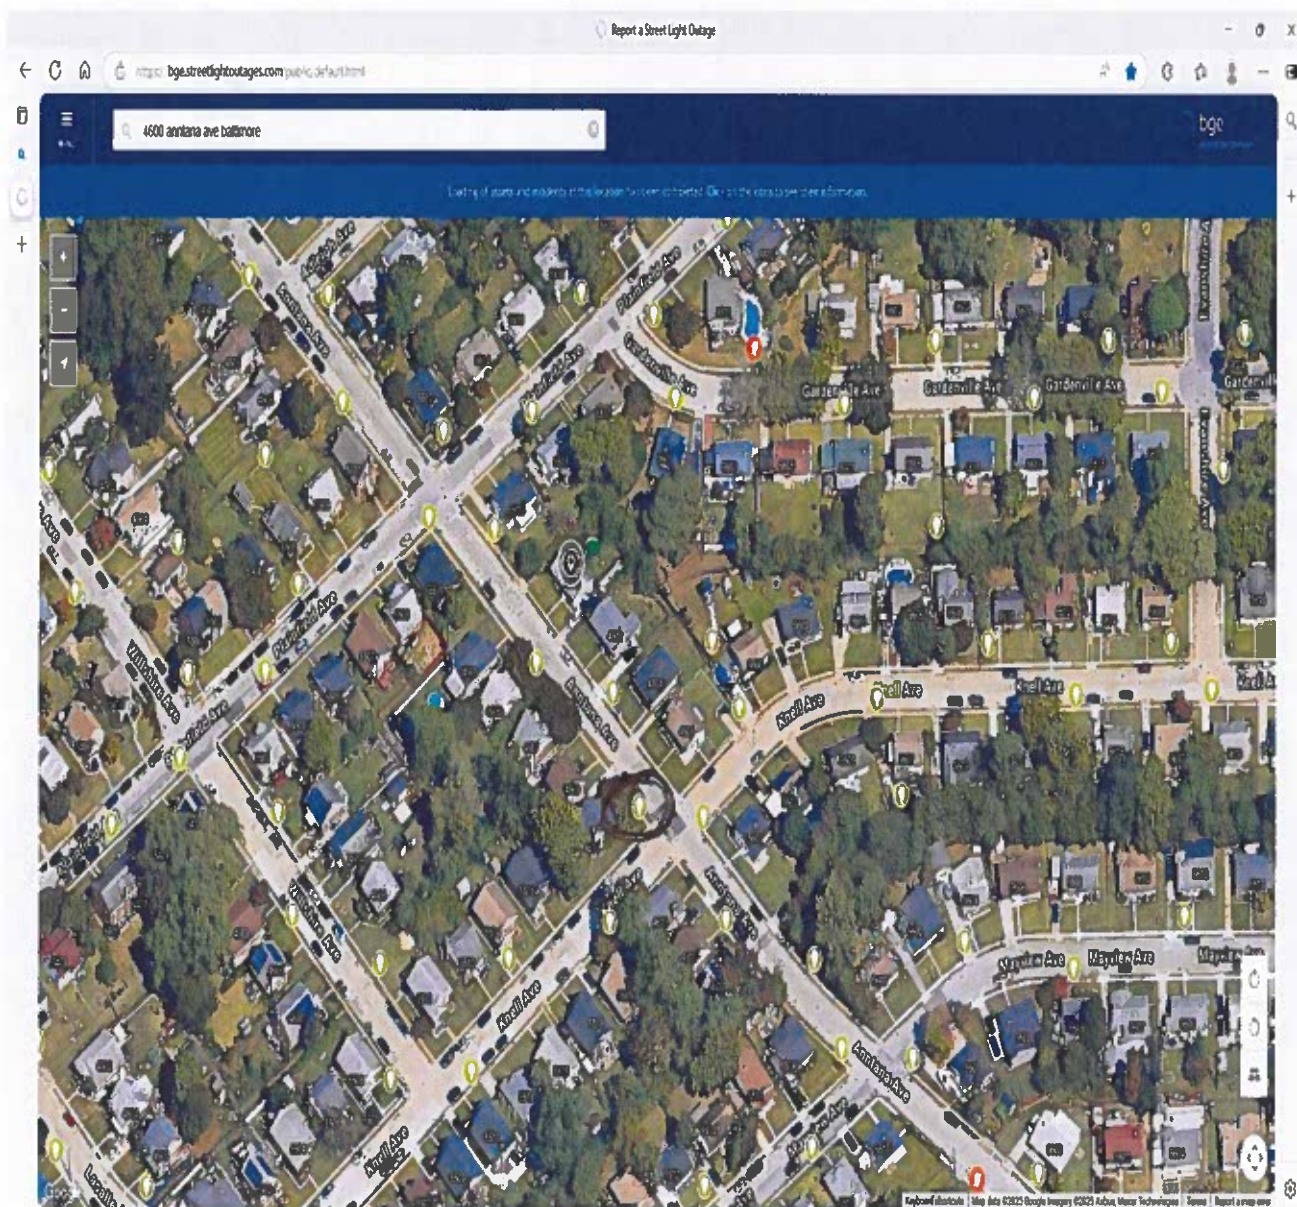
Deteriorated \_\_\_\_\_  
Missing ☒  
Damaged \_\_\_\_\_  
Arm/Fixture Missing \_\_\_\_\_  
Other \_\_\_\_\_

NEEDS  
NEW BASE

PMA  
BLE  
LED
