# Sewer Scope Report

20 N Collington Ave  
Baltimore, MD 21231

Inspected by:  
Patrick Harrison  
Blue Crab Inspections

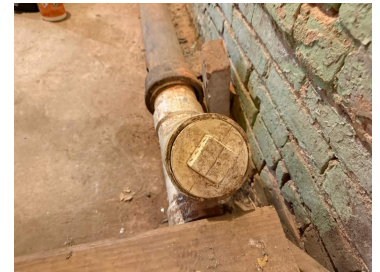
### 2. ☒☐☐☐☐ Drain Access Location Front of Basement

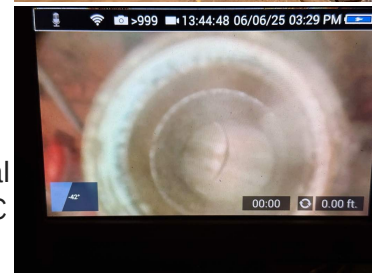
### 3. ☒☐☐☐☐ Sewer Lateral PVC - Showing entrance at cleanout. Line zeroed out

PVC piping noted in use. PVC has been in use since 1982 with an expected lifespan of over 100 years. PVC joints are sealed and more resistant to root intrusion. Installation of PVC in ground requires special care to ensure proper bedding of the material. Common failures of PVC are bellies in the pipe.

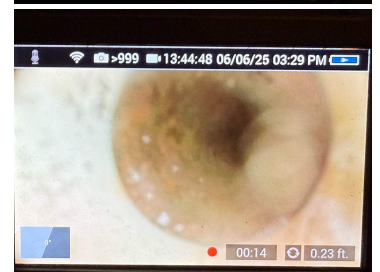
### 4. ☒☐☐☐☐ Sewer Lateral Cast Iron - The sewer lateral transitions to Cast Iron material at approximately 0.23 ft.

Cast iron drain piping observed. Cast iron drain piping has a typical lifespan of about 50 years. Common issues with cast iron drain piping can include scaling and pitting.

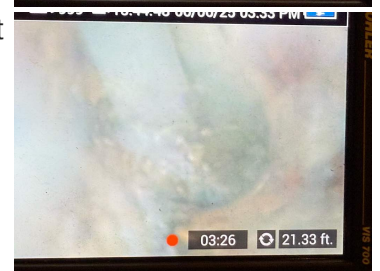
### 5. ☒☐☐☐☐ Sewer Lateral Cast Iron - Sewer Camera approached 45 degree turn at approximately 21.33 ft.

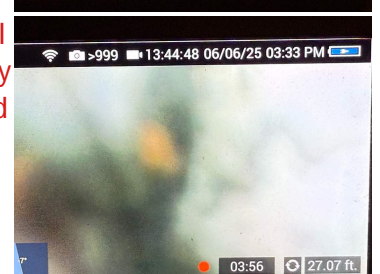
### 6. ☐☐☐☐☒ Sewer Lateral Cast Iron - Standing water was observed in sewer lateral at approximately 27.07 ft. Standing water can indicate a potential belly or clog in the line. A licensed plumber is recommended to evaluate and estimate repairs.

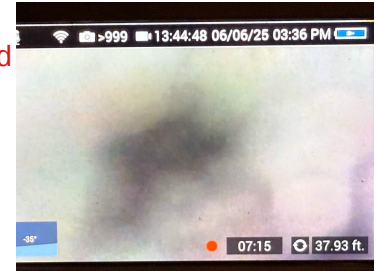
7. ☐☐☐☐☒ Sewer Lateral Cast Iron - Obstruction observed in sewer lateral at approximately 37.93 ft. could not push camera past obstruction, ended sewer lateral inspection.  
Standing water was observed in sewer lateral at approximately 37.93 ft. Standing water can indicate a potential belly or clog in the line. A licensed plumber is recommended to evaluate and estimate repairs.
