# Inspections: Damaged Pole Report

Service Request 25-00612498 Sector: \_\_\_\_\_ Gateway: \_\_\_\_\_ Primary: \_\_\_\_\_

Location on Service Request: 300 Warren Ave

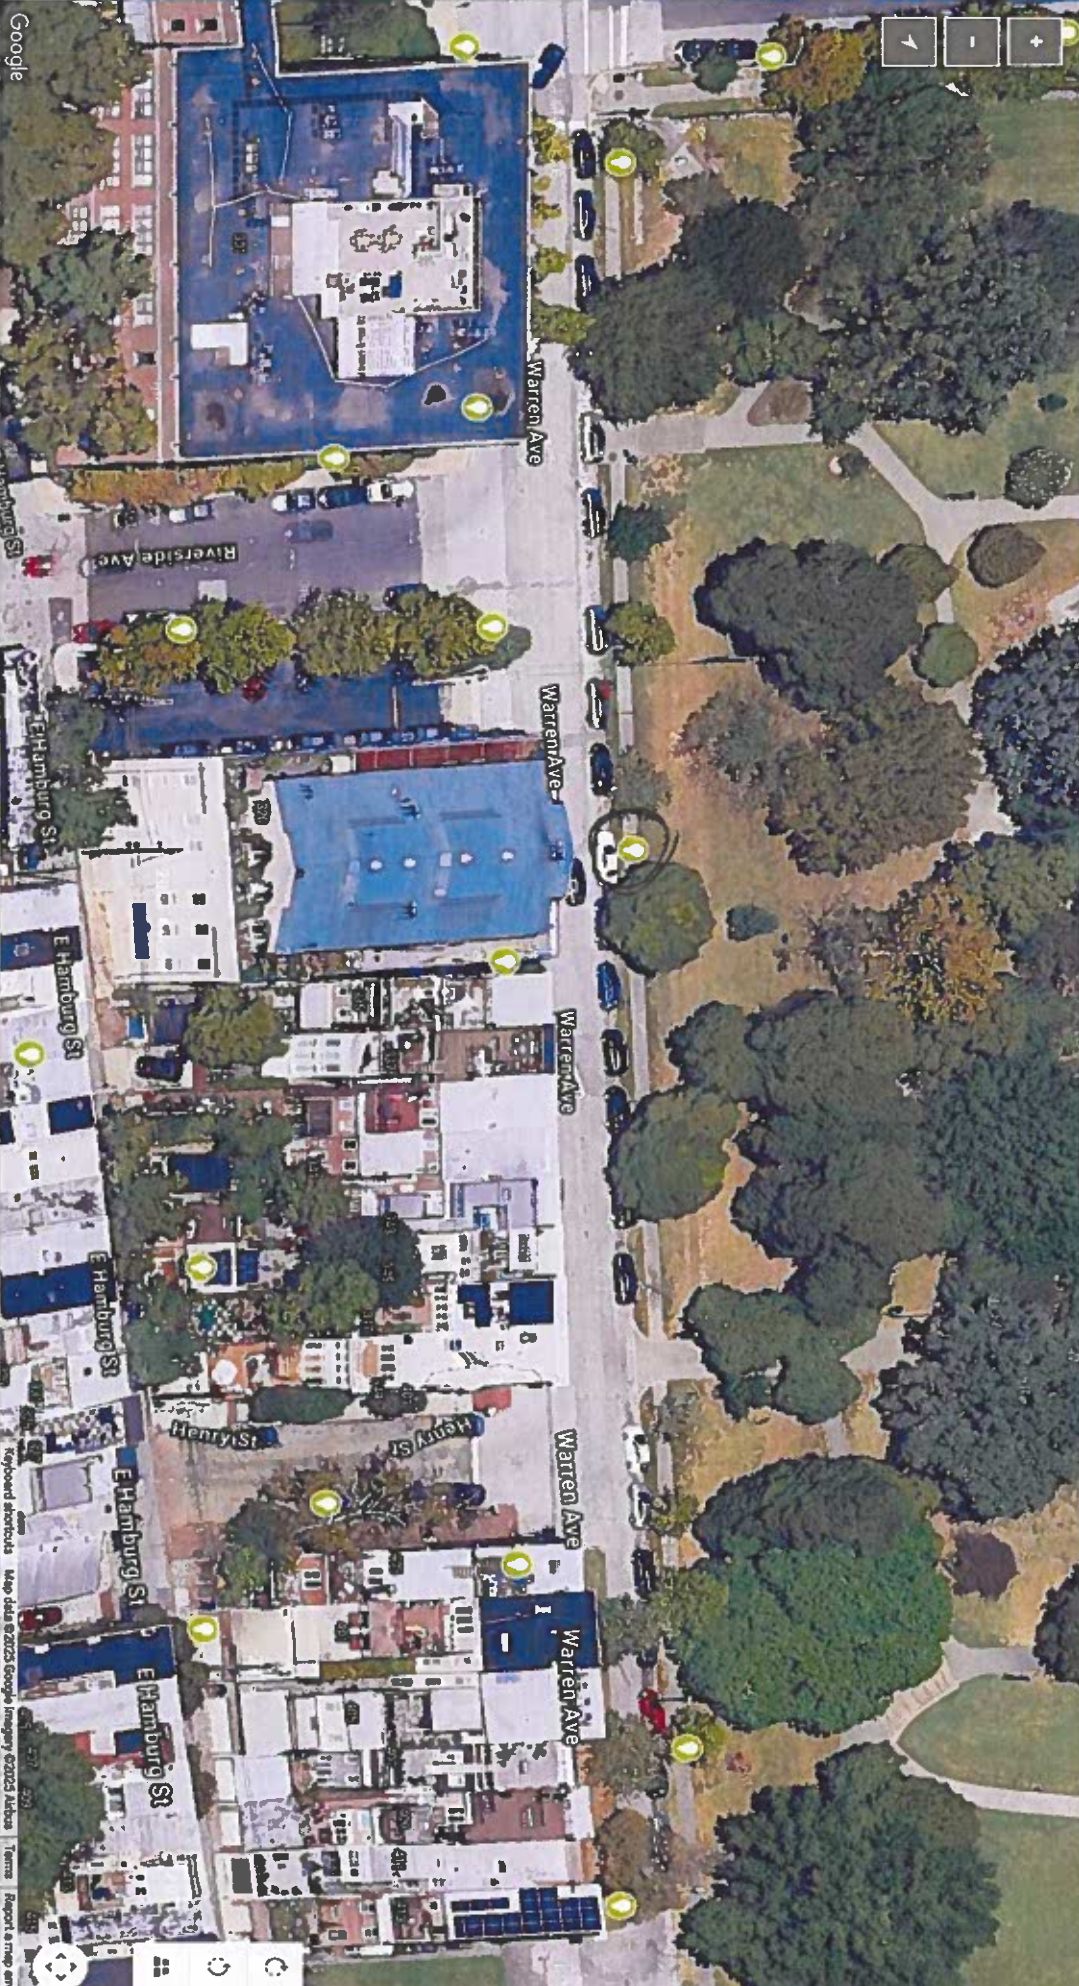
Missing ☒

Home and Acorn Fixture
