# Inspections: Damaged Pole Report

Service Request 25-00620616 Sector \_\_\_\_\_ Gateway \_\_\_\_\_ Primary \_\_\_\_\_

Location on Service Request: 3600 O'donnell St

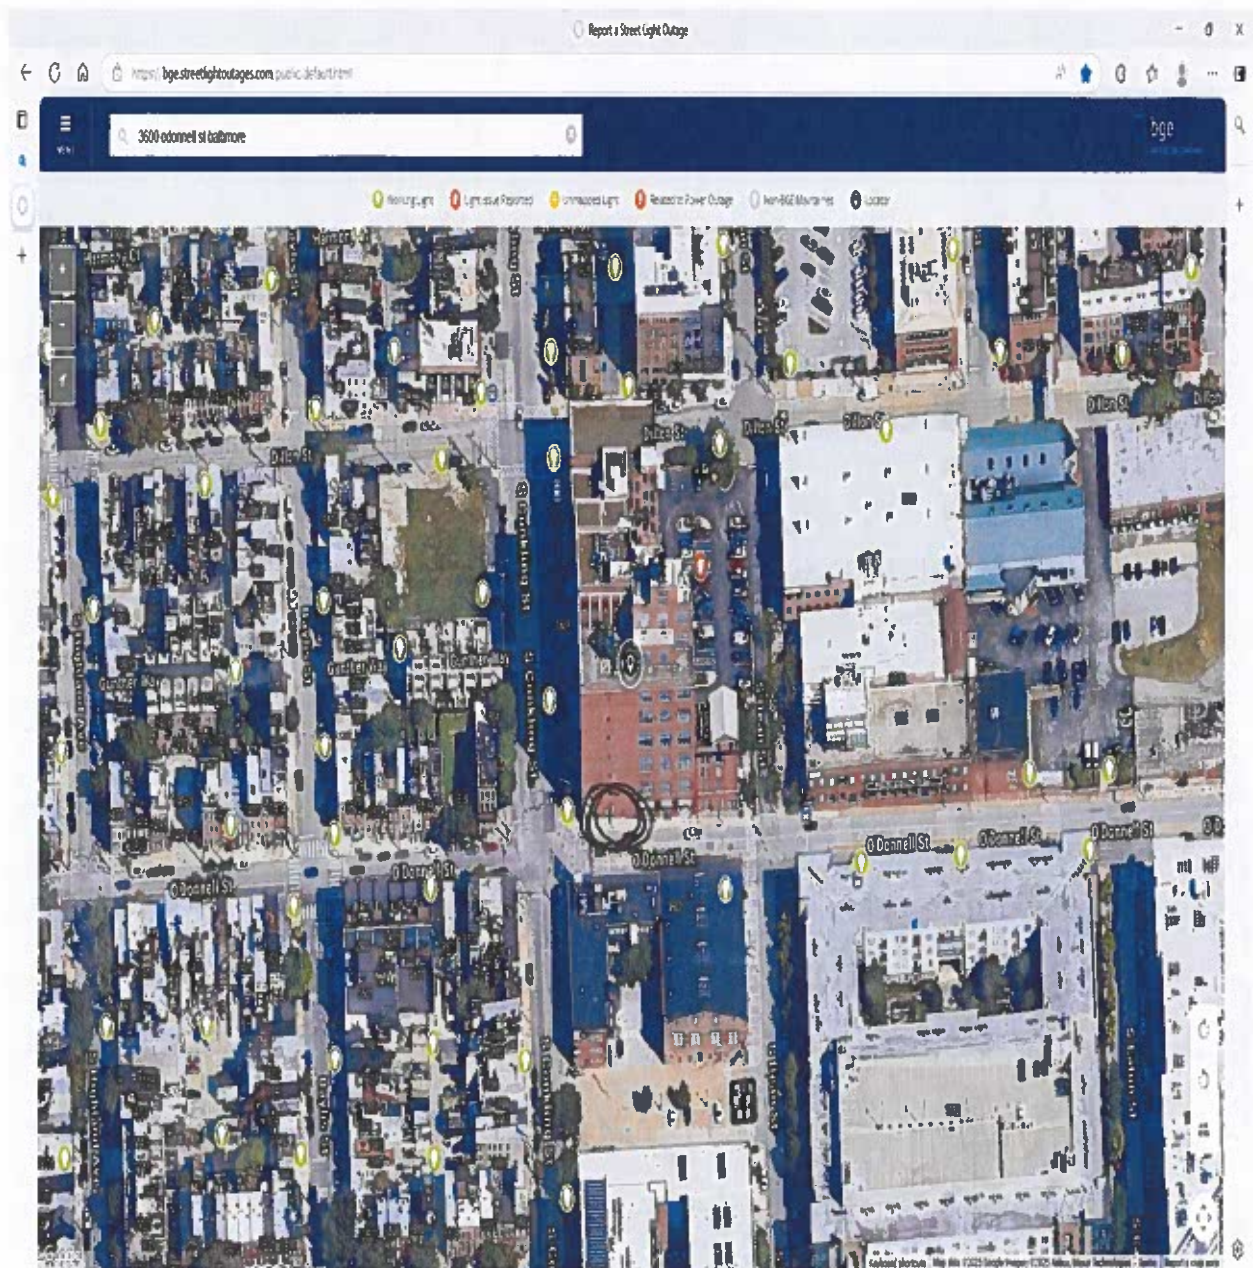
4020320

Deteriorated \_\_\_\_\_  
Missing ☒  
Damaged \_\_\_\_\_  
Arm/Fixture Missing \_\_\_\_\_  
Other \_\_\_\_\_

25 Foot pole  
Cobra Head  
LED
