# Inspections: Damaged Pole Report

Service Request: 25-00693801 Sector: \_\_\_\_\_ Gateway: \_\_\_\_\_ Primary: \_\_\_\_\_  
 Location on Service Request: 891 N. Howard St  
 Grid : 1010140 ILC: 7921

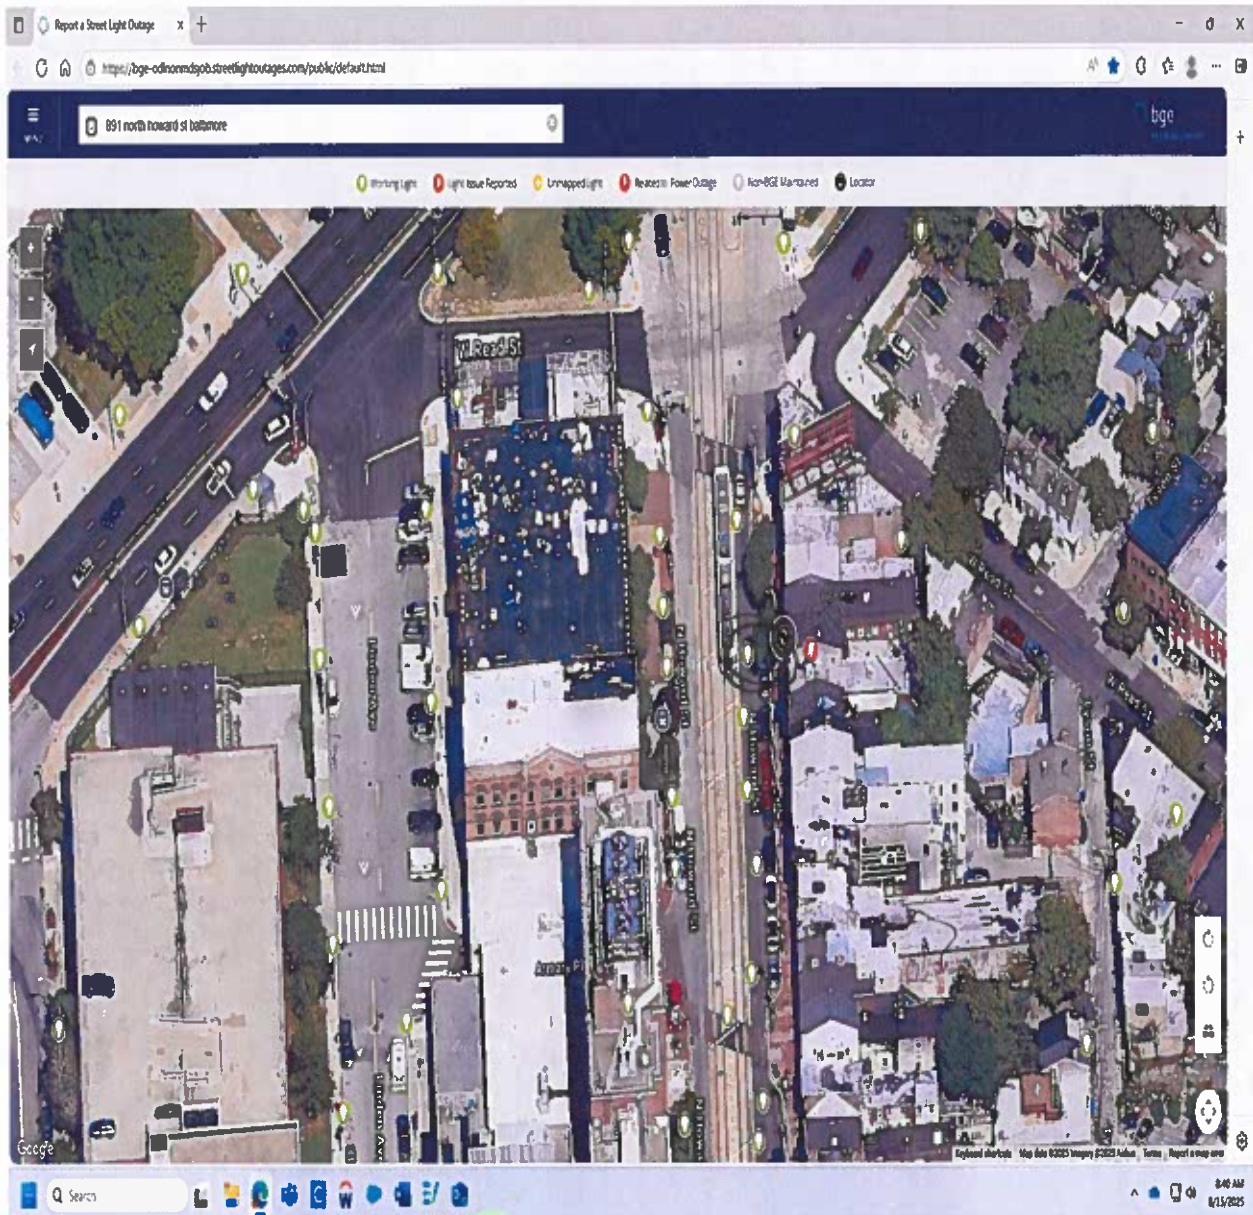
Deteriorated \_\_\_\_\_  
 Missing ☒  
 Damaged \_\_\_\_\_  
 Arm/Fixture Missing \_\_\_\_\_  
 Other \_\_\_\_\_

Ottenbetrn pole  
Ottenbetrn  
Fixture
