Inspections: Damaged Pole Report

Service Request: 25-00700794 Sector: \_\_\_\_\_ Gateway: \_\_\_\_\_ Primary: \_\_\_\_\_

Location on Service Request: 5128 CHALgrove Ave

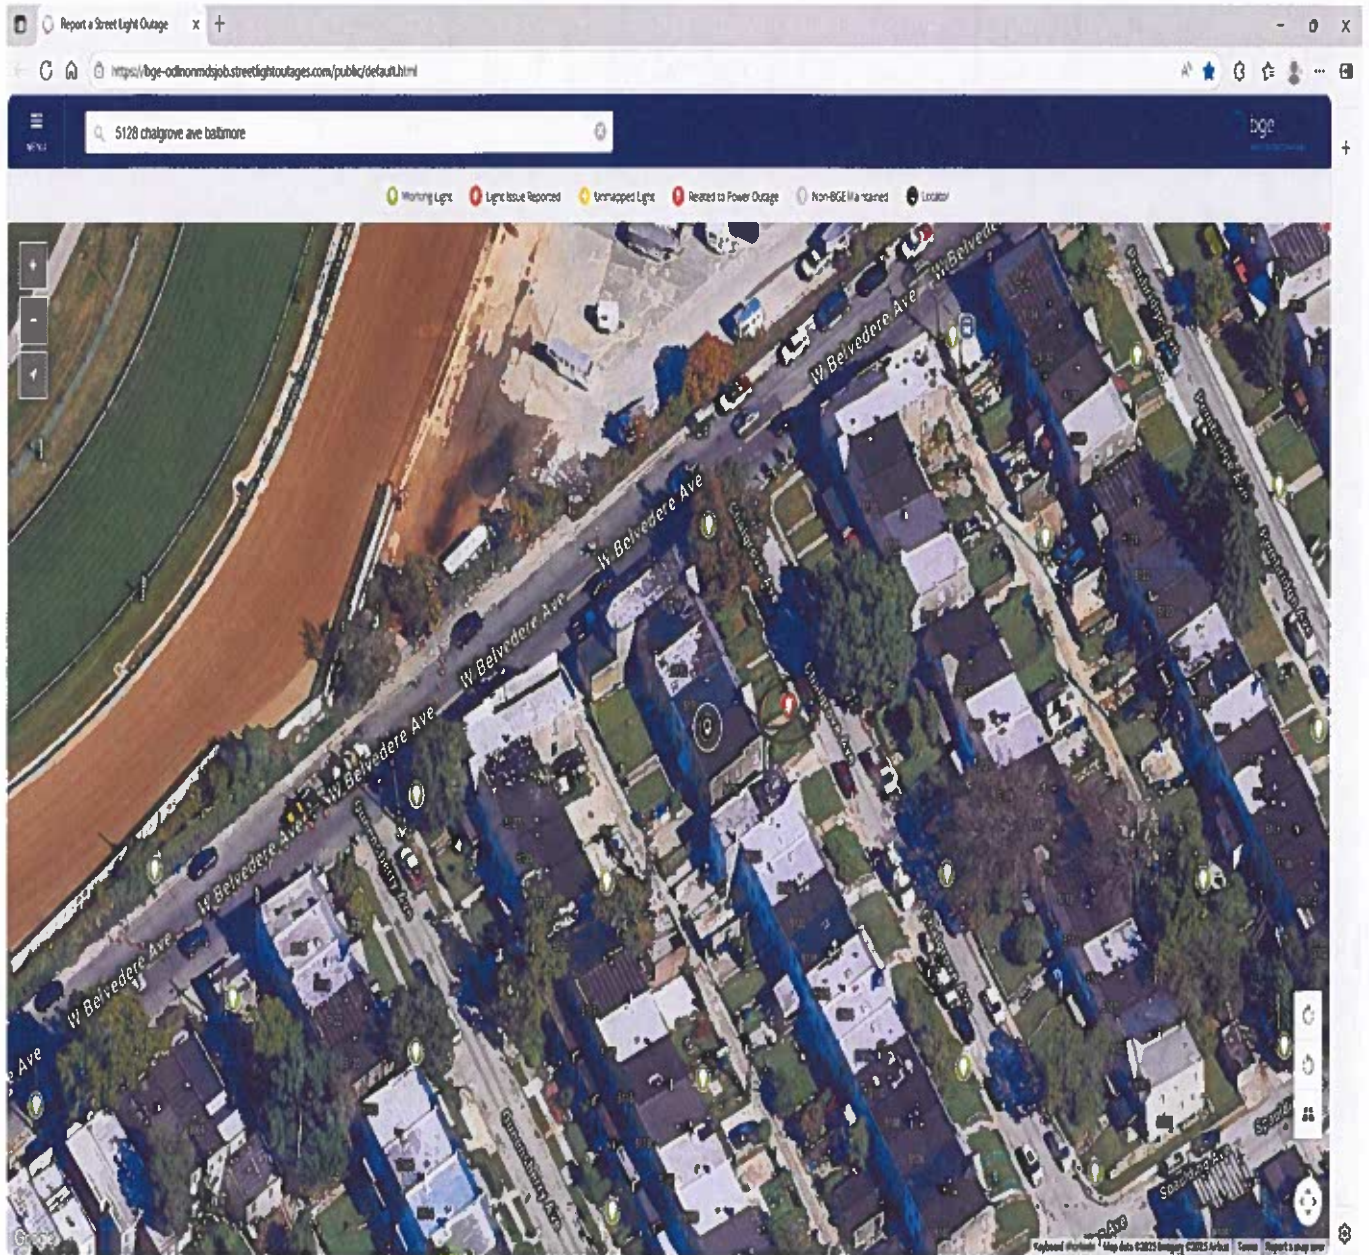
Missing ☒

**NEEDS  
New  
BASE**

Bolts ☒  
Wires ☒  
Conduit ☒

Other \_\_\_\_\_  
**Work order #  
20287102**
