Inspections: Damaged Pole Report

Service Request: 25-00705361 Sector: \_\_\_\_\_ Gateway: \_\_\_\_\_ Primary: \_\_\_\_\_  
 Location on Service Request: No Robinson St & Pulaski Hwy  
 Grid : 4010310 LLC: 6260

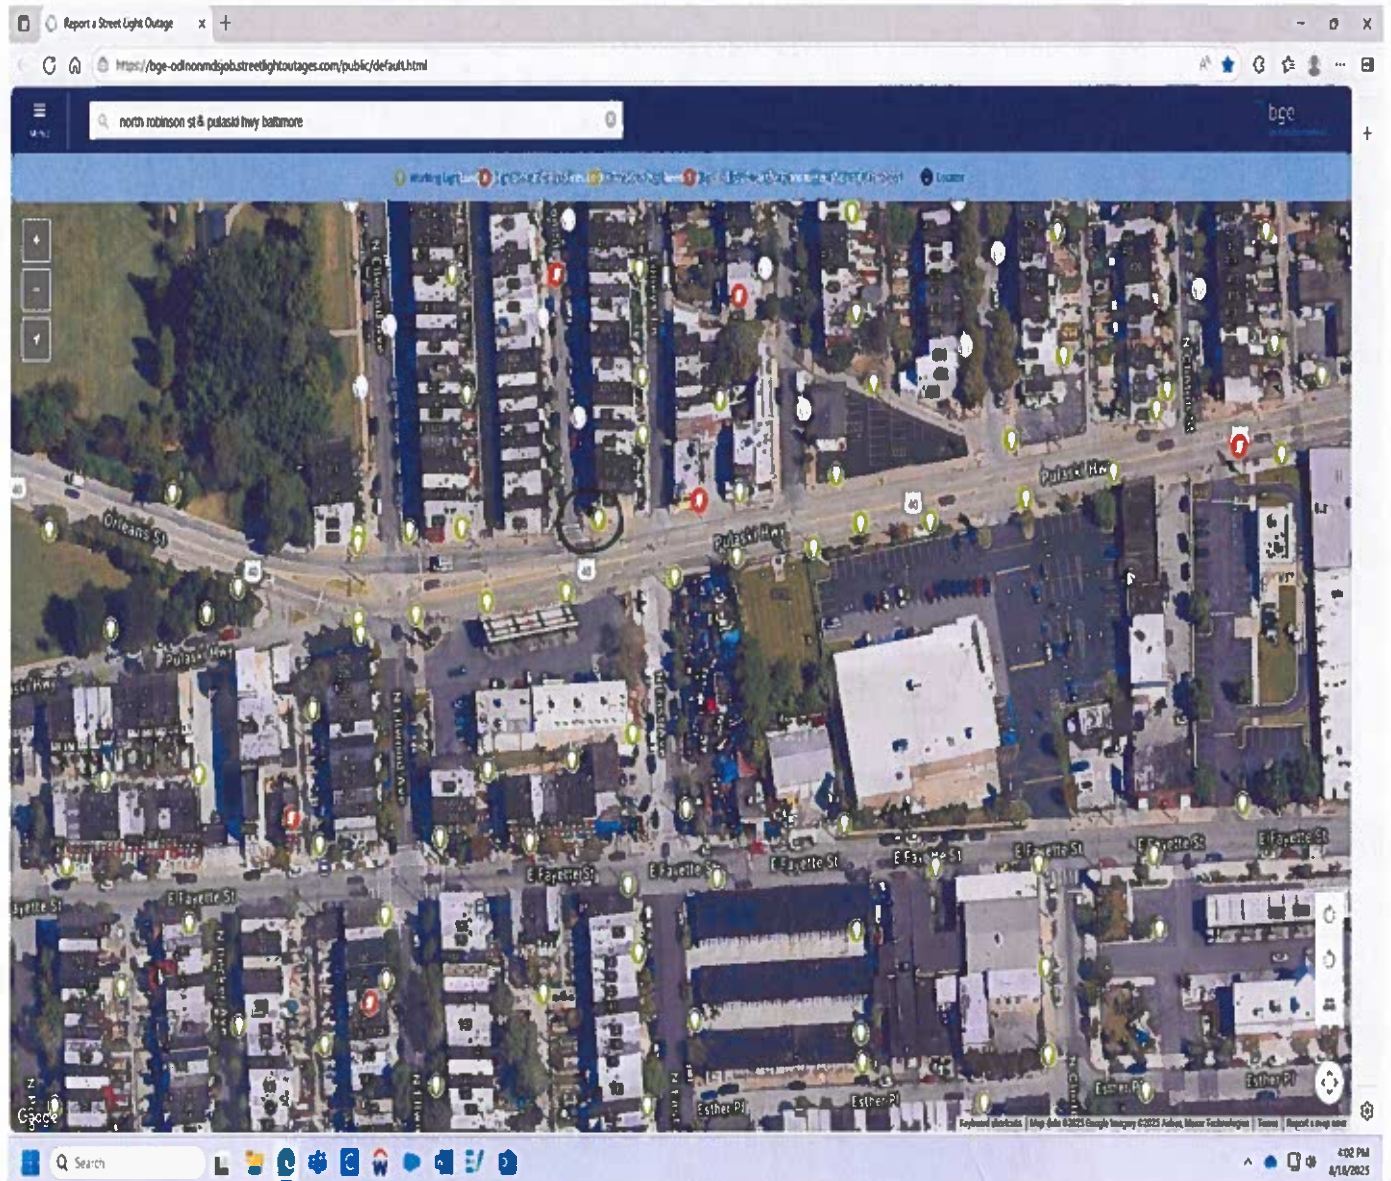
Deteriorated \_\_\_\_\_  
 Missing ☒  
 Damaged \_\_\_\_\_  
 Arm/Fixture Missing \_\_\_\_\_  
 Other \_\_\_\_\_

Otterbein  
Acorn Fixture
