# Inspections: Damaged Pole Report

Service Request: 25-00709503 Sector: \_\_\_\_\_ Gateway: \_\_\_\_\_ Primary: \_\_\_\_\_

Location on Service Request: 502 N. Chapel Gate LN

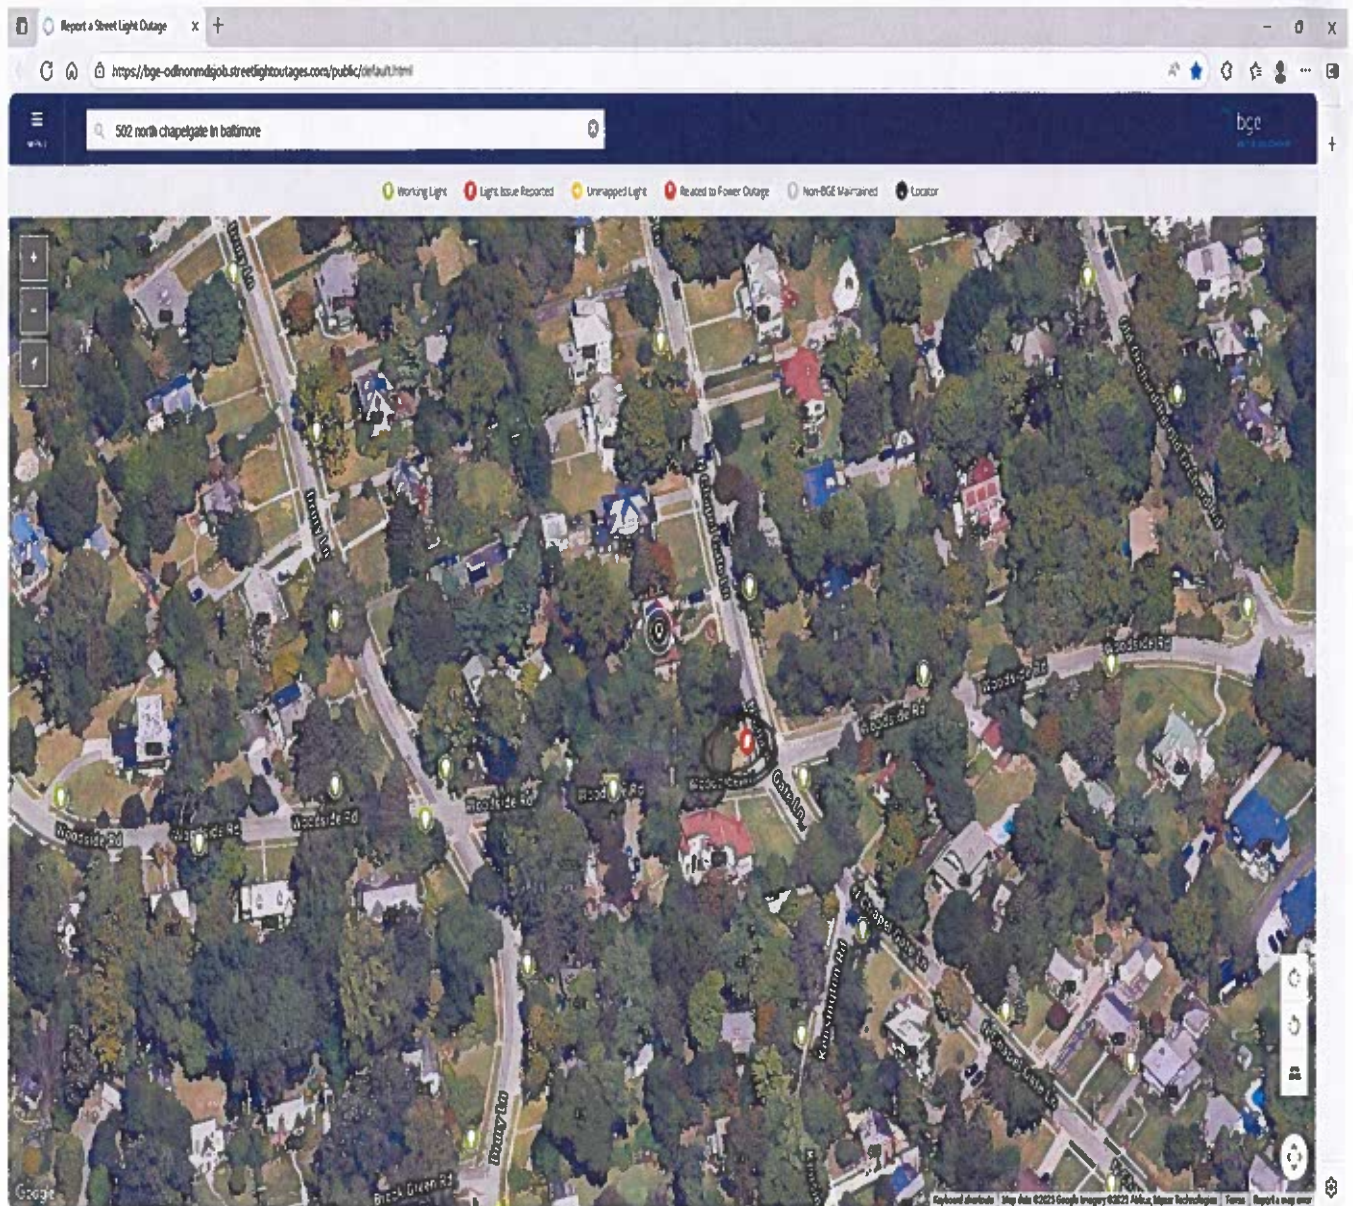
Home landscape  
Acorn Fixture
