# Inspections: Damaged Pole Report

Service Request: 25-00706519 Sector: \_\_\_\_\_ Gateway: \_\_\_\_\_ Primary: \_\_\_\_\_

Location on Service Request: 2300 Garrison Blvd

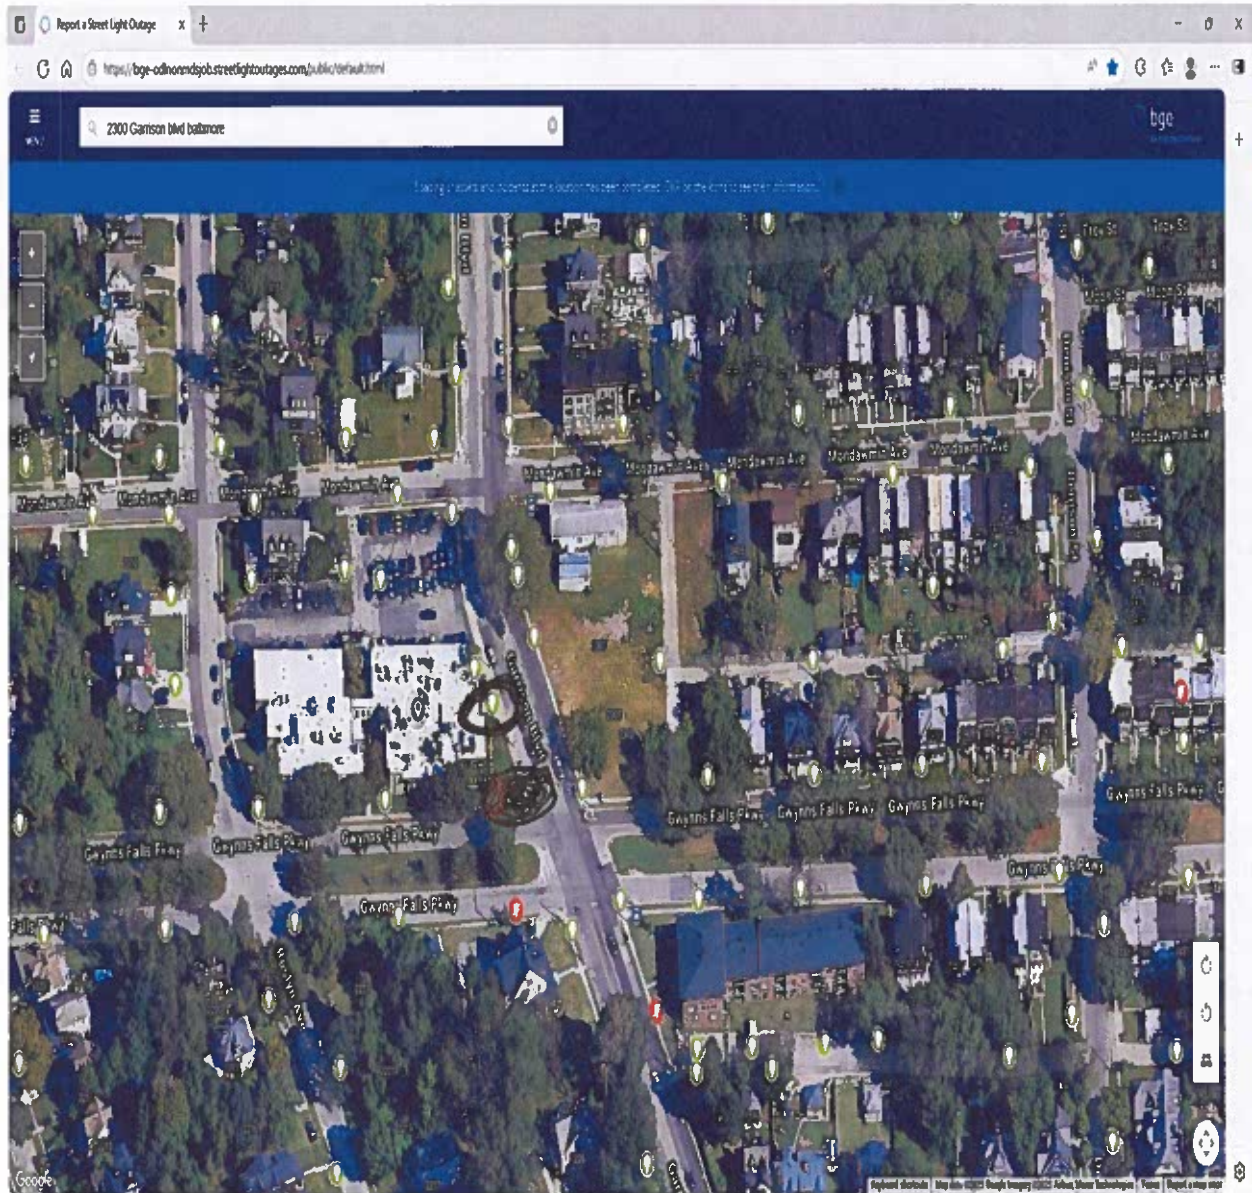
Deteriorated ☒

Missing ☒

25 Foot Aluminum  
pole  
Color Head  
LED
