8-21-25

Quest Management  
1929 Old Valley Road  
Stevenson, Md. 21153

RE: 209@Pickwick  
2700 Fallstaff Road Baltimore, Md.  
Poor Water Flow / Water Usage

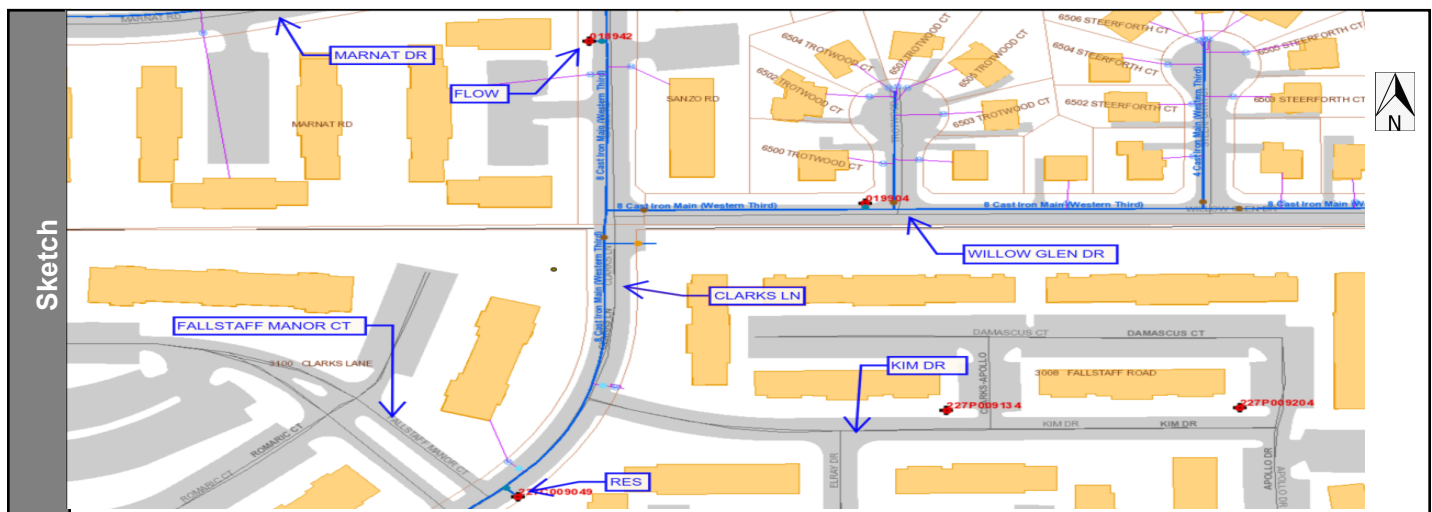
| Test Data | Residual Hydrant "R" or "RES" | | | Flow Hydrant "F" or "FLOW" | | |
|---|---|---|---|---|---|---|
| | Asset Location: | Static Pressure (psi): | 50 | Asset Location: | Measured Flow (gpm): | 1007 |
| | FH-Clarks Ln @ Fallstaff Manor Ct | Residual Pressure (psi): | 46 | FH-Clarks Ln @ Marnat Rd | Calculated Flow at 20 psi (gpm): | 2989.252311 |
| | Asset Number: 227C009049 | Pressure Drop: | 4 | Asset Number: 018942 | $Flow\ Calculation: Q_{max} = Q \times \frac{(P_{static} - 20)^{.54}}{(P_{static} - P_{residual})^{.54}}$ | |
| | | Pressure Drop to 20 psi: | 30 | | | |
