# Inspections: Damaged Pole Report

Service Request 25-00736196 Sector: \_\_\_\_\_ Gateway \_\_\_\_\_ Primary: \_\_\_\_\_

Location on Service Request: 613 S. East Ave

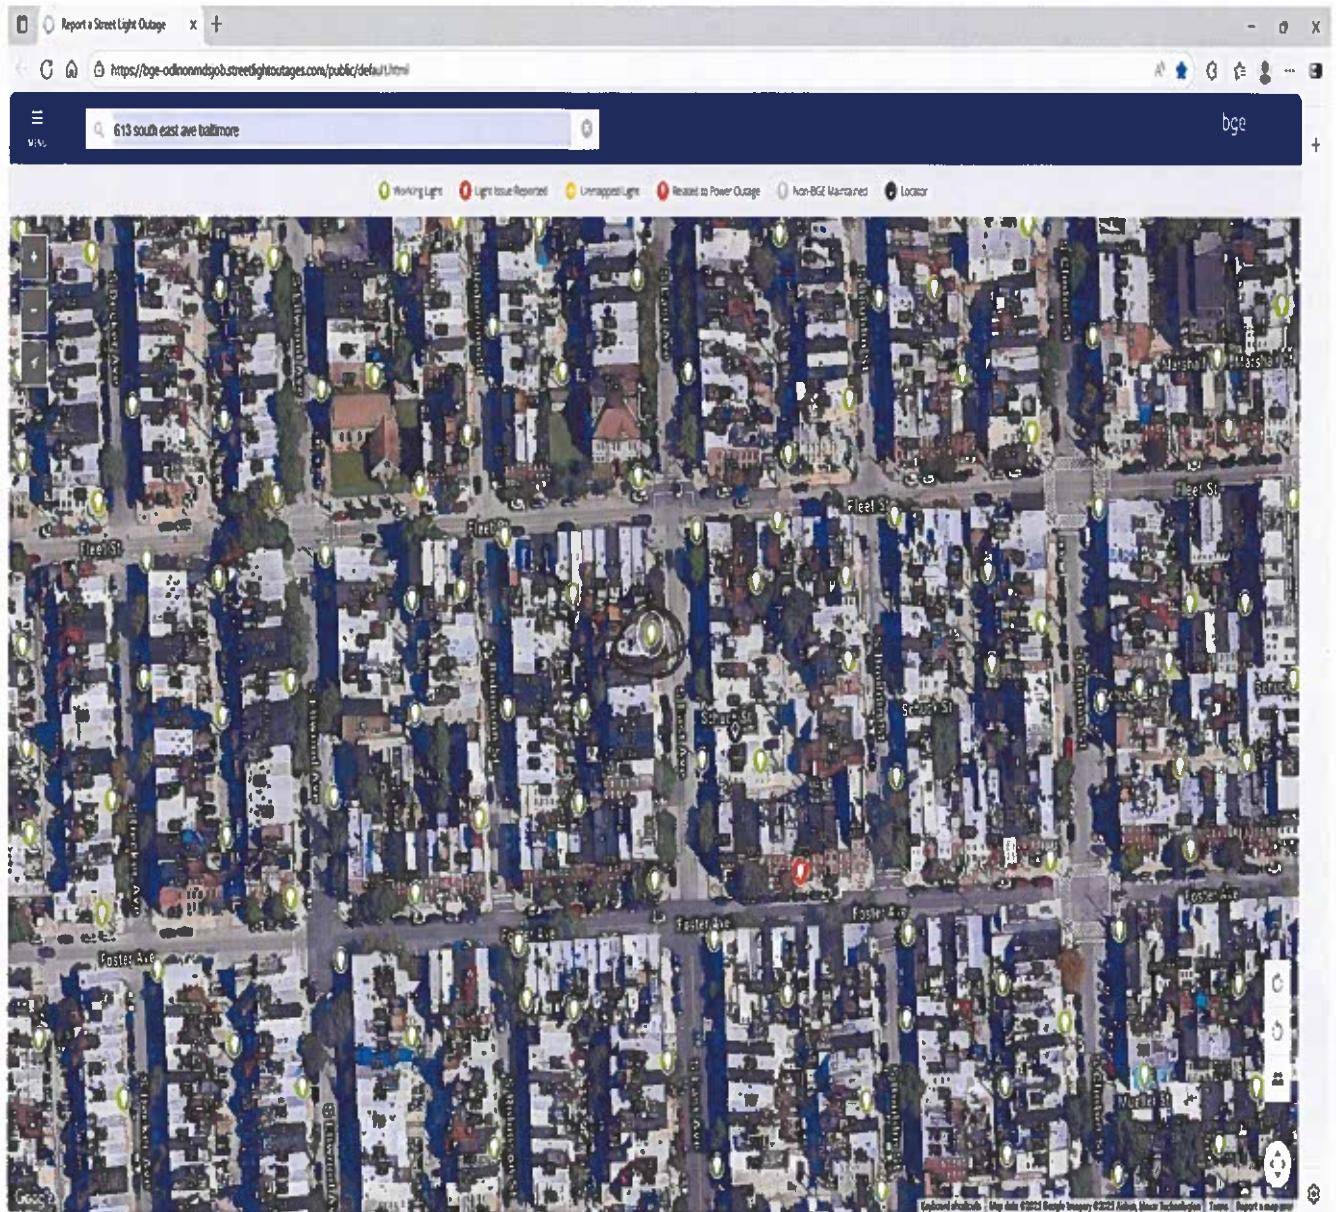
Deteriorated ☒

Missing ☒

Bolts ☒  
Wires ☒  
Conduit ☒

25 Foot  
Aluminum pole  
column mounted  
LED
