# Inspections: Damaged Pole Report

Service Request 25-00746470 Sector: \_\_\_\_\_ Gateway: \_\_\_\_\_ Primary: \_\_\_\_\_

Location on Service Request: 423 E. Hamburg St

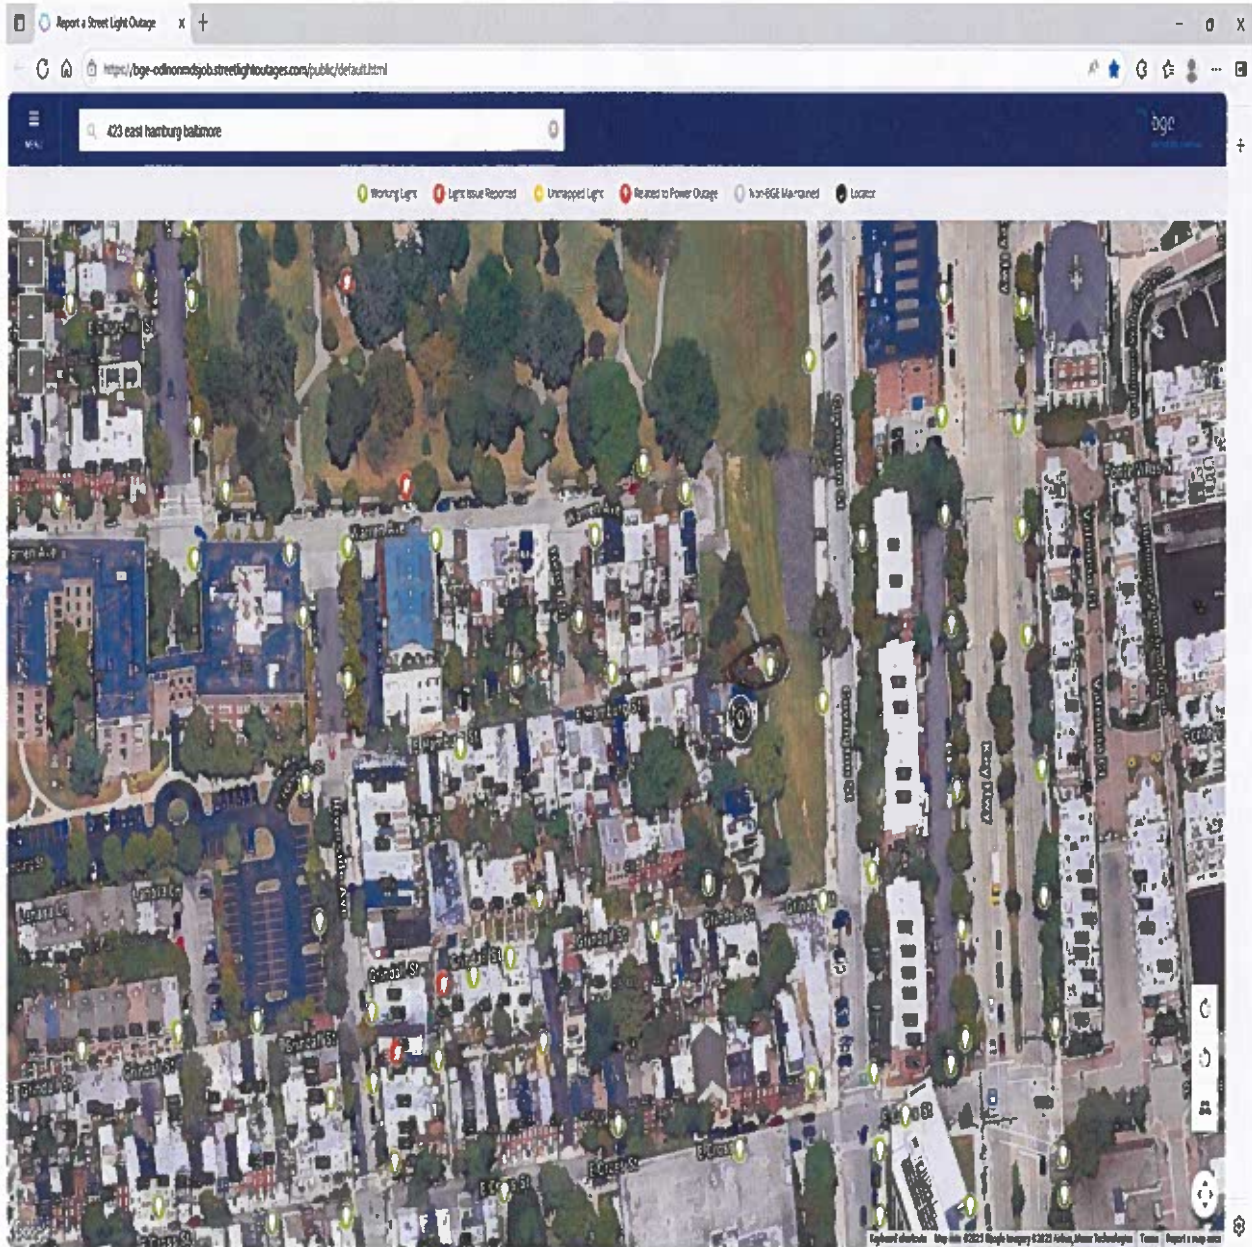
Missing ☒

25 Foot  
Aluminum pole  
cobra head  
LED
