# Inspections: Damaged Pole Report

Service Request 25-00748066 Sector: \_\_\_\_\_ Gateway: \_\_\_\_\_ Primary: \_\_\_\_\_

Location on Service Request: 1434 Bonsai St

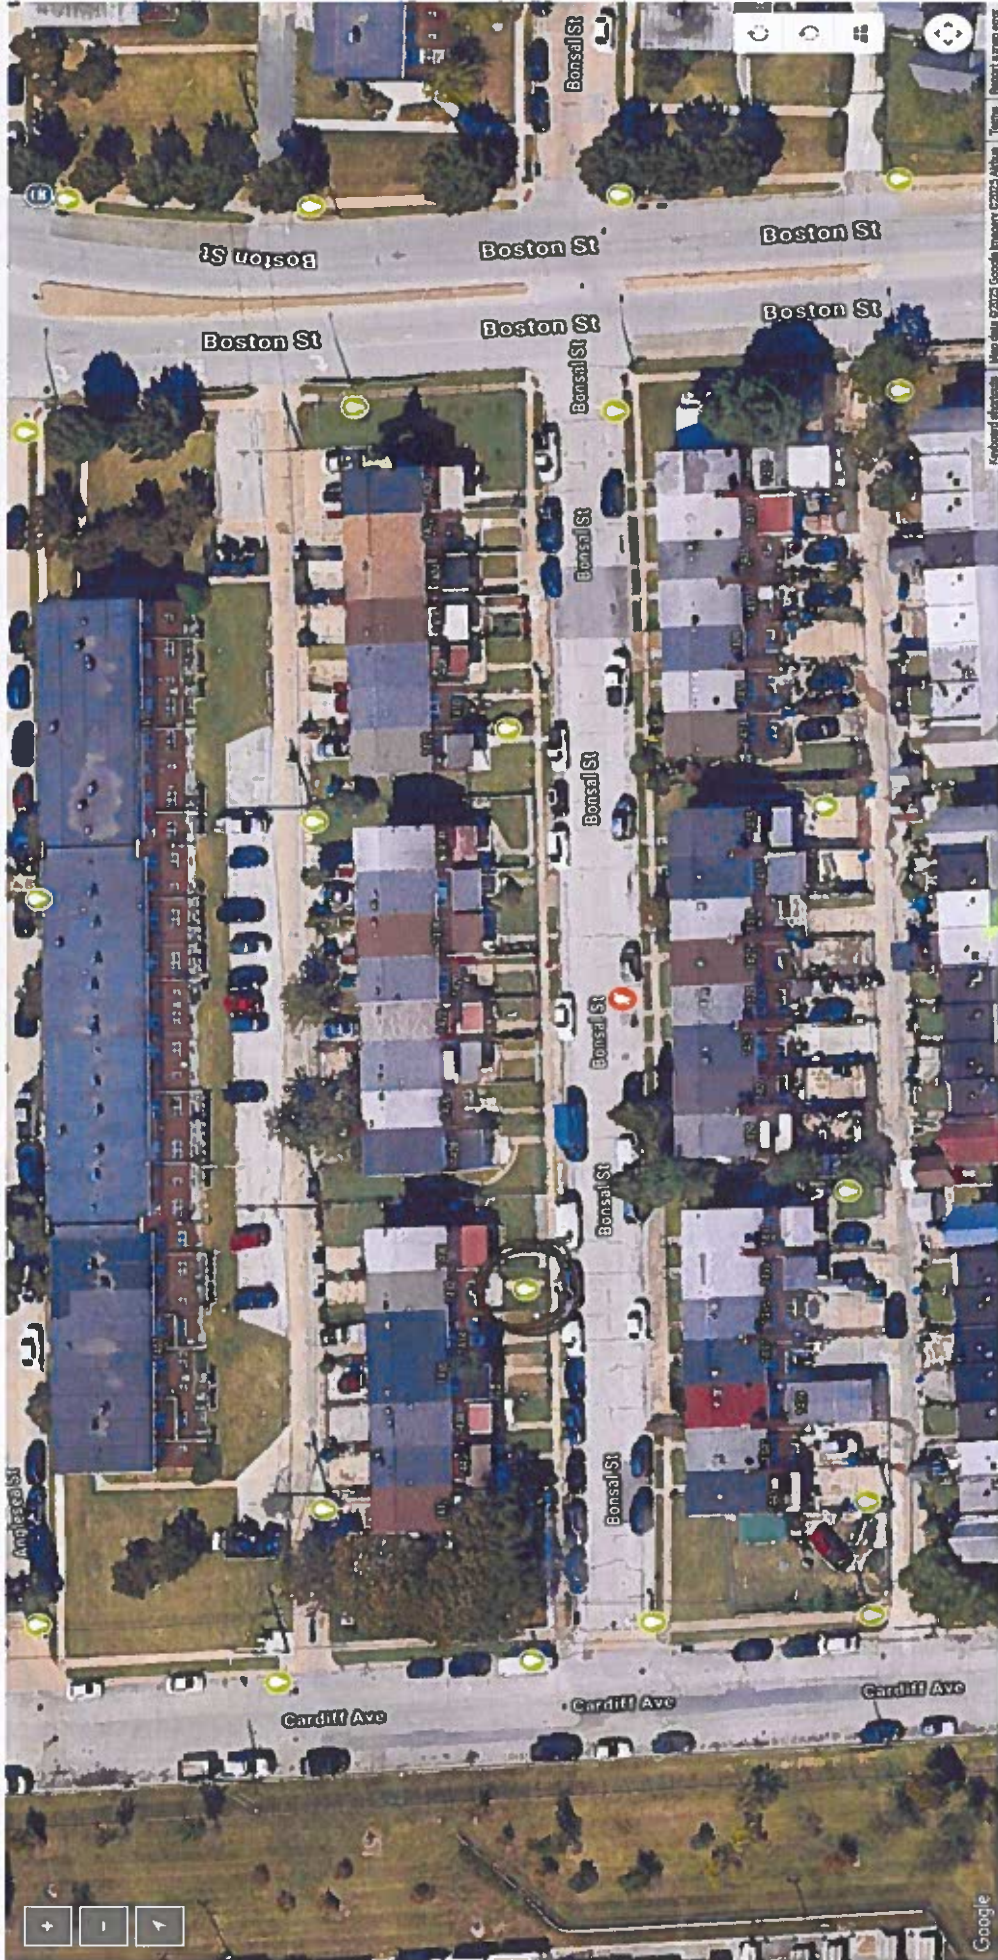
Deteriorated ☒  
Missing \_\_\_\_\_  
Damaged \_\_\_\_\_  
Arm/Fixture Missing \_\_\_\_\_  
Other \_\_\_\_\_

NEeds  
New Base

Steel  
PMA  
HPS
