# Inspections: Damaged Pole Report

Service Request: 25-00812803 Sector: \_\_\_\_\_ Gateway: \_\_\_\_\_ Primary: \_\_\_\_\_  
 Location on Service Request: S. Frederick<sup>st</sup> & Water<sup>st</sup>  
 Grid : 4010130 LLC: 7054

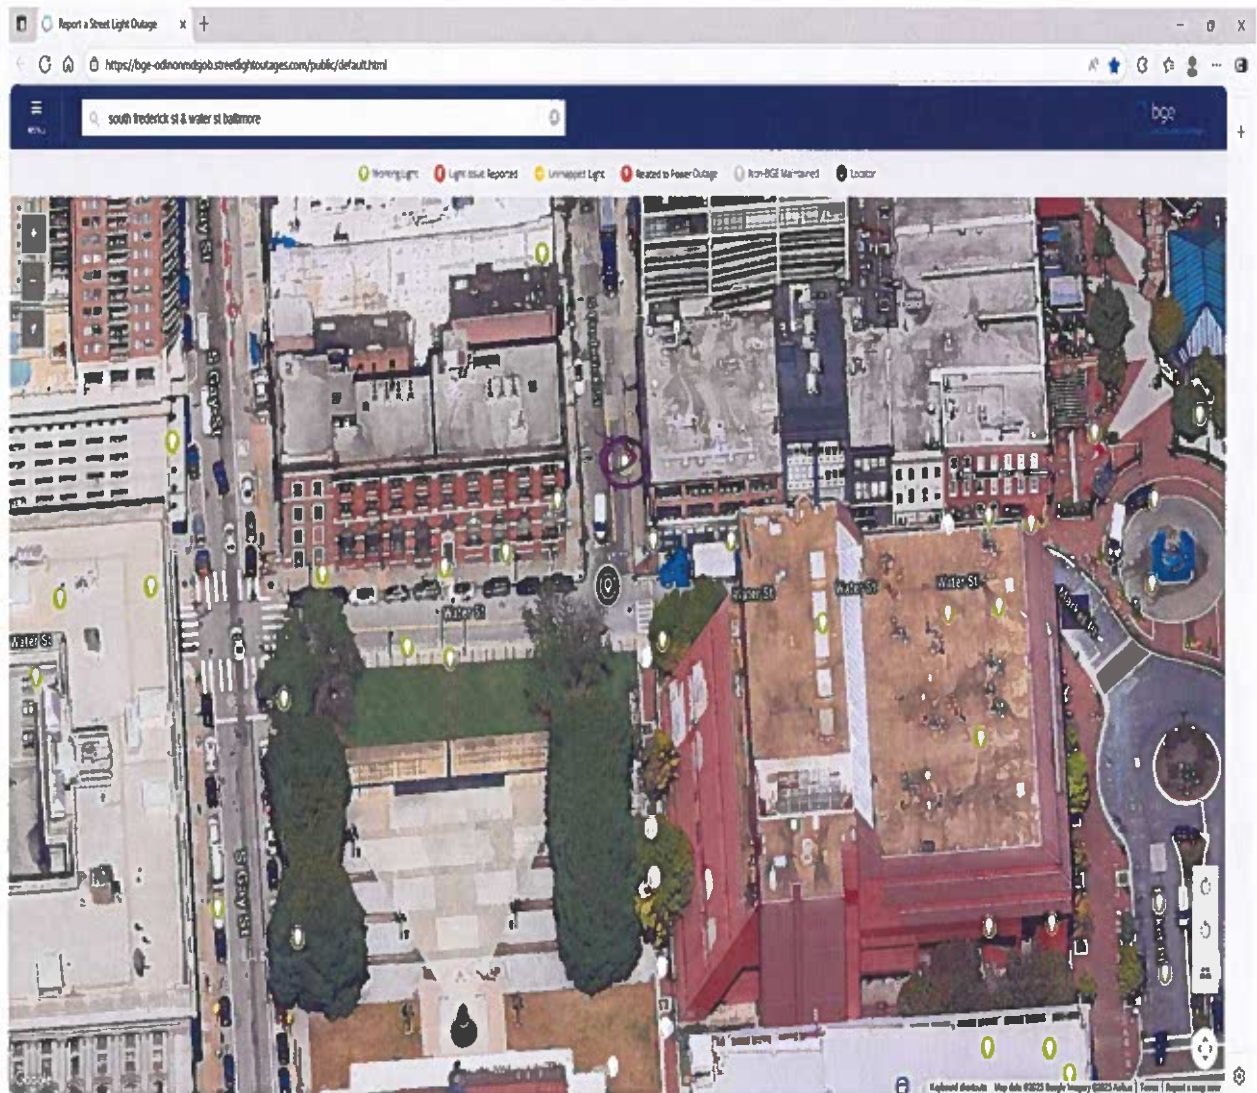
Deteriorated \_\_\_\_\_  
 Missing ☒  
 Damaged \_\_\_\_\_  
 Arm/Fixture Missing \_\_\_\_\_  
 Other \_\_\_\_\_

Other than  
ACORN Fixture
