# Inspections: Damaged Pole Report

Service Request: 25-00938659 Sector: \_\_\_\_\_ Gateway: \_\_\_\_\_ Primary: \_\_\_\_\_

Location on Service Request: 1129 S. Charles St

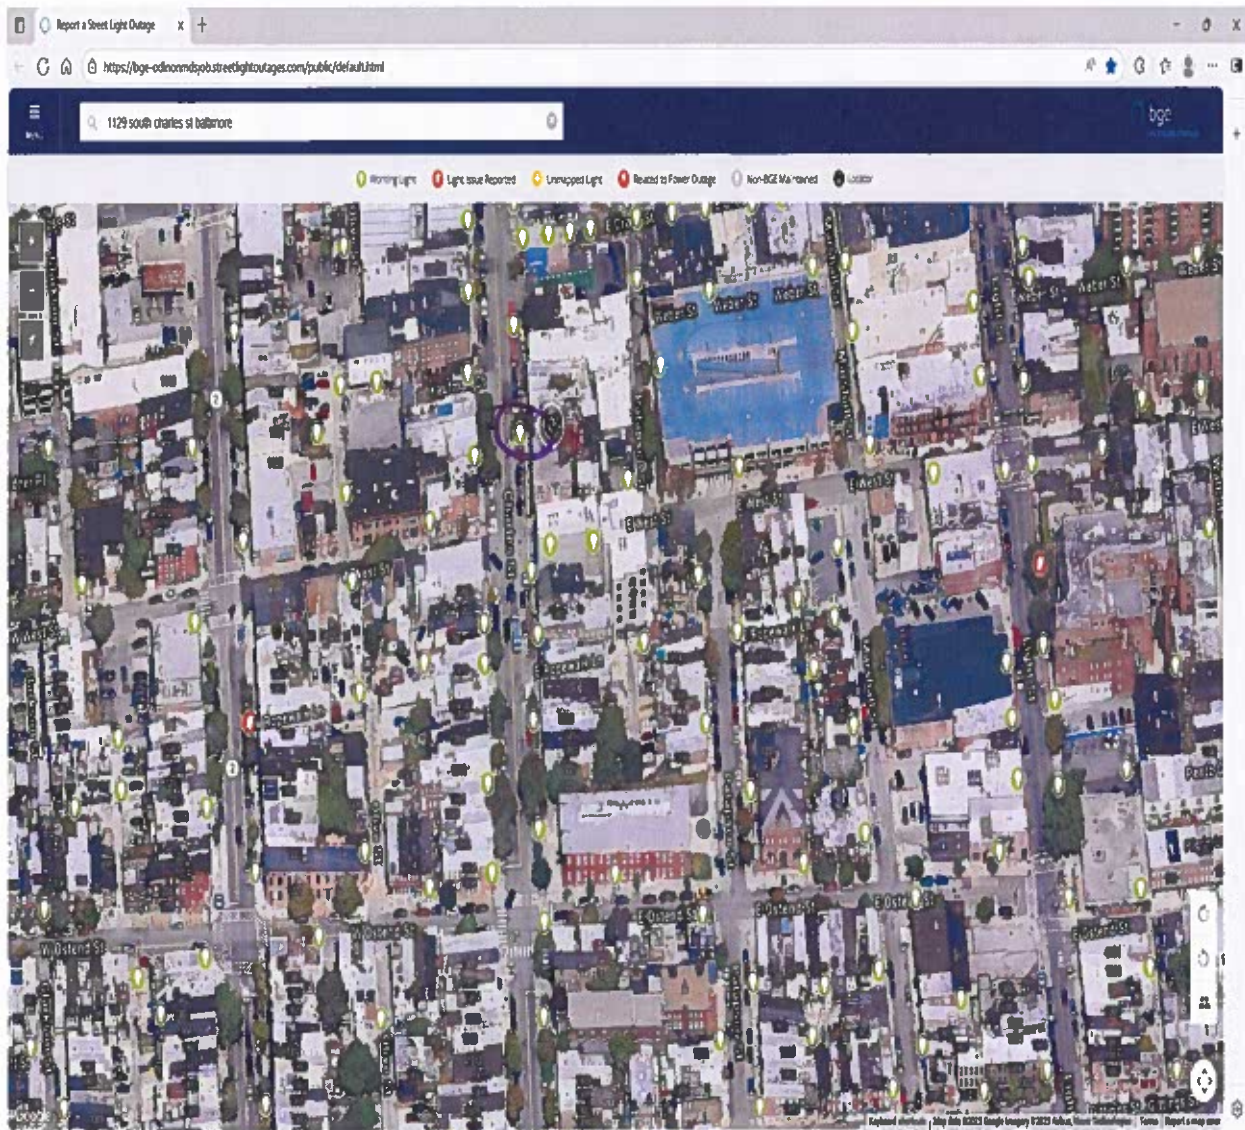
Missing ☒

Ottenberr  
Acorn Fixture
