# Inspections: Damaged Pole Report

Service Request: 25-00846073 Sector: \_\_\_\_\_ Gateway: \_\_\_\_\_ Primary: \_\_\_\_\_  
 Location on Service Request: 700 S. Robinson St  
 Grid : 4010330 LLC: 7462

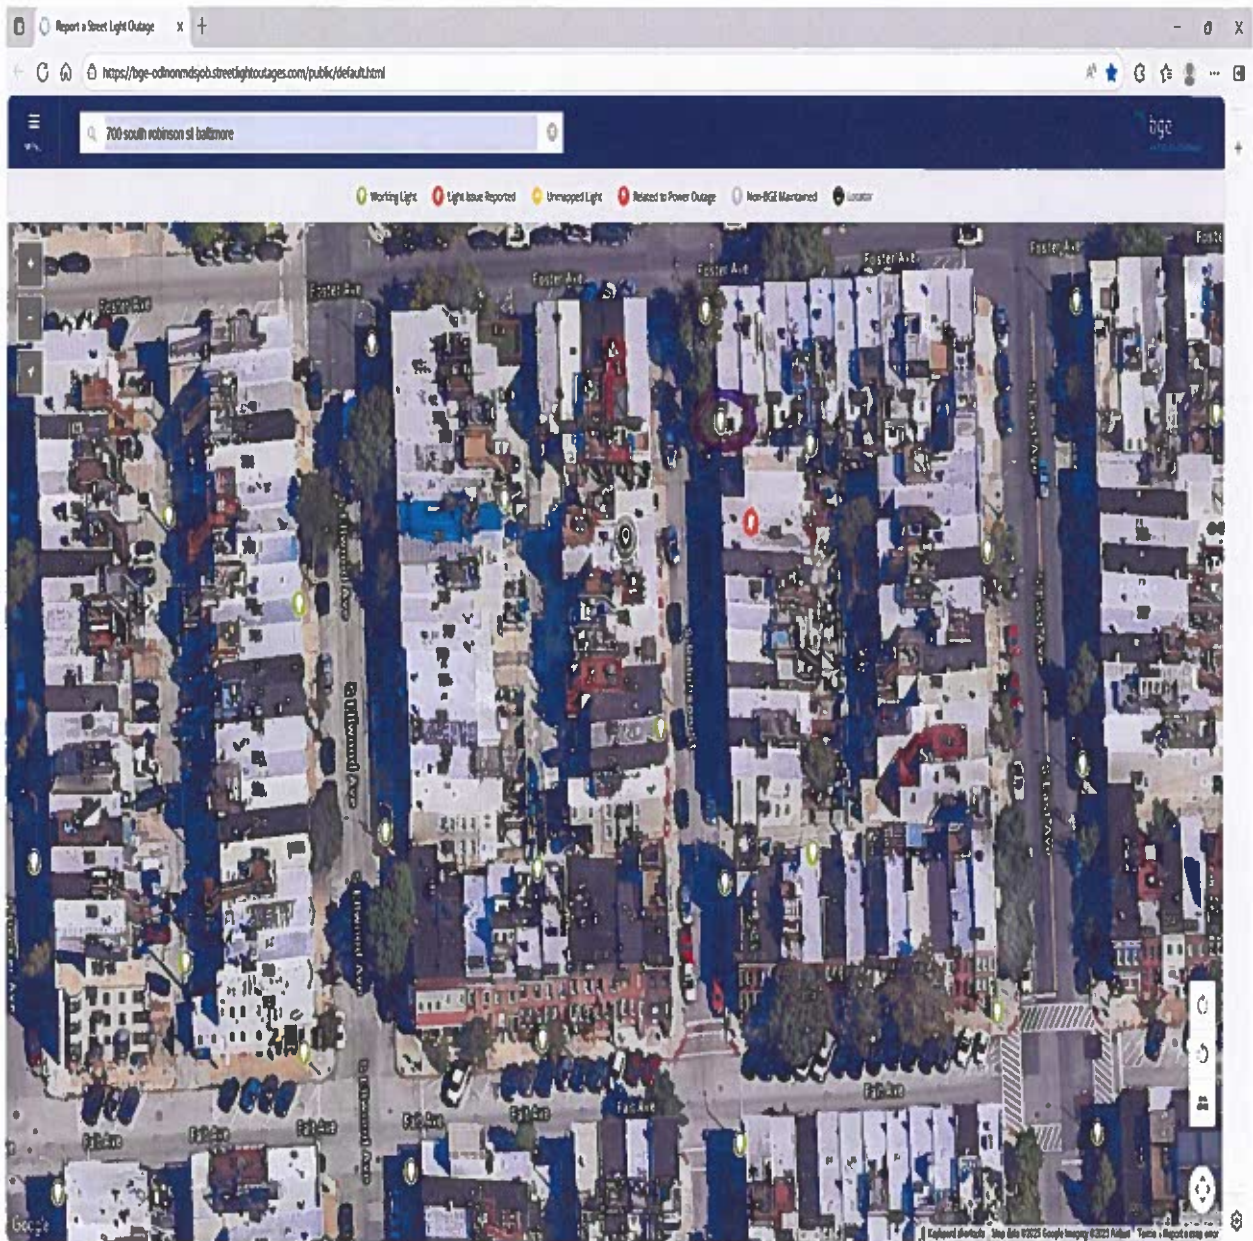
Deteriorated ☒  
 Missing ☒  
 Damaged \_\_\_\_\_  
 Arm/Fixture Missing \_\_\_\_\_  
 Other \_\_\_\_\_

Bolts ☒  
 Wires ☒  
 Conduit ☒

NEEDS  
NEW  
BASE
