# Inspections: Damaged Pole Report

Service Request: 25-00853284 Sector: \_\_\_\_\_ Gateway: \_\_\_\_\_ Primary: \_\_\_\_\_

Location on Service Request: 6011 Pinehurst Rd

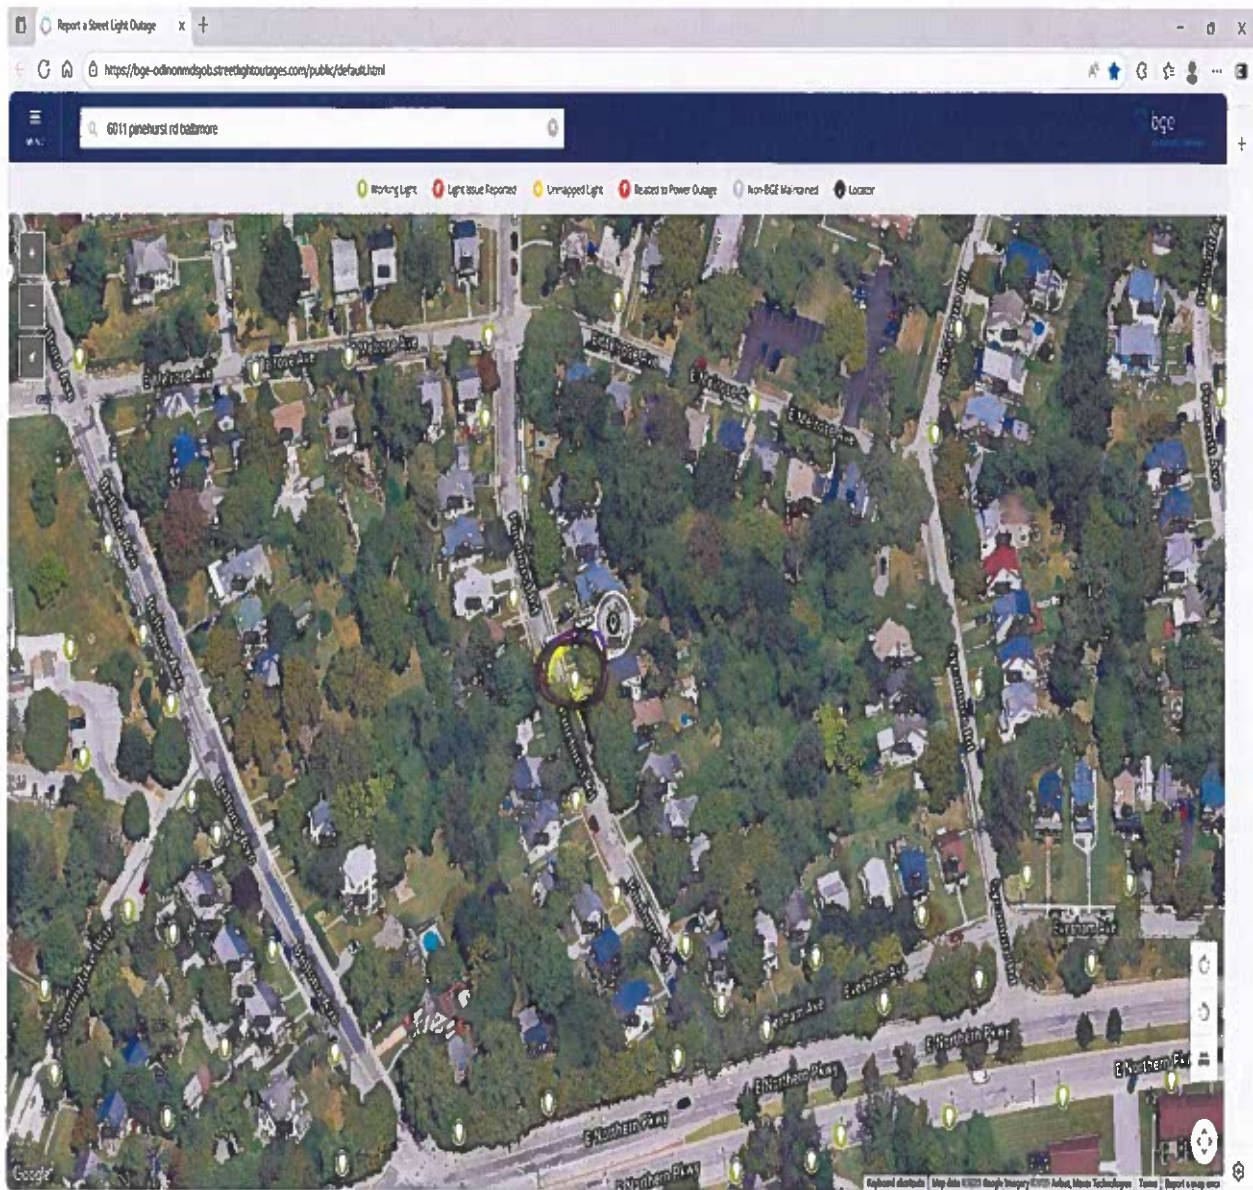
Missing ☒

**NEEDS  
NEW BASE**

PMIA  
HPS
