# Inspections: Damaged Pole Report

Service Request: 25-00850168 Sector: \_\_\_\_\_ Gateway: \_\_\_\_\_ Primary: \_\_\_\_\_  
 Location on Service Request: 1414 E. Cold Spring Ln  
 Grid : 2040230 LLC: 7052

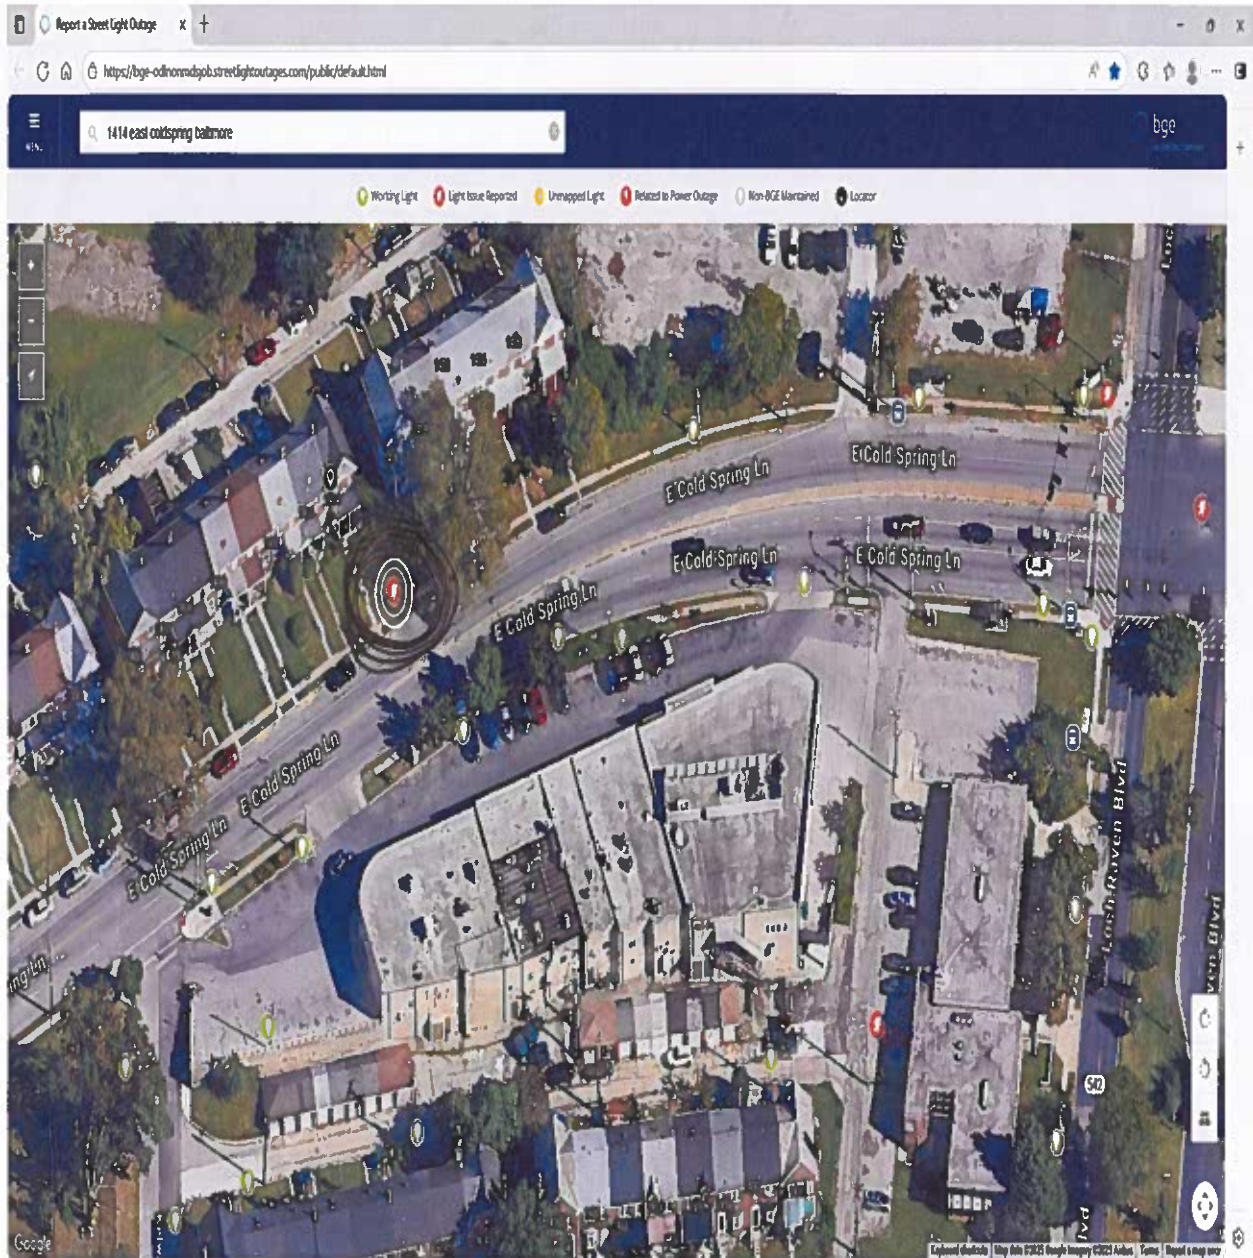
25 Foot  
Aluminum  
pole  
Corner Head  
LED
