# Inspections: Damaged Pole Report

Service Request 25-00870379 Sector \_\_\_\_\_ Gateway \_\_\_\_\_ Primary \_\_\_\_\_  
 Location on Service Request: 7. E. North Ave  
 Grid : 1010120 LLC: 6293

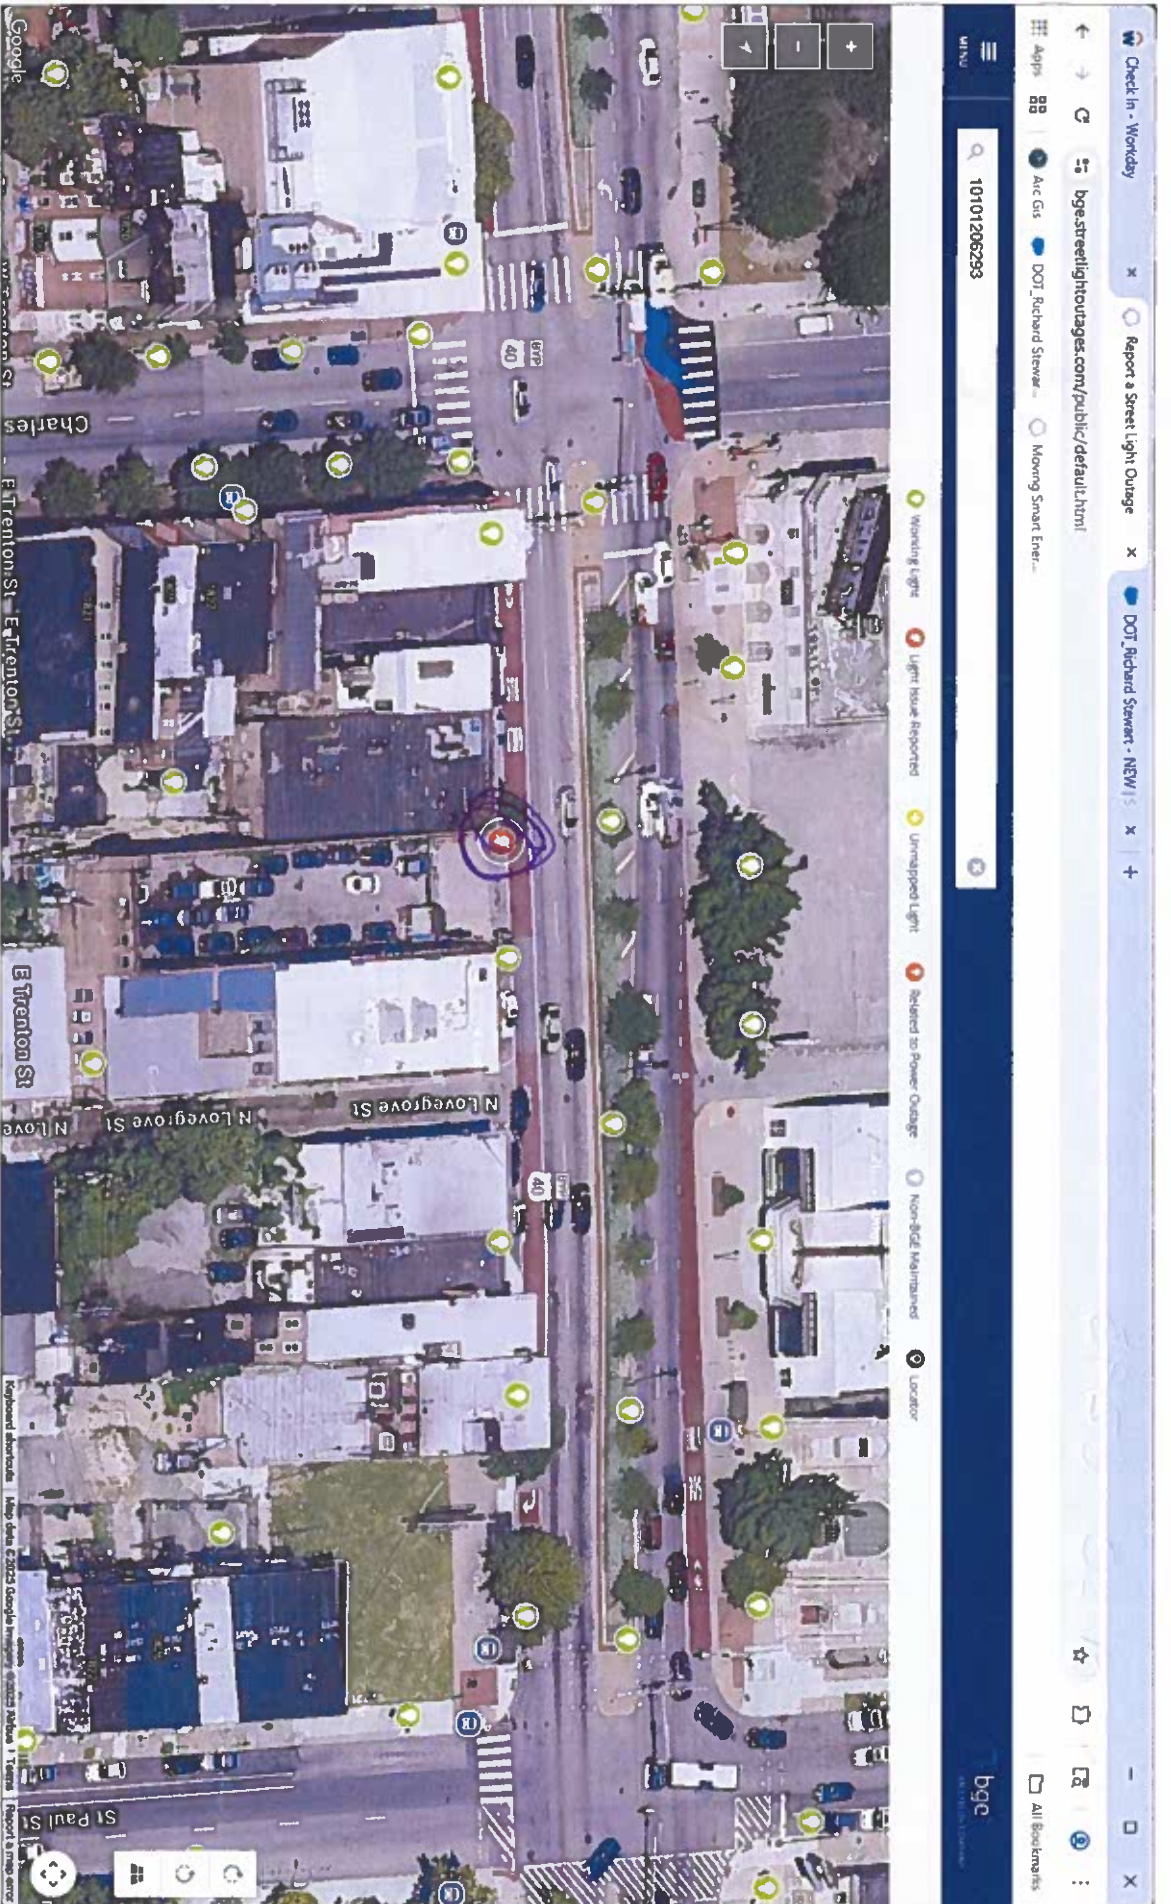
Deteriorated \_\_\_\_\_  
 Missing ☒  
 Damaged \_\_\_\_\_  
 Arm/Fixture Missing \_\_\_\_\_  
 Other \_\_\_\_\_

Home land  
Acorn Fixture
