Inspections: Damaged Pole Report

Service Request 25-00875134 Sector: \_\_\_\_\_ Gateway: \_\_\_\_\_ Primary: \_\_\_\_\_  
 Location on Service Request: 46 E. HAMBURG ST  
 Grid : 4020110 LLC: 7320

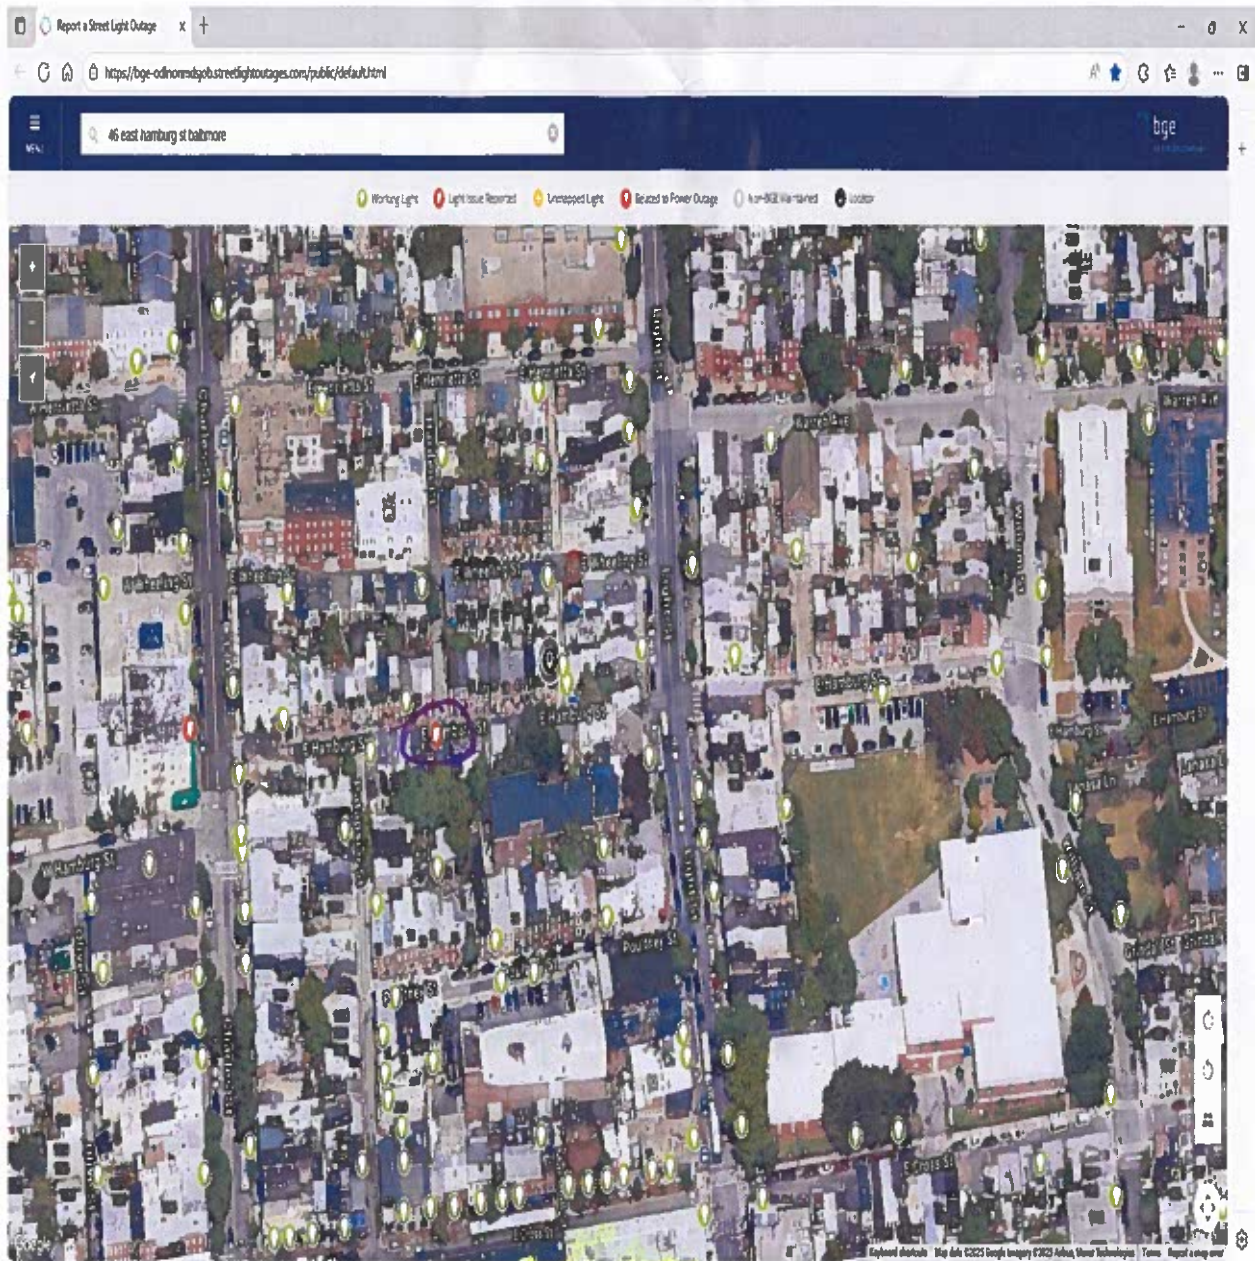
Deteriorated \_\_\_\_\_  
 Missing ☒  
 Damaged \_\_\_\_\_  
 Arm/Fixture Missing \_\_\_\_\_  
 Other \_\_\_\_\_

NEEDS  
 NEW  
 BASE

PMA  
LED
