# Inspections: Damaged Pole Report

Service Request: 25-00874587 Sector: \_\_\_\_\_ Gateway: \_\_\_\_\_ Primary: \_\_\_\_\_  
 Location on Service Request: S. Carey St w W. Pratt St  
 Grid : 3010240 LLC: 7139

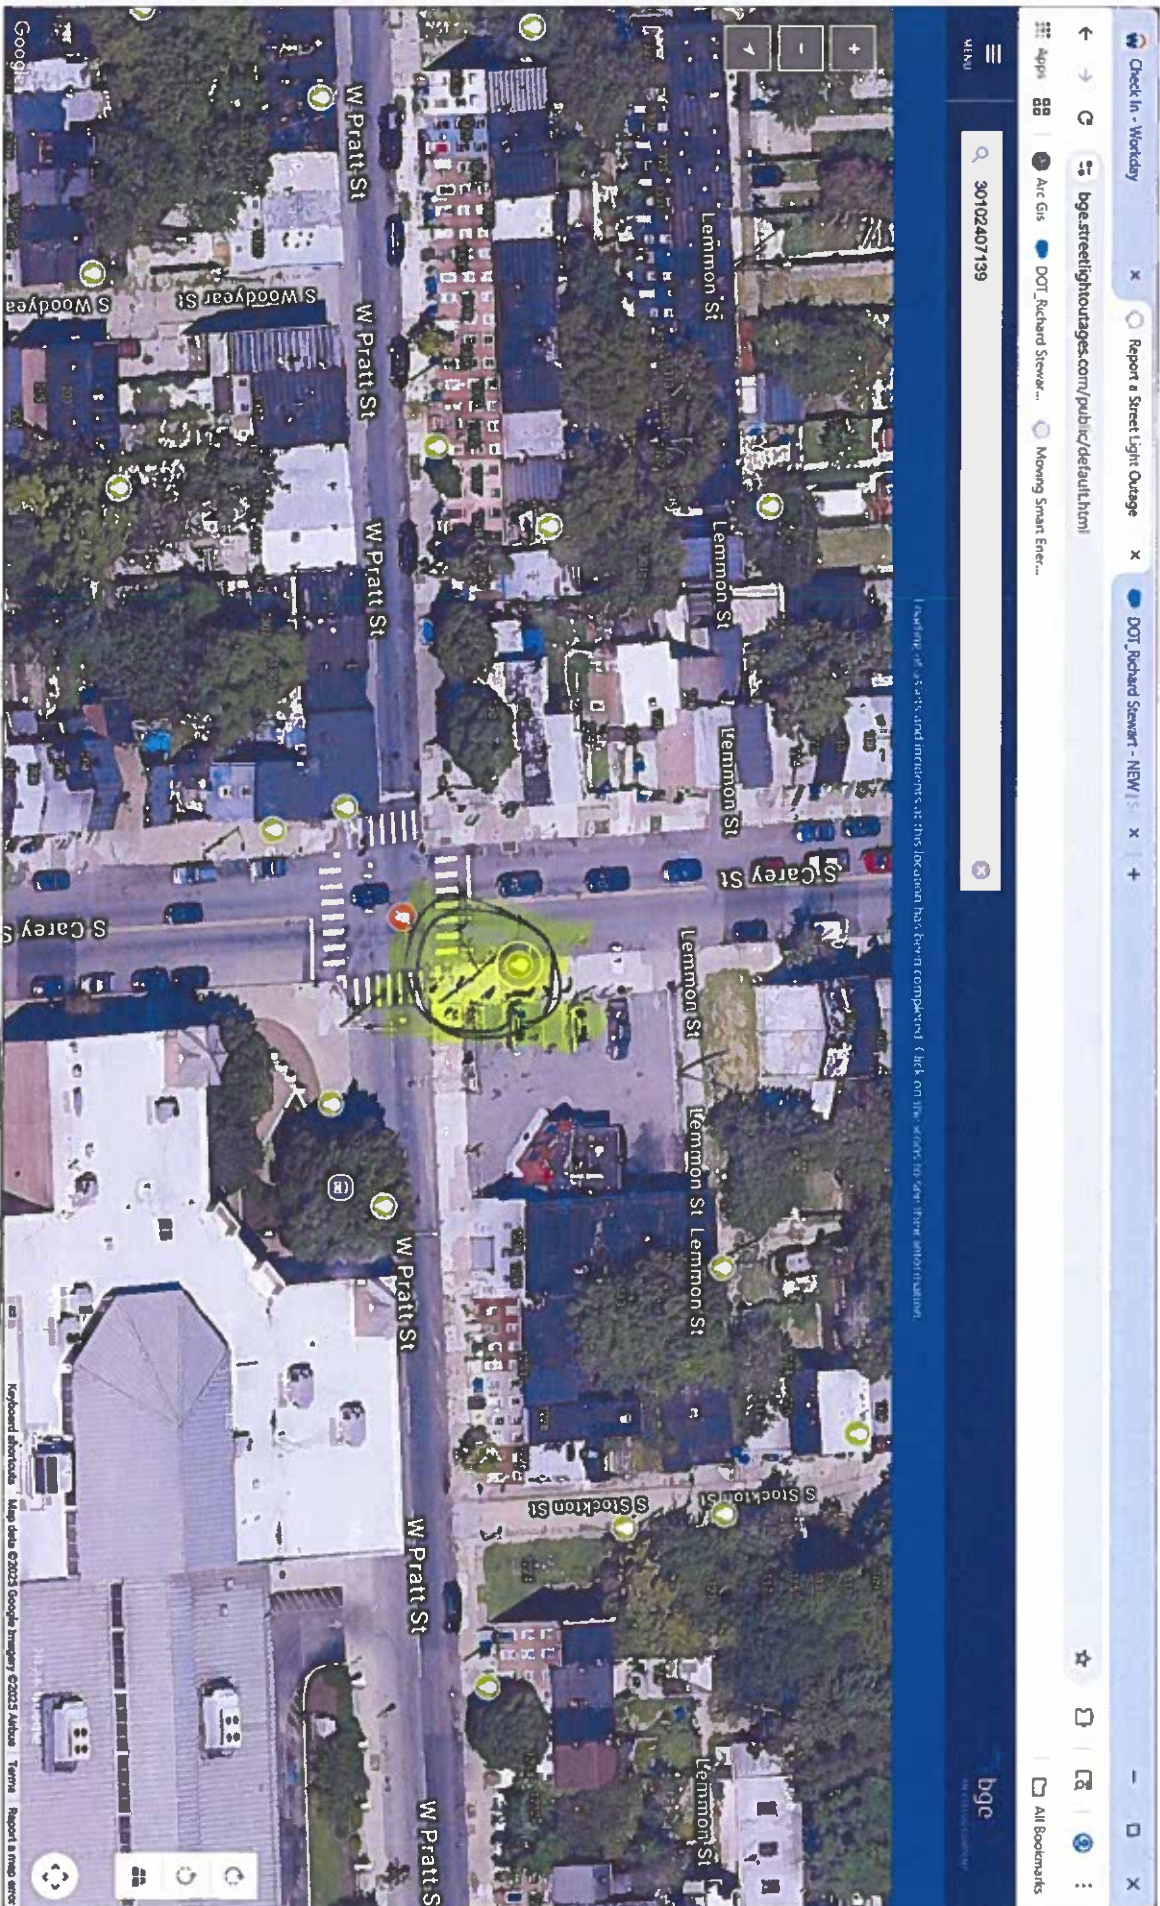
Deteriorated \_\_\_\_\_  
 Missing ☒  
 Damaged \_\_\_\_\_  
 Arm/Fixture Missing \_\_\_\_\_  
 Other \_\_\_\_\_

25 ft CH LED  
Spoke with Frank New picks up pole
