# Inspections Damaged Pole Report

Service Request 25-00889447 Sector Gateway Primary           
 Location on Service Request: 3123 Dillon St  
 Grid : 4020310 LLC: 7292

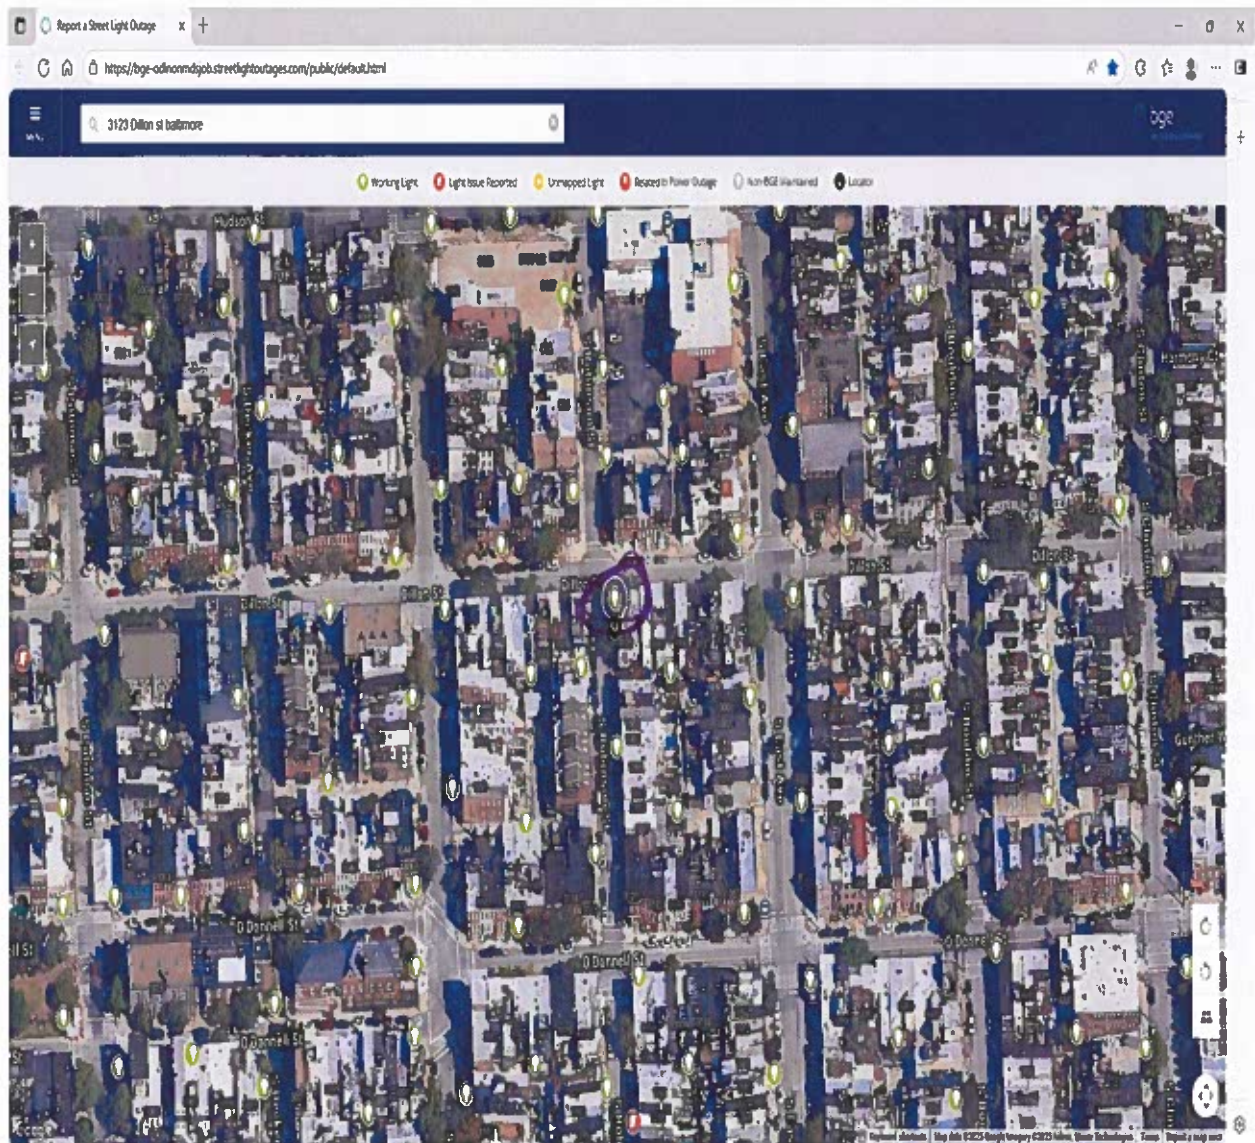
25 Foot Aluminum  
pole  
COBRA HEAD  
LED
