# Inspections: Damaged Pole Report

Service Request 25-00912964 Sector: \_\_\_\_\_ Gateway: \_\_\_\_\_ Primary: \_\_\_\_\_

Location on Service Request: 4847 Belvoir Rd

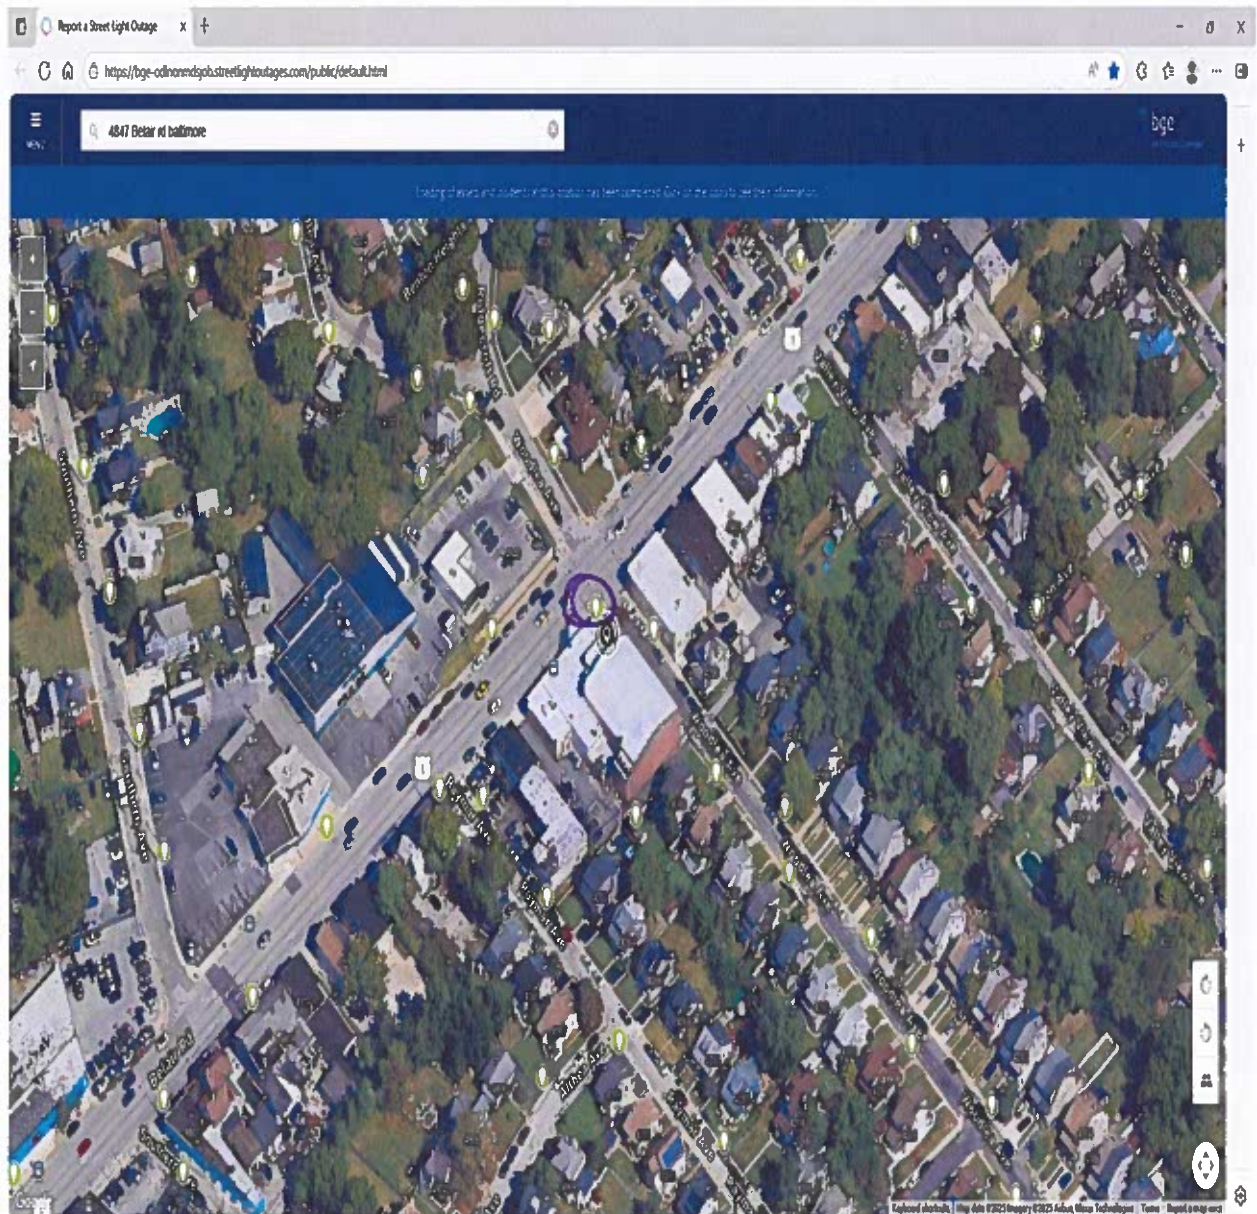
Deteriorated \_\_\_\_\_  
Missing ☒  
Damaged \_\_\_\_\_  
Arm/Fixture Missing \_\_\_\_\_  
Other \_\_\_\_\_

Damaged \_\_\_\_\_  
Missing ☒

25 Foot Aluminum  
pole

Cobra Head  
LED
